**NEAR COLLISION OF TRAINS
NO. IC568 AND 5503 BETWEEN ASZÓD
AND TURA RAILWAY STATIONS
ON 16 MAY 2011**

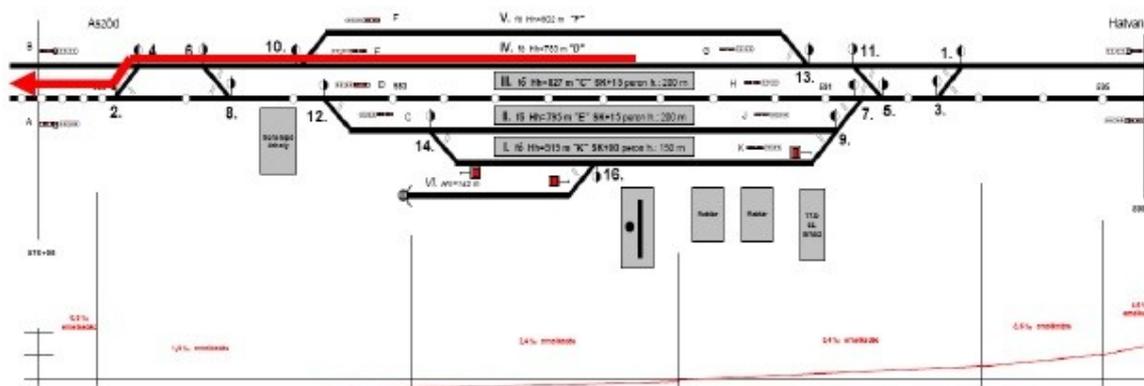
Figure 3: Track line of Train No. 5503 pulling out from Tura railway station

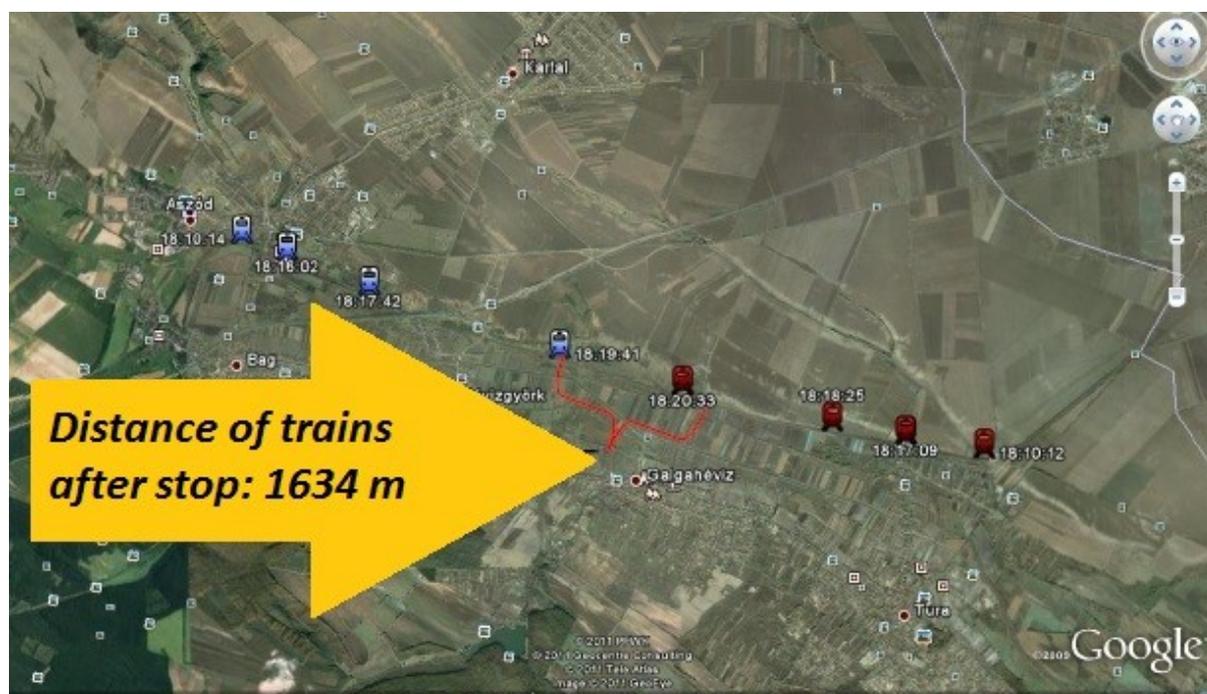
Figure 4: Near collision of the two trains

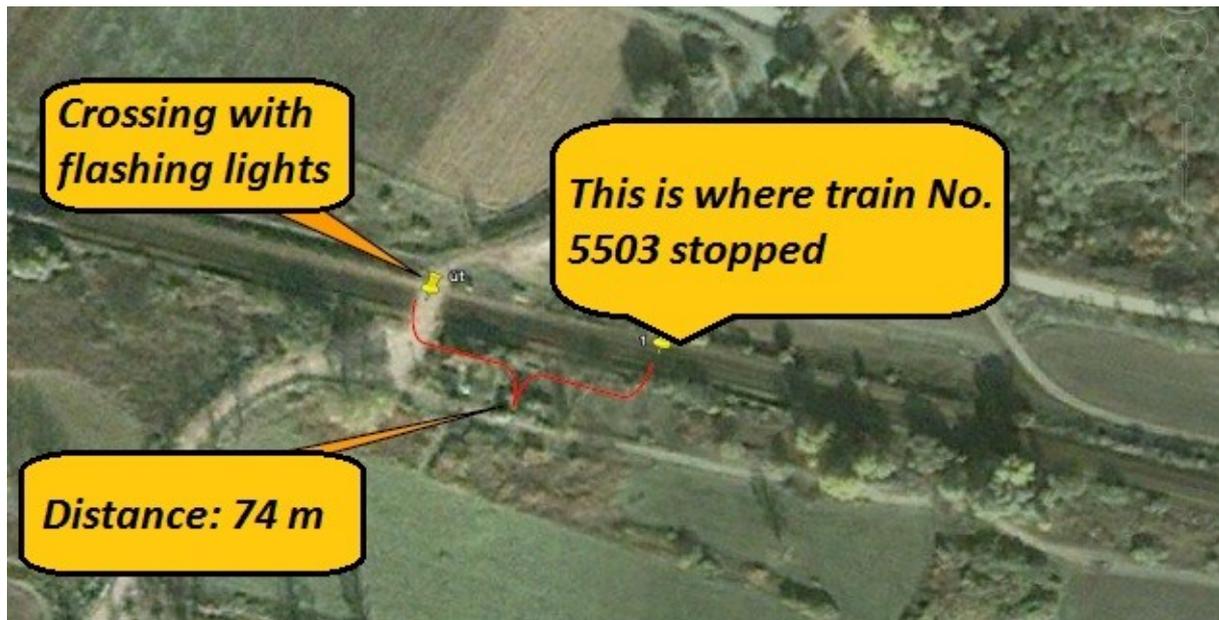
Figure 5: Train No. 5503

The two trains stopped at approximately 1,630 meters apart from each other, and Train No. 5503 stopped at approximately 70 meters from AS555 light barrier signalling white flashing light to those driving on the highway.

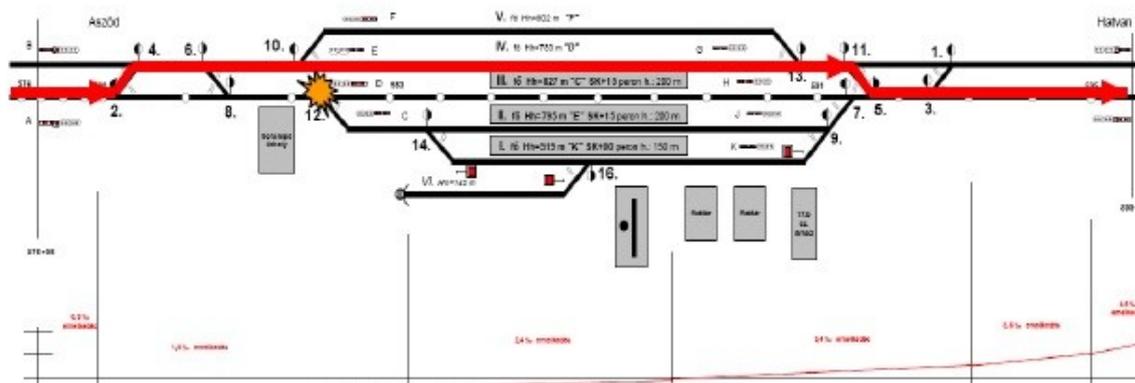
Before the arrival of train No. 5516, the traffic duty officer intended to conduct railway traffic – due to the occurrence of the faulty ‘occupied’ status signal of rail switch No. 12 located at (right-side) shunt line No. III – that he would direct train No. 5516 to a shunt line, to (left-side) shunt line No. IV, and then, after having delivered the Written Order, he would authorise the train to pass at the end-point side of the station to the right-side shunt rail line.

Figure 6: the entry direction of Train No. 5516 due to the apparent 'occupied' status of rail switch No. 12
