Lessons Learnt during Accident Investigations – Case of a Side Collision

Jasmeet Singh Bindra
 B.Tech, MBA
 Director (Safety), Indian Railways

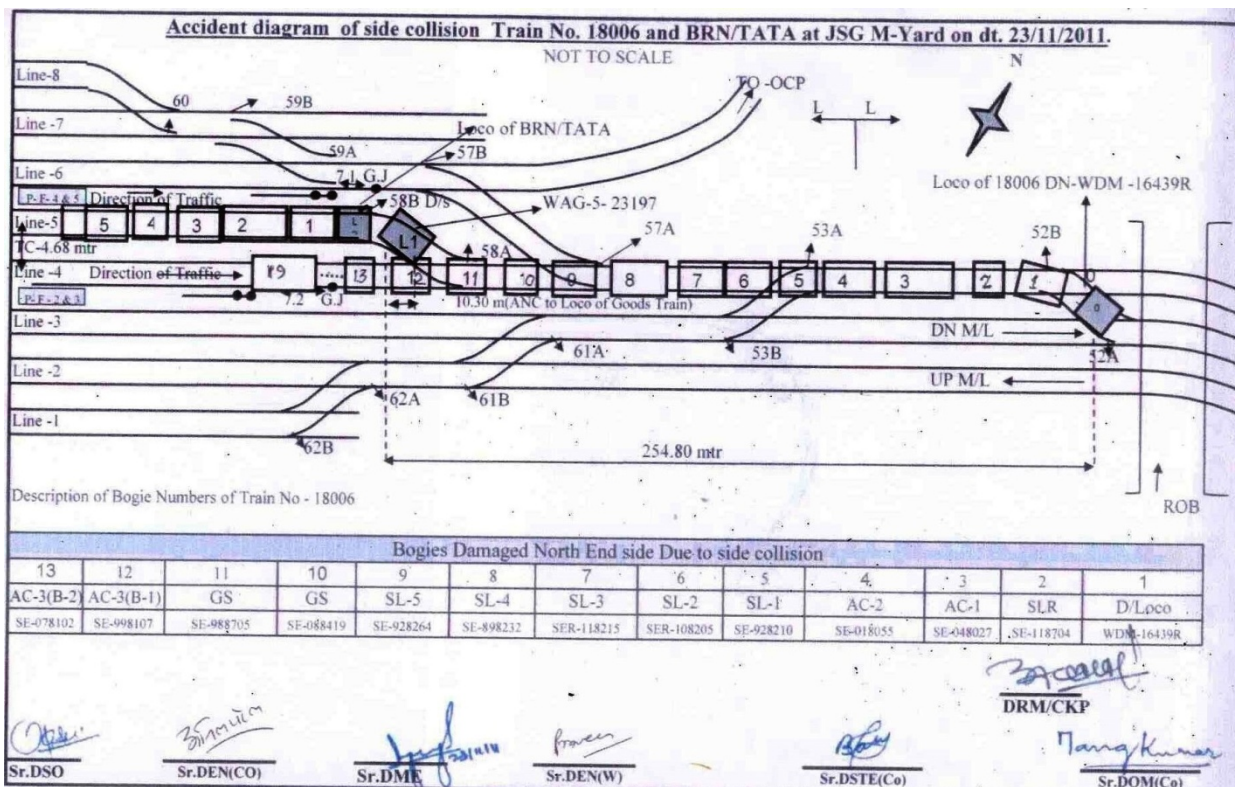
Diagram 1: Accident Diagram

Thus the train No.18006 started on observing the wrong signal and passed its **own** Starter Signal (S-20) at Danger; trailed through point (switch) No.58-A and continued running. At the same time, the freight train for which starter signal (S-22) had been cleared, also started from adjacent line. On seeing that train No.18006 was moving ahead on the same route, the Loco Pilot of freight train applied emergency brakes and stopped his train. The train stopped within a short distance but side collision between leading locomotive of freight train and 10 coaches of passenger train took place at the point of convergence of two lines. When 18006 subsequently stopped, 10 coaches (3rd to 12th) were damaged from outside. In the accident, 3 persons suffered injuries. 2 passengers needed medical aid at site and 1 was sent to Government hospital for further treatment.

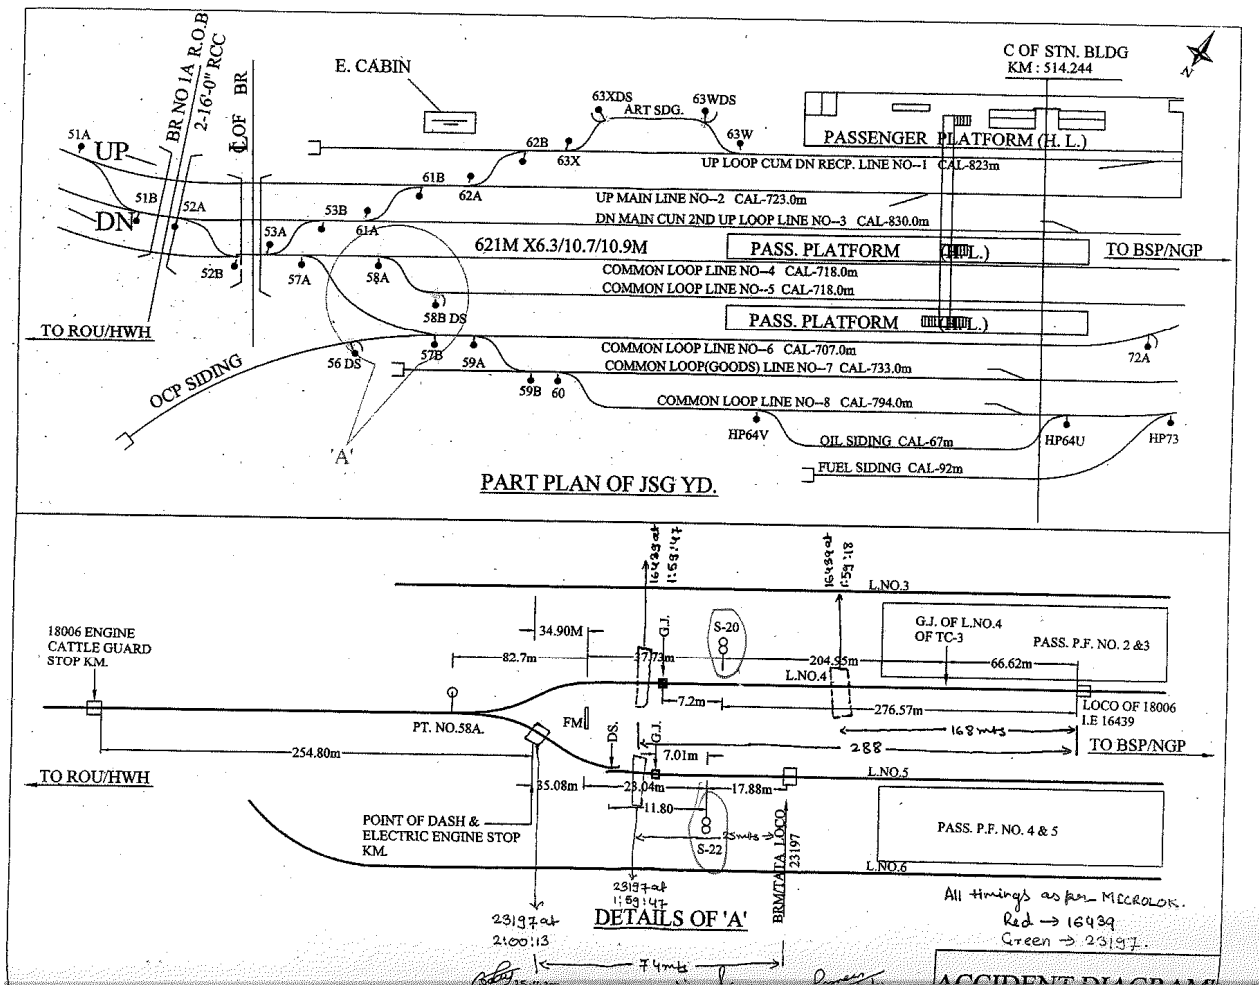
Diagram 2: Yard Layout

1. Starter Signal S-20 of line No.4 where 18006 was standing is located on the Right Hand Side of the track instead of the normal positioning on the left side of the track. Loco Pilot (LP) sits on the right side and Asstt. Loco Pilot (ALP) sits on the Left side. The Loco of this train was working long hood. In this type of operation of a loco with long hood driving, this signal was visible to the LP but not to the ALP. Moreover, S-20 was not visible from all locations of the platform No.3 where the locomotive normally halts. The Starter Signal S-22 of line No.5 where the freight train was standing is located on Left Hand Side of line No.5. This signal was visible to ALP of 18006 but not to LP. It remains a fact that both the starter signals S-20 & S-22 were not visible simultaneously to LP and ALP due to long hood working of diesel locomotive.

2. The signal S-20 was erected on the right hand side due to inadequate track centre distance. This was done during yard remodelling work, a couple of years back. However, approval of the competent authority was not taken for this deviation. Approval of a relatively junior officer was taken.

4. Since both lines are in curvature towards right, geographical situation also leads to the confusion in misreading the signal of line No.5 as that of line No.4.

LESSON LEARNT: Long hood working of locomotive leading to restricted signal visibility should be avoided as far as possible and practical..

LESSON LEARNT: Signals must be located on proper side of the track and if there is a deviation to this Rule, the approval of the 'Authorised Officer' should be taken.

LESSON LEARNT: Line curvatures must be taken care of while locating signals.

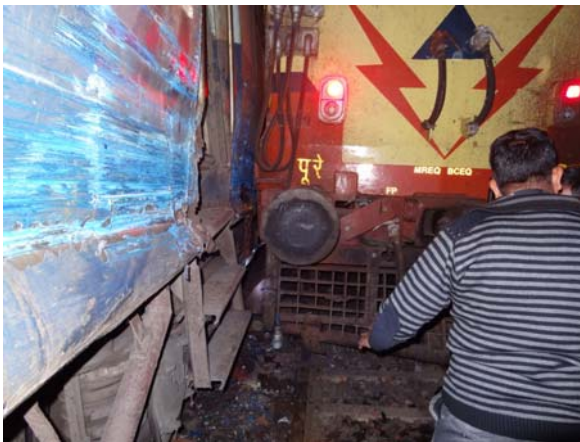
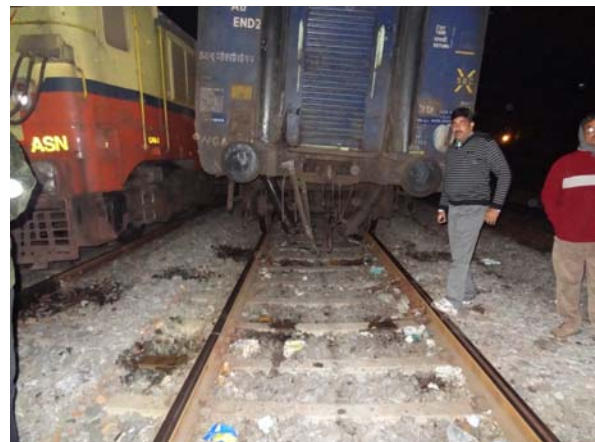
Photo 1 and 2: Accident site after the collision
