## METHODS AND OPTIONS FOR PRESERVING RAILWAY SAFETY KNOWLEDGE IN A CHANGING ENVIRONMENT. – THE IMPORTANCE OF HUMAN FACTORS MANAGEMENT IN TRAIN OPERATIONS.

D. Bouwer, S.P. Hubinger B.Sc. Eng. (Mech.), Pr. Eng.

South African Railway Safety Regulator

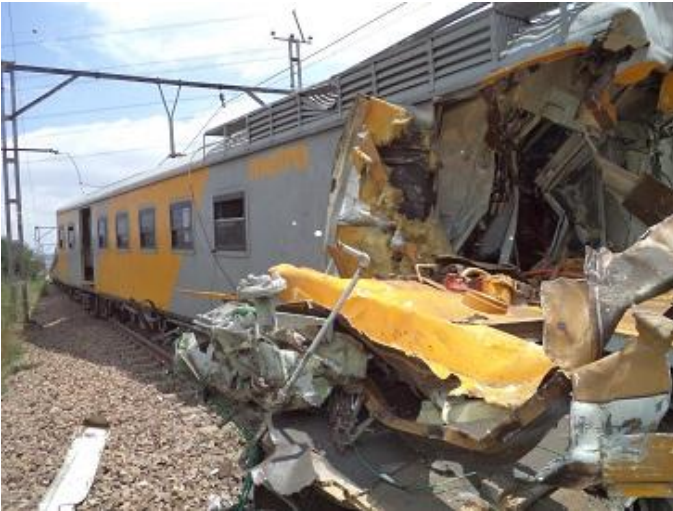
**Figure 2: Pinedene rear end collision**

On the 25<sup>th</sup> of June 2006, the negative traction return cables were stolen. These cables are required to route both normal traction return currents, and currents initiating from short circuits, back to the electrical substation. On the 26<sup>th</sup> of June 2006 the 3000V dc feeder cable broke on a splice joint, and fell on the exposed signalling cables next to the railway line. The resulting current was fed back to the Kaalfontein relay room. This caused considerable damage, and knocked out the whole signalling system between Kaalfontein and Irene stations.

This loss of signalling resulted in the institution of “abnormal trains working” where one train control officer issued multiple authorisations, from Kaalfontein station to the first signal, controlled by the Pretoria North centralised train control office, at Pinedene station. This signal was displaying a danger aspect.

Train A was authorised to proceed to this signal. On arriving at this signal, the driver of train A did not succeed in contacting the train control officer at the Pretoria North centralised train control office, to obtain permission to pass the signal that was at danger. This authorisation process increased the workload of the train control officer to unacceptable levels.

By this time the train control officer at Kaalfontein authorised train B to proceed to the same signal, without ascertaining from the train control officer in Pretoria North centralised train control office, that train A had cleared the section. The driver of train B did not “drive on sight” (to drive at such a speed, with your train under control, to enable the driver to stop within sighting distance) as required by the train operating rules. He could not stop in time, and collided with the rear of train A.

The driver of train B contravened the train operating rules by

- not “driving on sight” when authorised to pass the faulty signals, and
- the driver was speeding by exceeding the maximum speed limit of 90km/h on the line by driving at 104km/h.

The wrong method of train control in an abnormal situation was used. This had the effect that the train control officer in the Pretoria North centralised train control office could not cope with his workload. The introduction of speed monitoring and adherence to the correct train operating rules were ignored by management. There was no formal intraface agreement between the two regions, regulating train operations. Six commuters did not survive this incident.

The Human Factors Standard prevents management from over burdening an employee and provides an avenue for the employee to object to such practices.

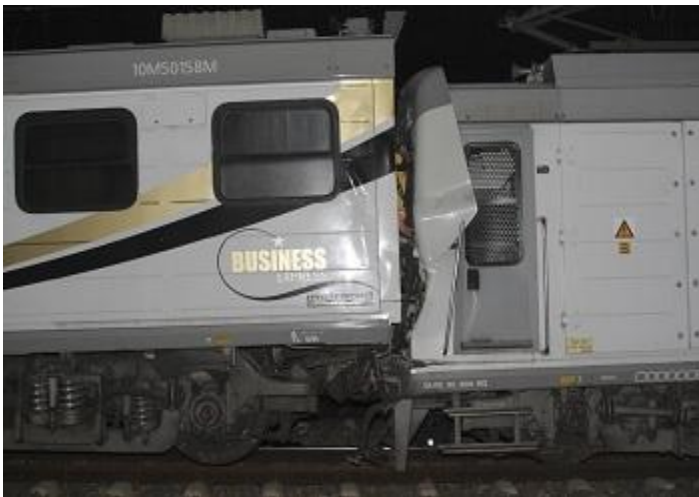
**Figure 3: Mzimhlope rear end collision**

On 19 May 2011, between Mzimhlope and Phomolong, train A failed in front of an intermediate block signal situated

around the bend from the end of the platform of Mzimhlope station, displaying a proceed aspect.

En route to Mzimhlope station, the driver of train B passed the 1st intermediate block signal displaying a caution aspect without slowing down, as required by the train operating rules. The driver of Train B then passed a second intermediate block signal displaying a danger aspect, before coming to a halt at the Mzimhlope station platform. After the driver of train B departed from the platform, he kept on accelerating and passed another intermediate block signal at danger. Shortly after this he noticed train A standing in the section in front of him. He applied the emergency brake and collided with the rear of train A.

Contravention of various train operating rules took place in this incident.

- The driver of train A did not instruct the train guard to protect the rear of his train.
- The driver of train B did not bring his train under control, to stop at the next signal which was displaying a danger aspect when encountering the intermediate block signal displaying an aspect at caution.
- The driver of train B did not stop when he encountered the intermediate block signal displaying a danger aspect.
- The driver of train B should not have departed from the station platform whilst facing a signal at danger.

The driver of train B committed seven disciplinary offences during the previous eighteen months. Several of these offences were for speeding. If management had followed the disciplinary process correctly, the driver of train B would have been removed from driving duties before this incident occurred.

Management also failed to heed his medical surveillance report. Allegedly he was a hyper active, jovial person. These factors placed him in a high risk category that is not suitable for a train driver.

A series of internal deviations by management from the agreed norms and standards, with respect to their tolerance to sub-standard acts and practices in train operations, were conducive to the occurrence of the accident.

It is unlikely that such an incident would re-occur because the Human Factors Standard mandates that management only appoints personnel in safety critical grades with the correct risk profile for the particular occupation. The

standard also requires appropriate action by management, if there is a sudden deviation of the said profile.

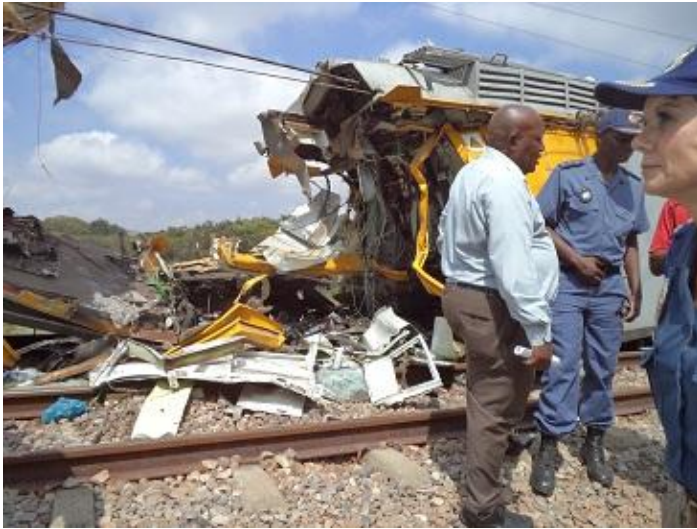
**Figure 4: Cor Delfos collision**

Due to cable theft, several signals were not working between Cor Delfos and Saulsville, affecting signals 1, 2, 3, 4 and 5.

The handover of the panel was not done properly between the night shift train control officer and the standby train control officer - it was not in writing. The standby train control officer then handed the panel to the day shift train control officer, who was late reporting for duty. The night shift train control officer had not yet authorised train A past signal 1. The fact that train A was standing in front of signal 1 was lost in the verbal hand over of the panel.

The driver of train A was not authorised to pass signal 1. The driver of train B was driving at a speed exceeding 20km/h before the accident occurred and was therefore not driving on sight, as required by the train operating rules.

The driver of train B was standing in front of the signal preceding signal 1. This signal operated normally. Due to the

wrong handover procedure, the day shift train control officer was not aware that authorisations only start at signal 1. He authorised train B to pass the signal preceding signal 1 at danger, not realising that the signal was detecting train A, occupying the track circuit in front of signal 1

In this incident the following train operating rules were contravened:

- the driver of train B not driving on sight, as required by the train operating rules when passing a signal with an authority obtained from the train control officer,
- the dayshift train control officer did not report for duty at the correct time for a formal documented hand-over of the train control panel, and
- there was no formal handover of the panel between the night shift train control officer and the standby train control officer.

The staffing levels of the supervisory staff in train operations were inadequate. There was a lack of discipline by employees not reporting on time for duty. They were not disciplined for it. There were no supervision of the handover procedures between employees signing on and off duty. This is a critical element of safety in any train control office. The Human Factors Standard prevents management from over burdening an employee and provides an avenue for the employee to object to such practices. It will also ensure adequate levels of supervisory staff.
