**A summary of the RAIU Investigation Report into the collapse of Malahide Viaduct on
the 21st August 2009**

J. Cregan & D.Murton

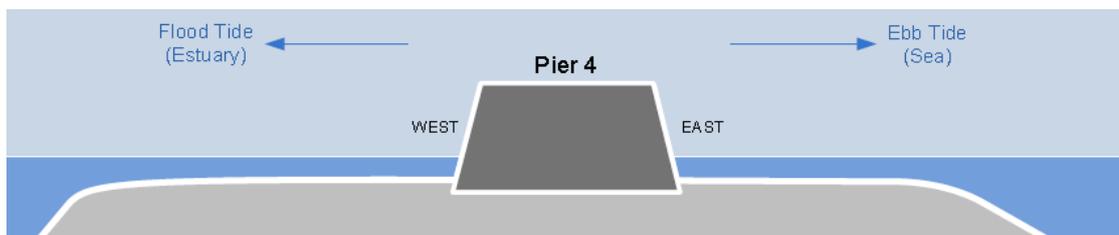
Figure 1 – Masonry pier constructed on weir

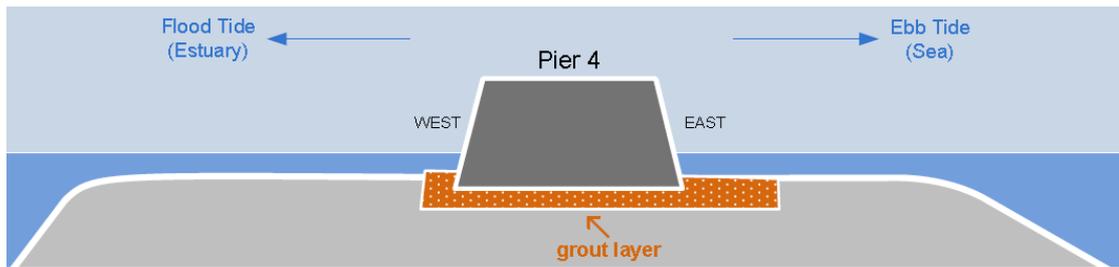
Figure 2 – Grout layer

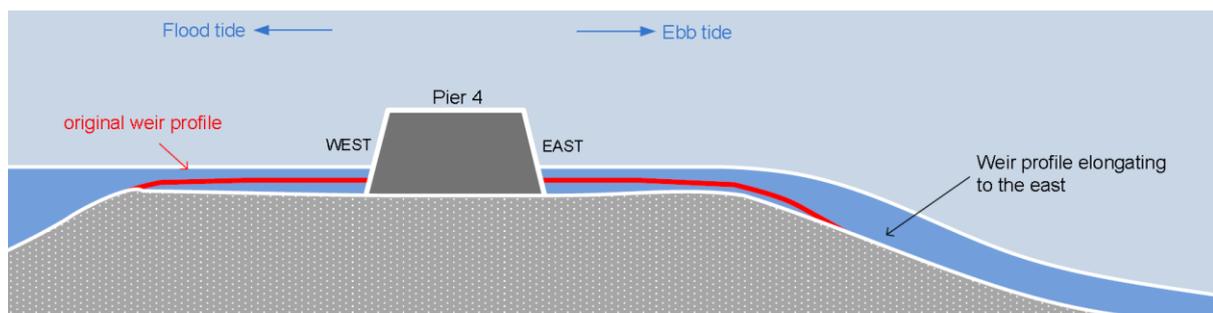
The physical models, using simulated stones, showed that the stones were unstable and moved even when slightly dislodged. This movement of stones, simulated over a period of many years, resulted in the material being eroded from the crest of the weir; this process is generally referred to as winnowing. This erosion resulted in the weir's profile changing over the years from the original weir profile, a more elongated weir on the eastern side, illustrated in Figure 3. This would have been magnified by the fact that there was more stones to be eroded as the weir crest was being replaced by $\text{I}\acute{\text{E}}$, through the continued discharge of stones.

Figure 3 – Weir elongating to the east due to erosion

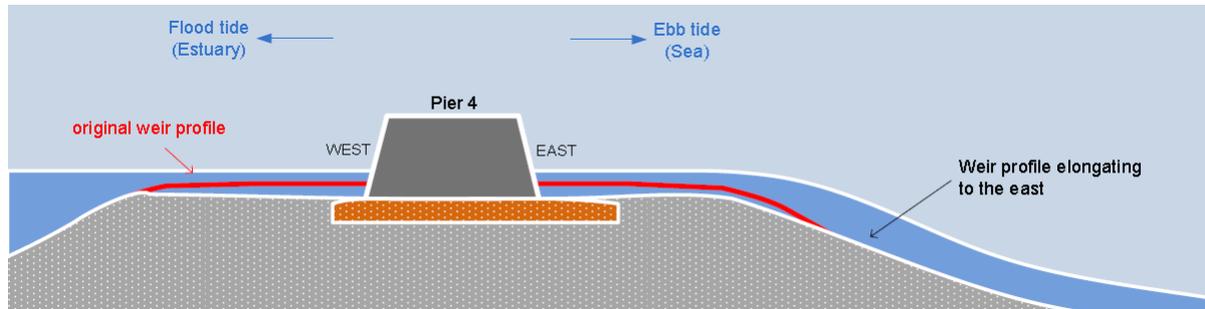
The stabilisation by the grouted rock armour was proved successful by the absence of observed scouring or potholing after the storms in February 1969, and the elongated profile on the east remained, (see Figure 4).

Figure 4 – Stabilising of weir profile as a result of grout

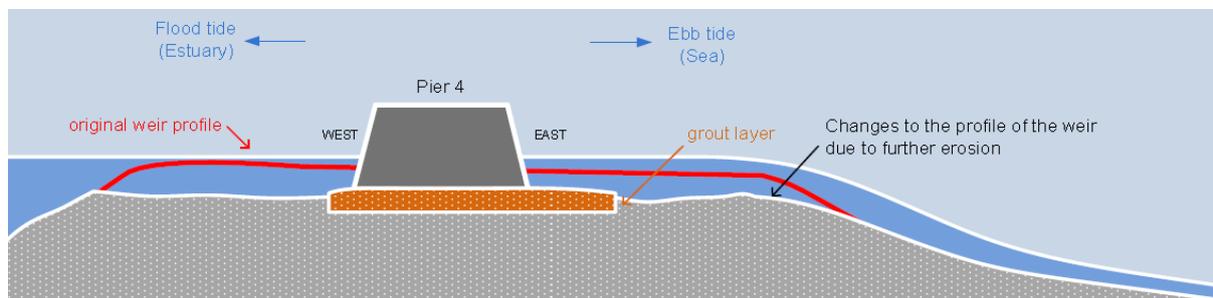
However, the grouted rock armour began to break down as a result of degradation of the grout (the grout on the west side remained semi-intact). This led to further transport of stone and grout from the weir crest. However, with the non-replacement of stones to the crest of the weir, since 1996, further erosion resulted under the eastern side of the pier, (see Figure 5).

Figure 5 – Erosion of the weir

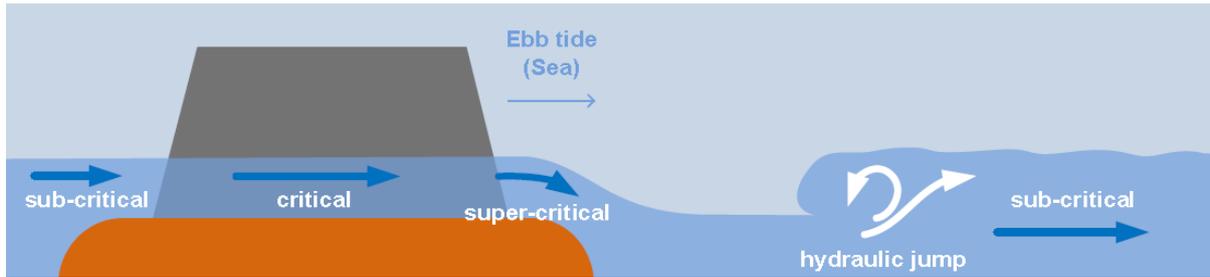
Figure 6 – Critical flows and hydraulic jump

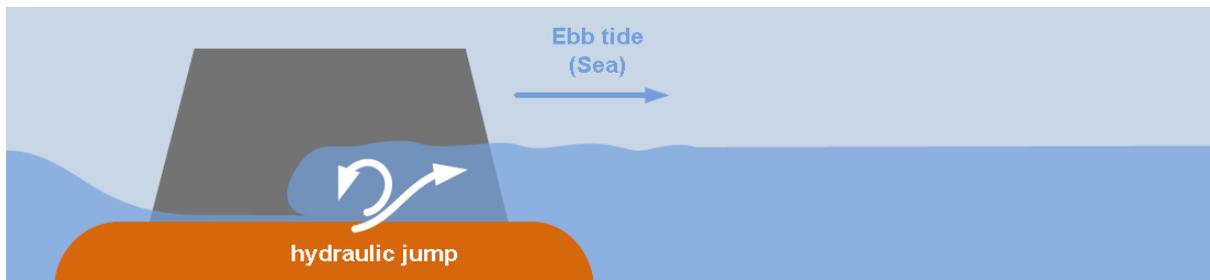
However, the models, simulating the high spring ebb tide flow rate, showed that when the tide reached certain critical levels on the eastern side, a hydraulic jump formed between Pier 4 and Pier 5, the location of the collapsed pier, see Figure 7.

Figure 7 – New position of hydraulic jump, between piers 4 and 5

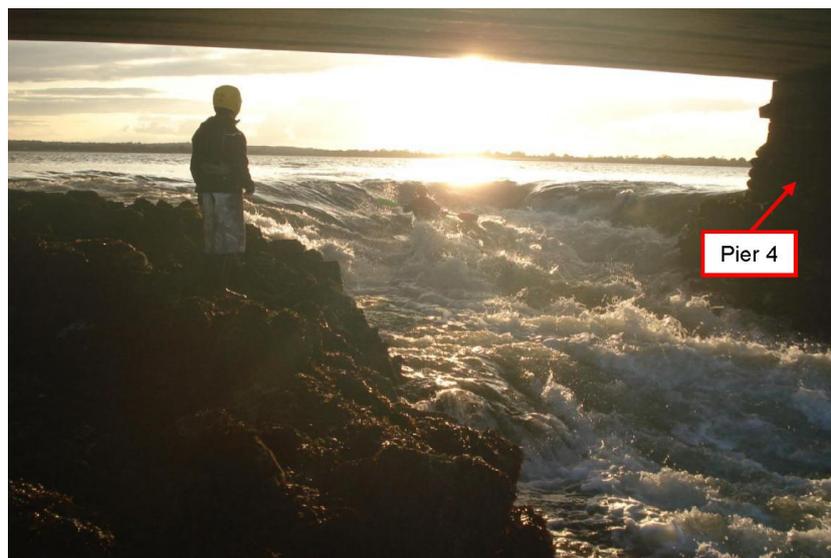
The turbulence from the hydraulic jump at the mid-point of Pier 4 would have meant that the stones were being eroded from the crest of the weir, with the stones being deposited on the eastern side of the weir, further elongating the weir profile. This erosion caused the area between piers 4 and 5 to deepen forming a channel, (see Photograph 1).

Photograph 1 – Deepened channel through Piers 4 and 5

This resulted in the majority of the water was flowing through this channel during the latter part of the ebb tide cycle, (the flow of water would normally be evenly distributed through all twelve spans). As a result of the channel and the erosion of the crest of the weir, the potential for the winnowing of smaller stones from the weir was now increased.

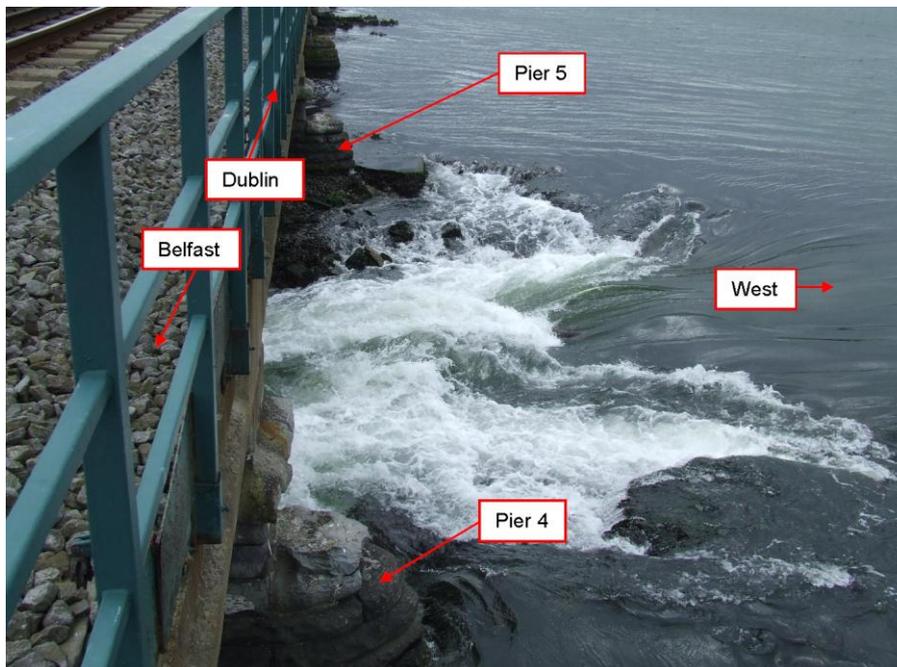
On the morning of the 17th August 2009, a canoeist, who regularly canoed in the Broadmeadow Estuary, noticed that some of the stones around the base of Pier 4 had been washed away, and he reported this to Iarnród Éireann on that day (four days before the accident). The reported washing away of stones would indicate that the erosion mechanism had accelerated and the stones close to the foundations of Pier 4 had started to be displaced on the western side of the weir. This can be verified from the photograph taken by Iarnród Éireann during the structural inspection on the 18th August 2009, (three days before the accident), see Photograph 2. It can be seen, from the photograph, that the ebb flow hydraulic control point had moved further west at Piers 4 and 5. This suggests that serious erosion was occurring in the months leading up to the collapse of the viaduct, confirming the flow was accelerating over the crest, resulting in high velocities upstream of the western foundations of Pier 4.

Photograph 2 – Photograph taken three days before the accident

- An inspection carried out on the Malahide Viaduct three days before the accident, after a report of a defect from the canoeist, did not identify the scouring defects visible at the time, see Photograph 2;
- A scour inspection undertaken in 2006 by diving engineer consultants, did not identify the Malahide Viaduct as a high-risk structure to the effects of scouring;
- Iarnród Éireanns likely failure to take any action after an independent inspection carried out on the Malahide Viaduct in 1997 identified that scouring had started at the base of Pier 4 and that the rock armour weir was “too light for the job”;
- The historic maintenance regime for the discharge of stones along the Malahide Viaduct appears to have ceased in 1996, resulting in the deterioration of the weir which was protecting the structure against scouring.

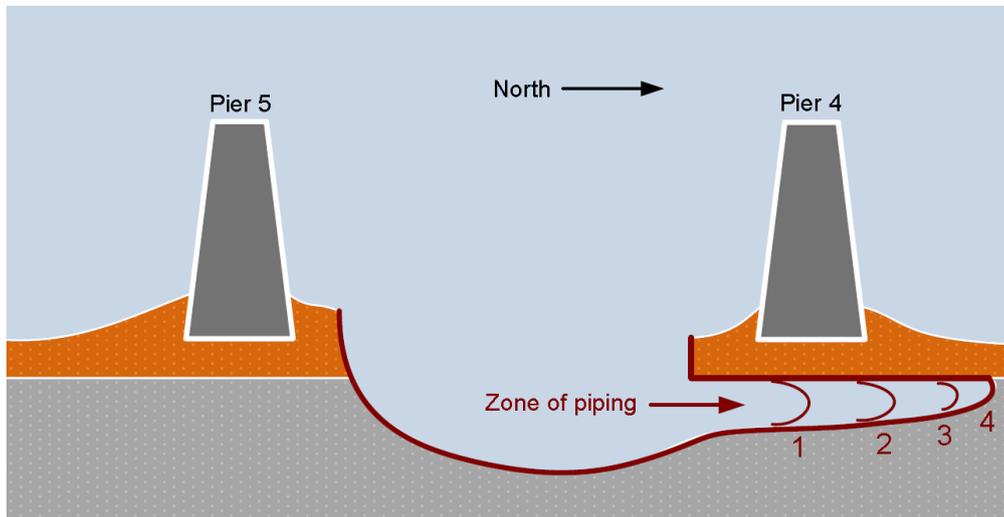
The narrowed flow path (through the channel) and the remaining semi-intact grout rock armour on the western side meant there was an increased potential for piping. Piping occurs when there is a sub-surface formation and progression of a continuous ‘pipe-like’ tunnel. The material is eroded by the flow of water through the tunnel, which then carries away these eroded particles, (see Figure 8).

Figure 8 – Piping under Pier 4

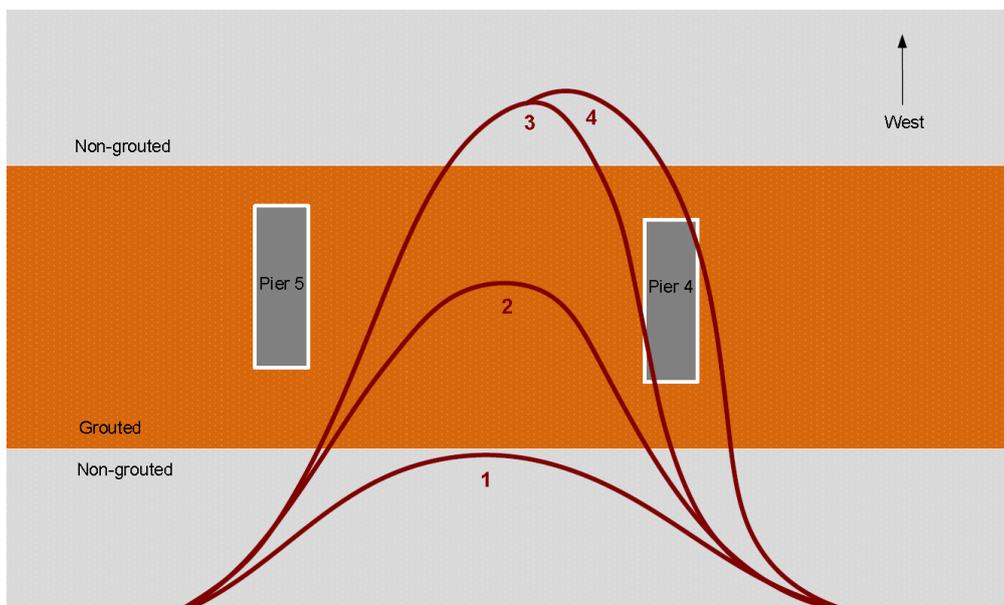
The piping flow path was under the remaining grout layer on the west side of the weir with the grout layer acting as an upper boundary to the flow pipe, causing undermining of Pier 4 (see Figure 9).

Figure 9 - Undermining of Pier 4 as a result of piping

The red lines 1 – 3 in Figure 9, illustrate the general westward propagation of the hydraulic jump where the grouted and non-grouted weir material has been removed by the scour action

(as occurred in the medium term events), the addition of red line 4 indicates the post collapse zone of the ‘piped’ scour that undermined the grout apron.

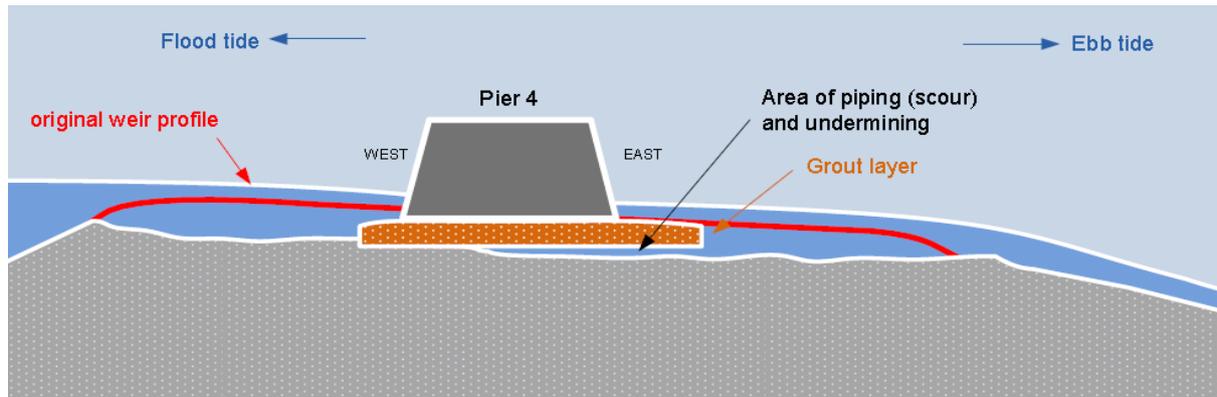
Figure 10 – Piping and undermining
