Malahide Viaduct Collapse County Dublin, Ireland

Railway Accident Investigation Unit

What happened on the 21st August 2009?

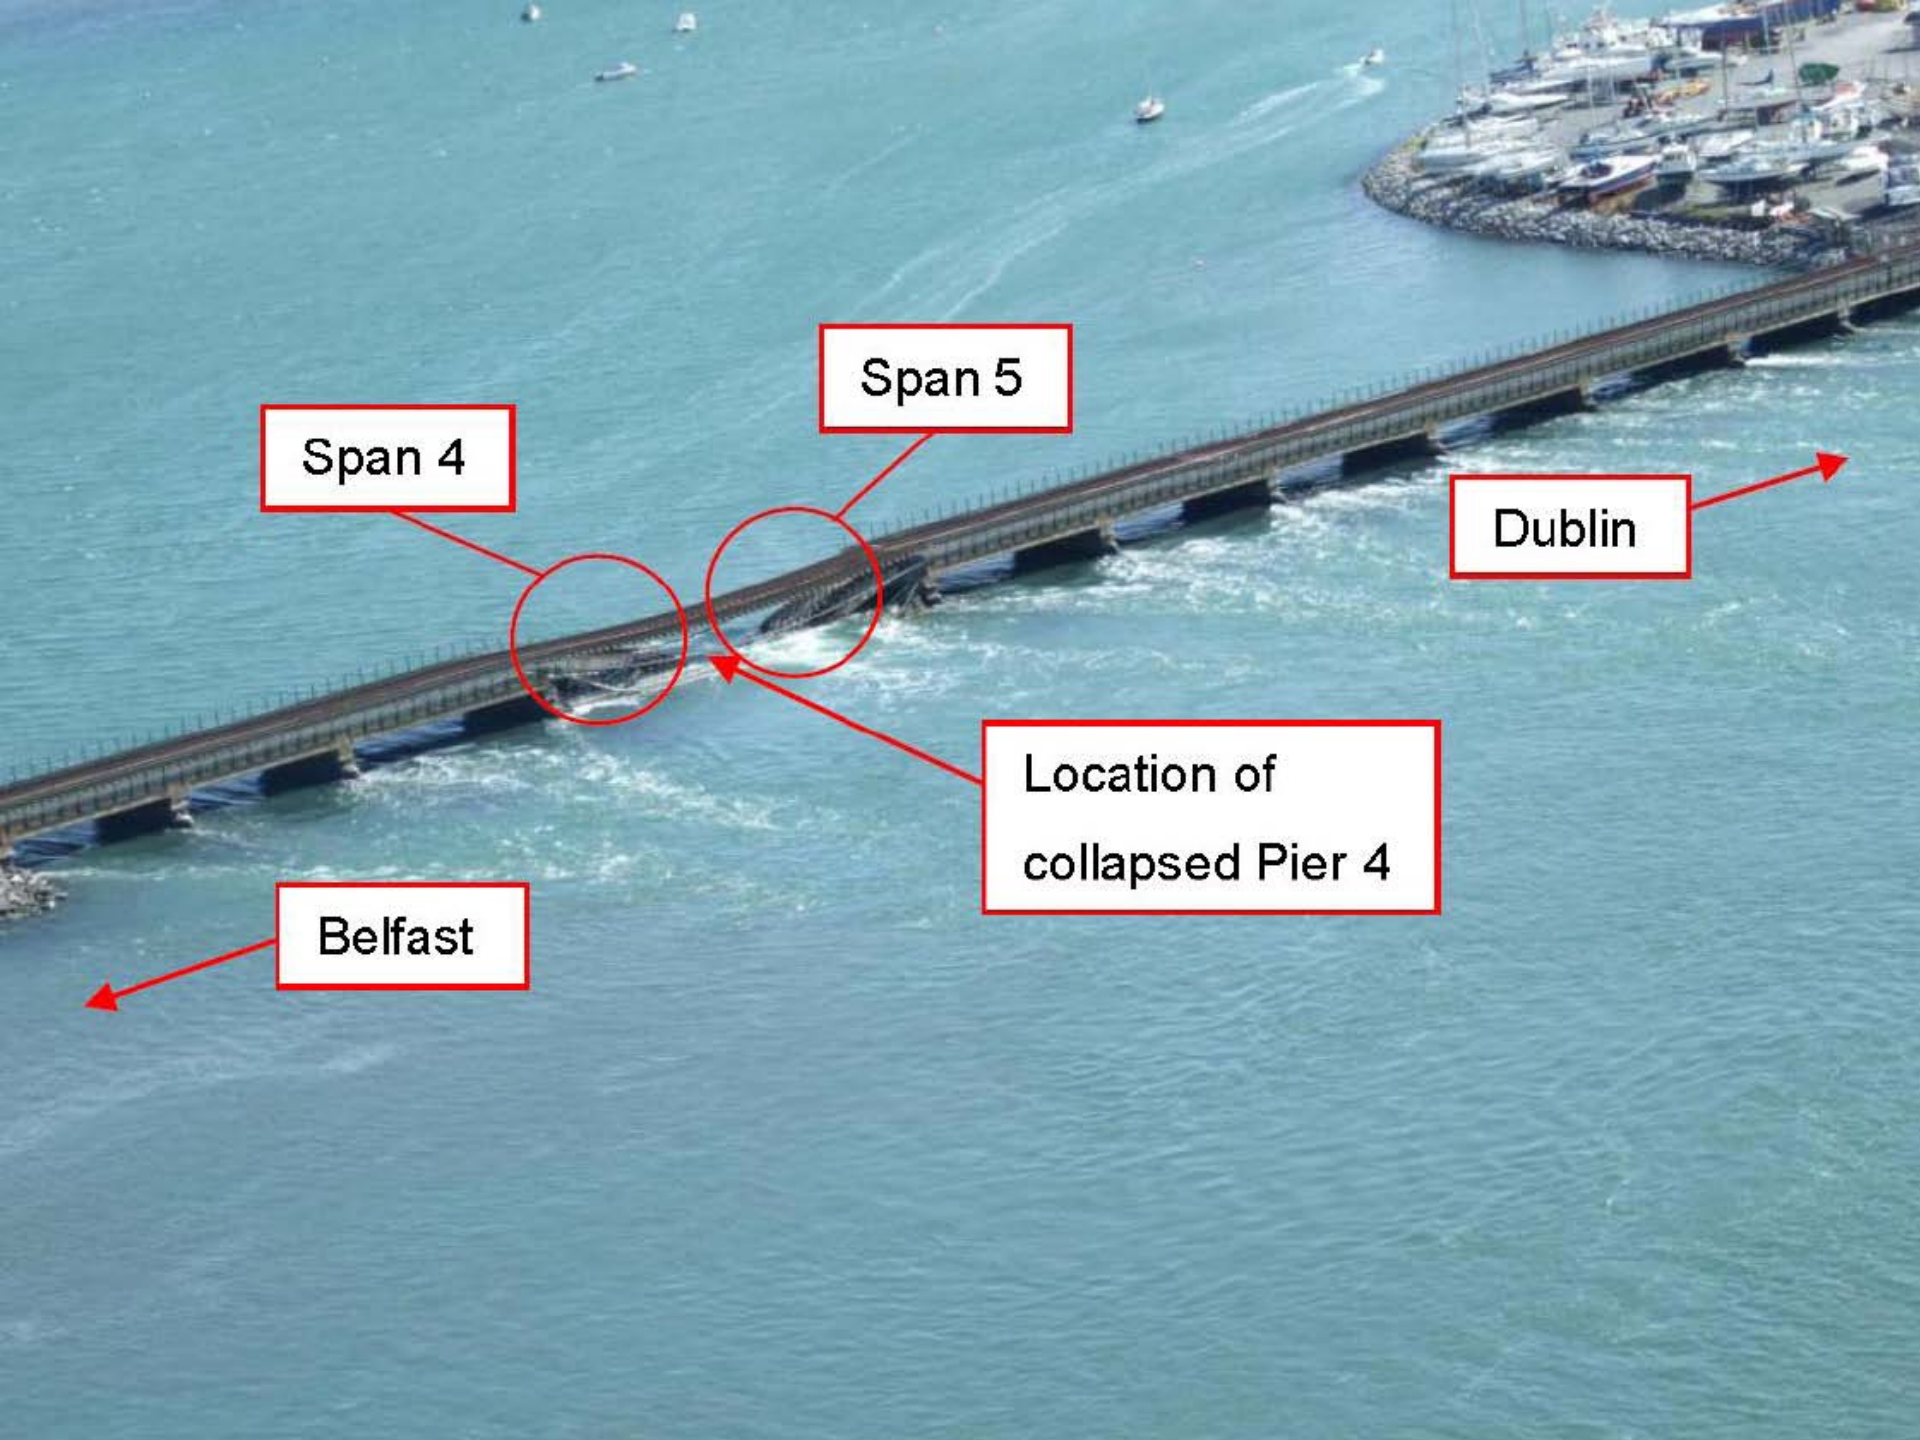
- While the Balbriggan to Connolly service passed over at 18.21 pm the driver noticed the partial collapse of down side viaduct
- All post accident procedures were followed correctly resulting in no injuries or fatalities
- Within ten minutes Pier 4 of the Malahide Viaduct had failed catastrophically

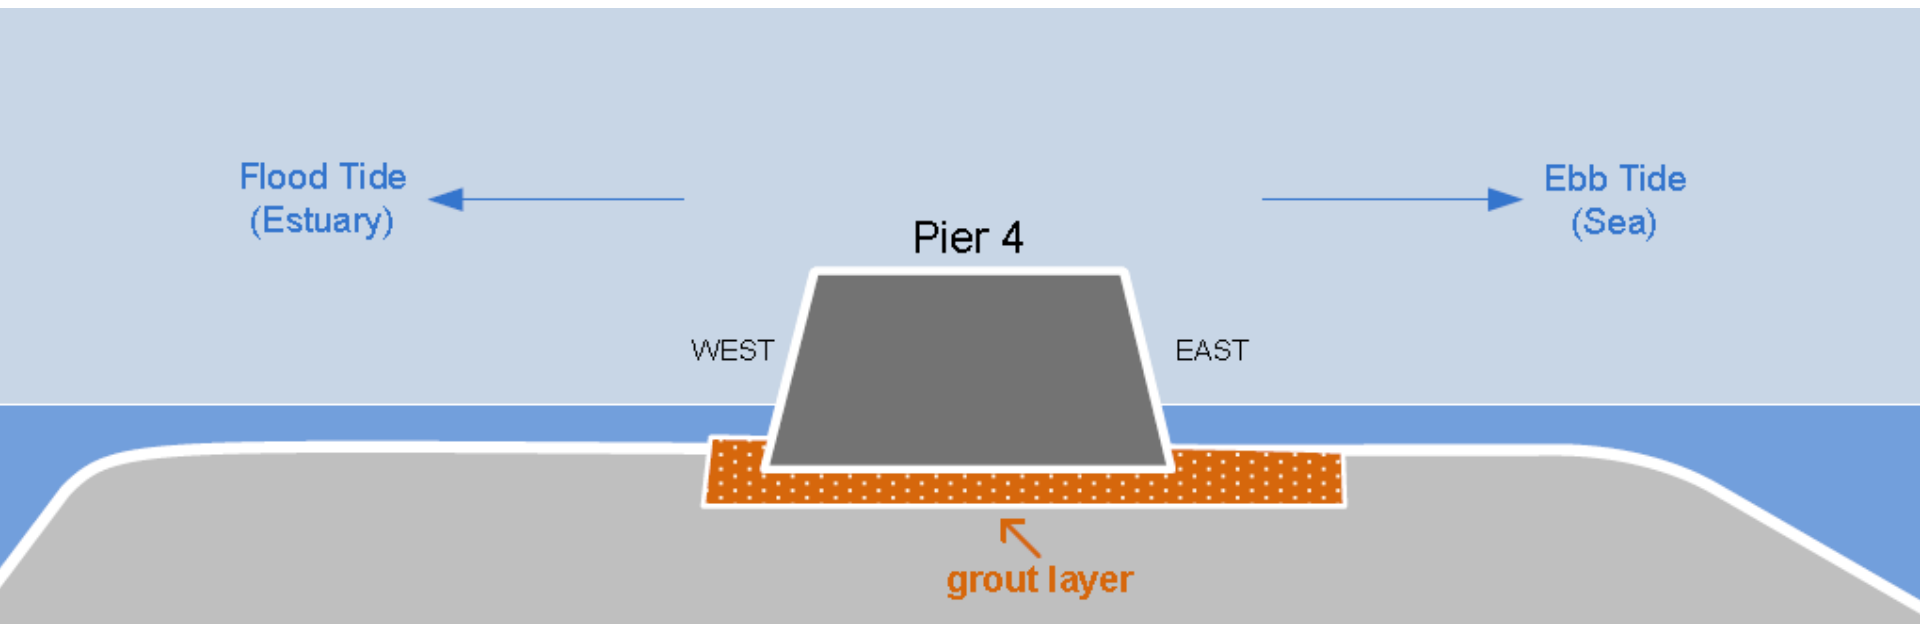
History of the Malahide Viaduct (continued)

- In 1967 – 1972, the weir was grouted to form a grouted rock apron

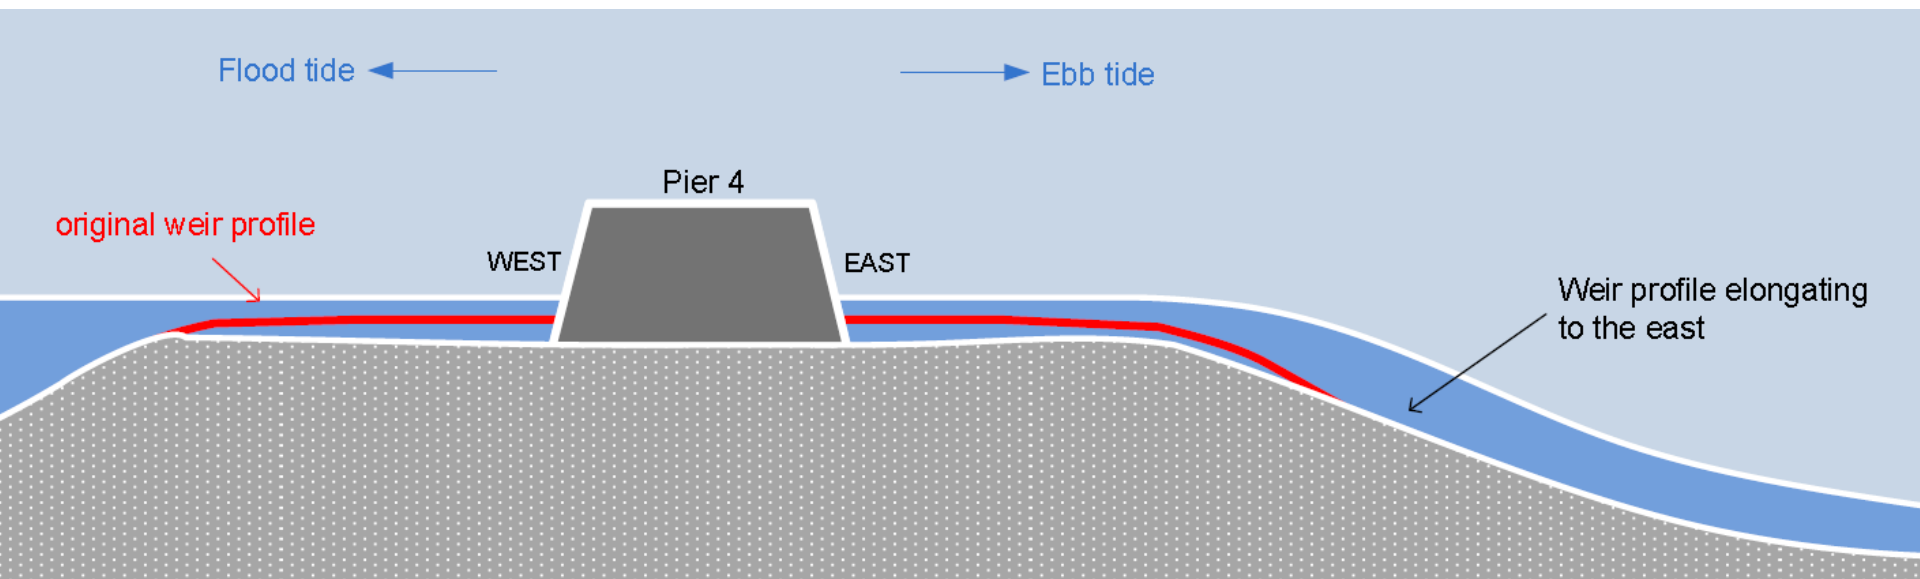
Long term events

- Stones eroded from the crest of the weir
- Elongated weir on the eastern side

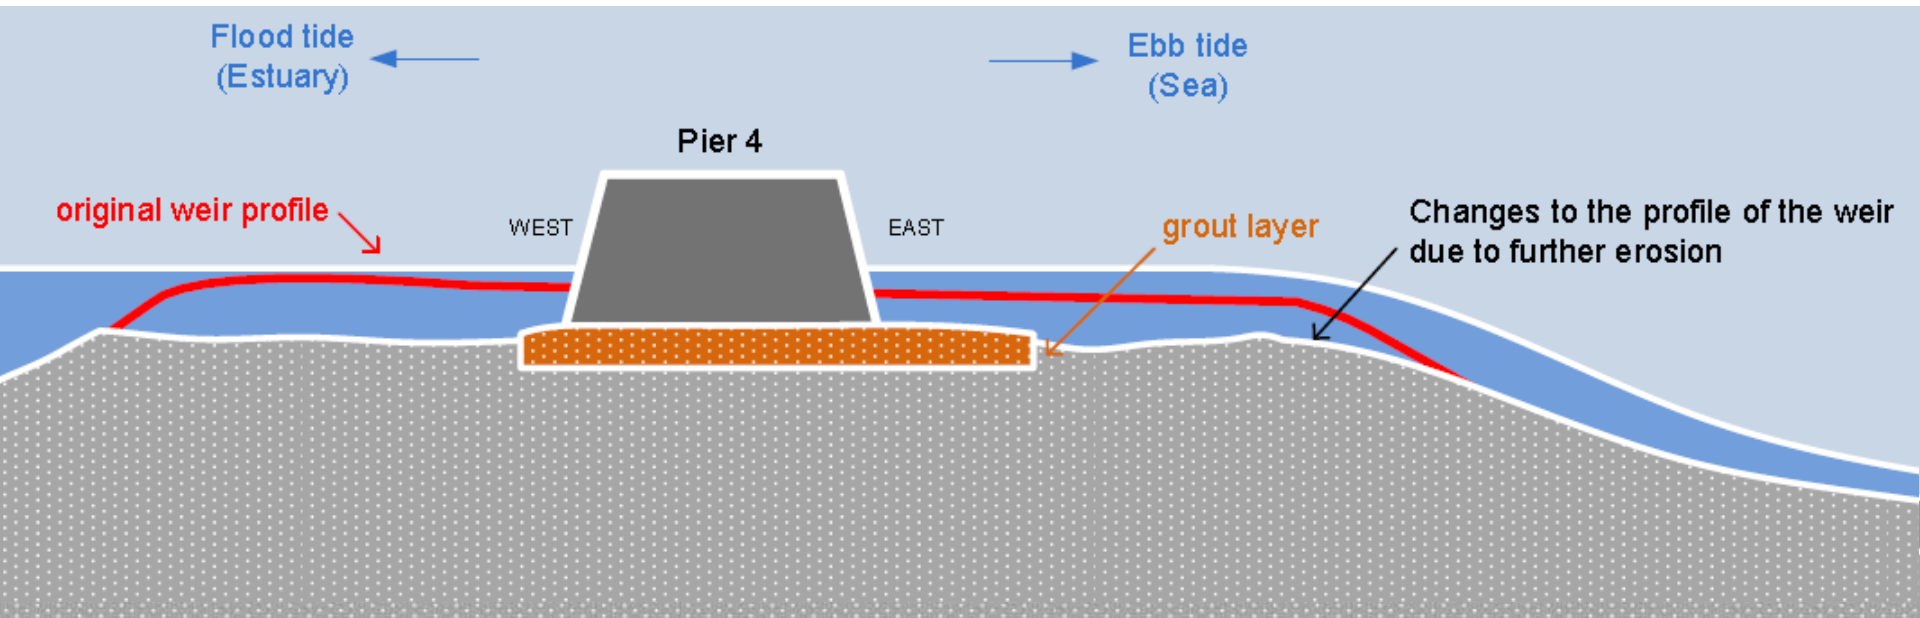
Medium term events

- Grout stabilised the weir profile for a period
- Grout began to degrade and the erosion continued

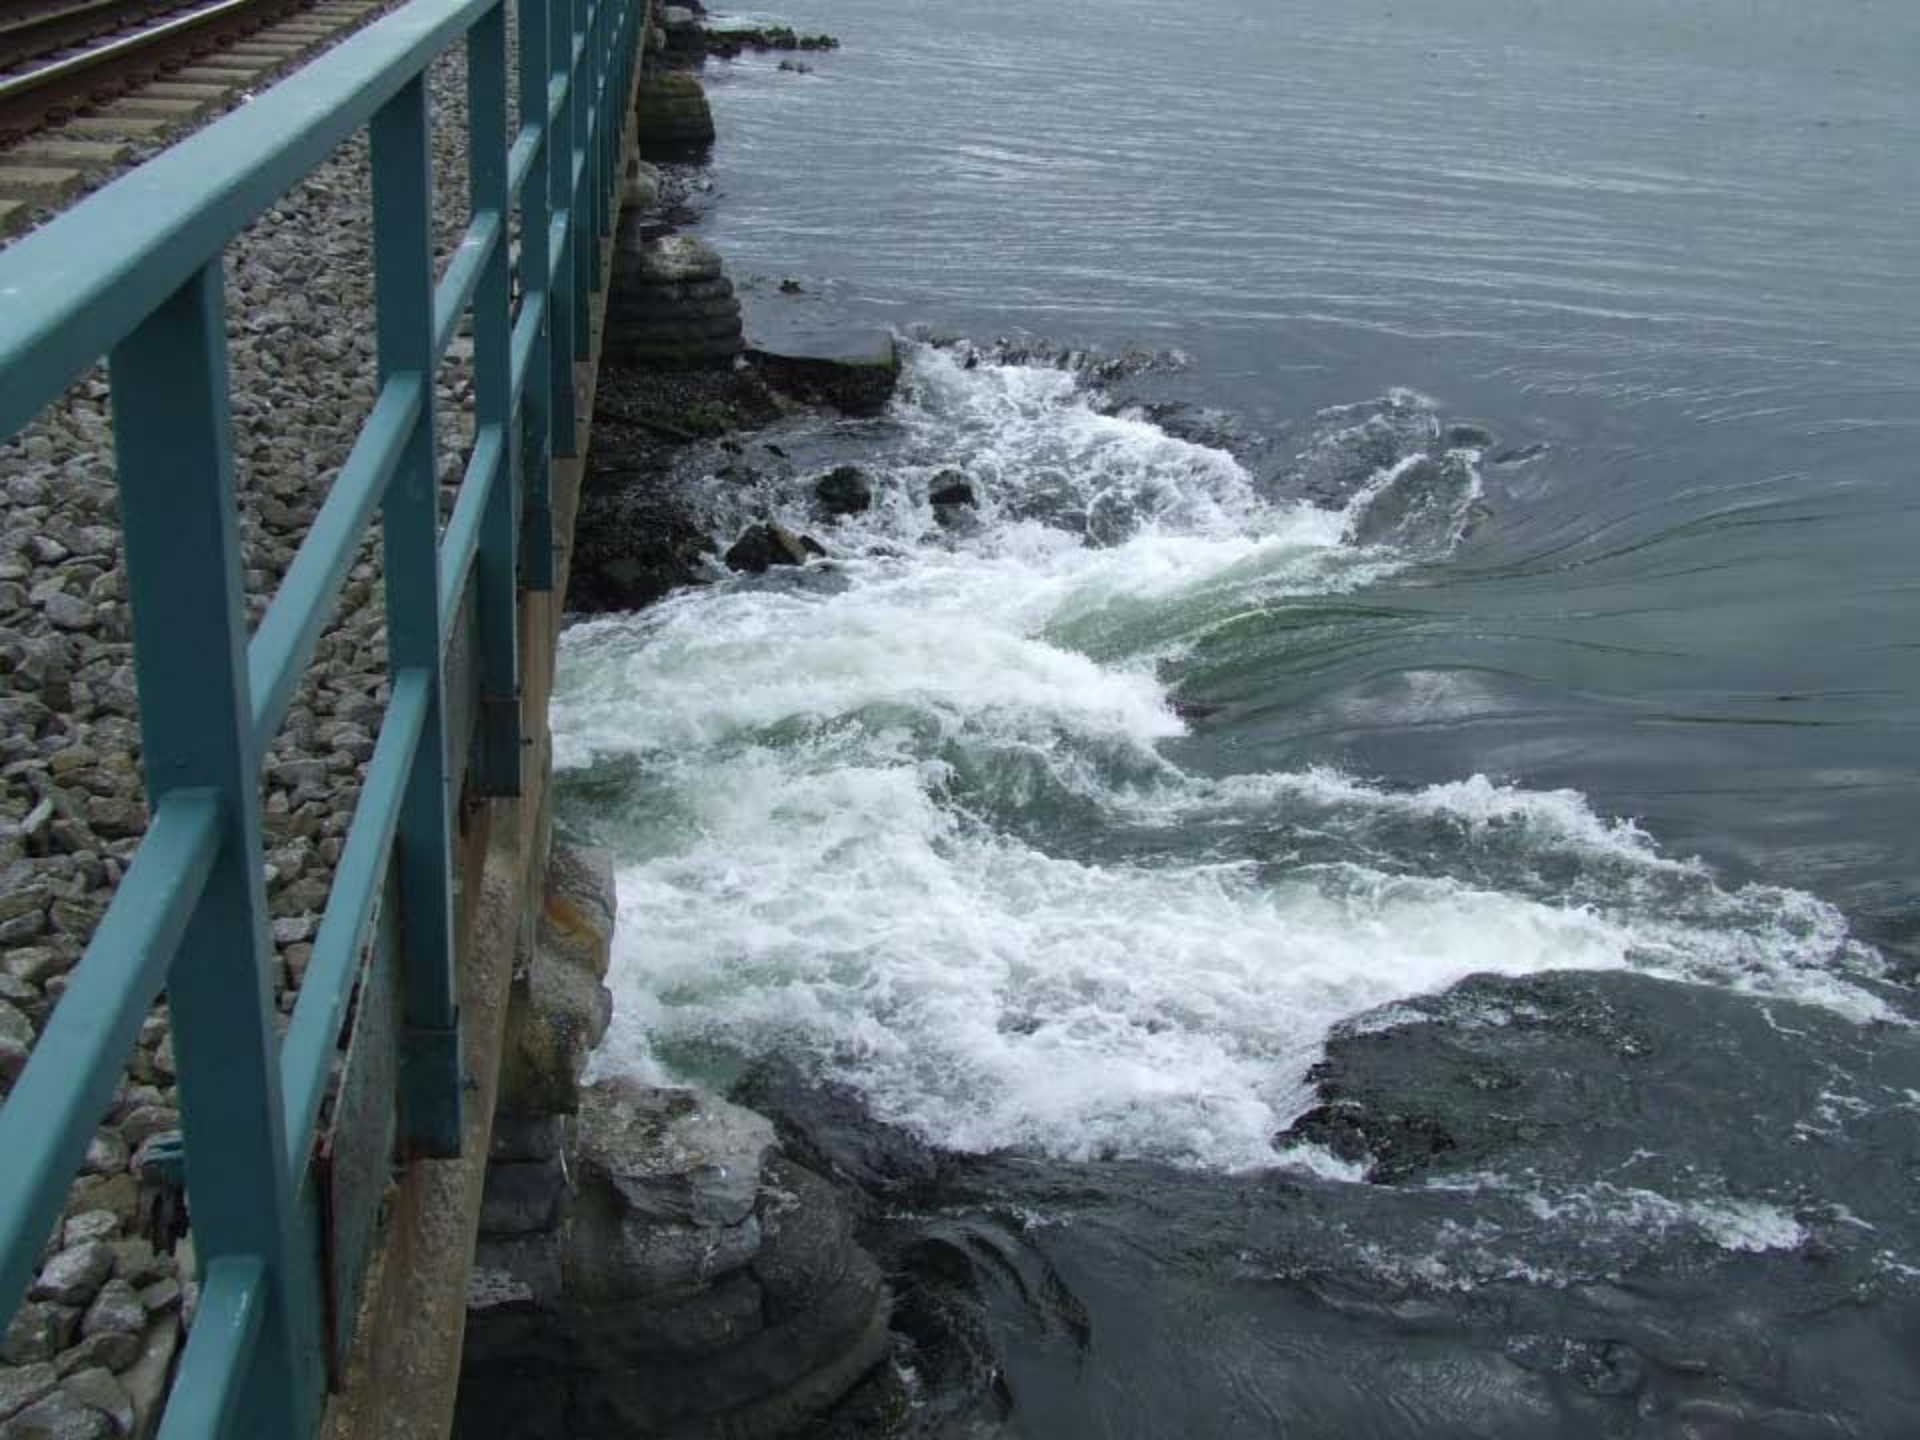
Immediate Cause

- The **immediate cause** of the collapse of Pier 4 was as a result of the undermining of the remaining grout apron that surrounds and supports Pier 4 through the action of piping (scour).
