<Lessons learned – X2000 collision with a heavy guided vehicle>

<MariaHedqvist>

<Trafikverket>

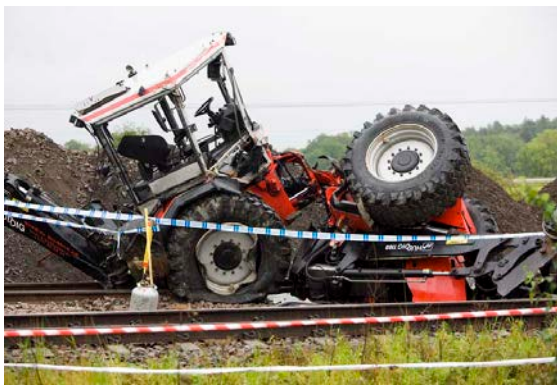
The accident happened when the back hoe loader was entering the track to go to its working place further along the track. The backhoe loader slid the rail. As the driver was inexperienced to work in the track area the efforts to get back on the rail did not work. The train was hit by the backhoes bucket, and due to the trains speed, it spun around several times and each time it spun the bucket hit the train

1. *The back hoe after the accident.*

The direct cause of the accident was that the backhoe came into the safety zone as the operator turned the machine through its centre pivot oscillation in an attempt to get the machine back on the rails again.

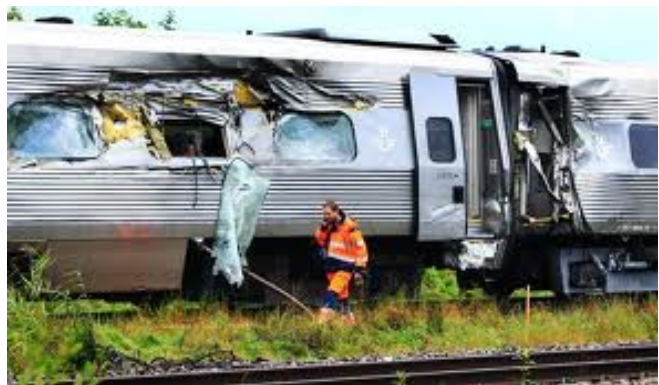
2. *Part of the damaged train.*

In connection with the collision train 505 derailed with one bogie and then went perverted 91 meters by switch No. 106, where the derailed bogie hit the cross section of the switch. Causing the wheel bogie to climb back on track and the train continued a few 100 meters before it stopped. In the accident one person was killed and 17 were injured and there was an emission of about 250 liters of hydraulic oil.

Damage was caused to infrastructure where rails and sleepers were damaged on both tracks. A switch on the track carrying the train was damaged by the derailed train, especially the crossing part that had to be replaced. The catenarie system was also damaged when two articulated support wires to an mast of an overhead line was hit by the backhoe as it went out. When the IM accident report was completed there were known cost for rehabilitation of infrastructure to 1.1 million SEK The railway company's costs for damage to train 505 were about 10 million SEK. The damage to the buck hoe loader was great and the machine was considered scrap and contractor costs for damage to the machine were at the completion of the investigation to 1.5 million SEK.

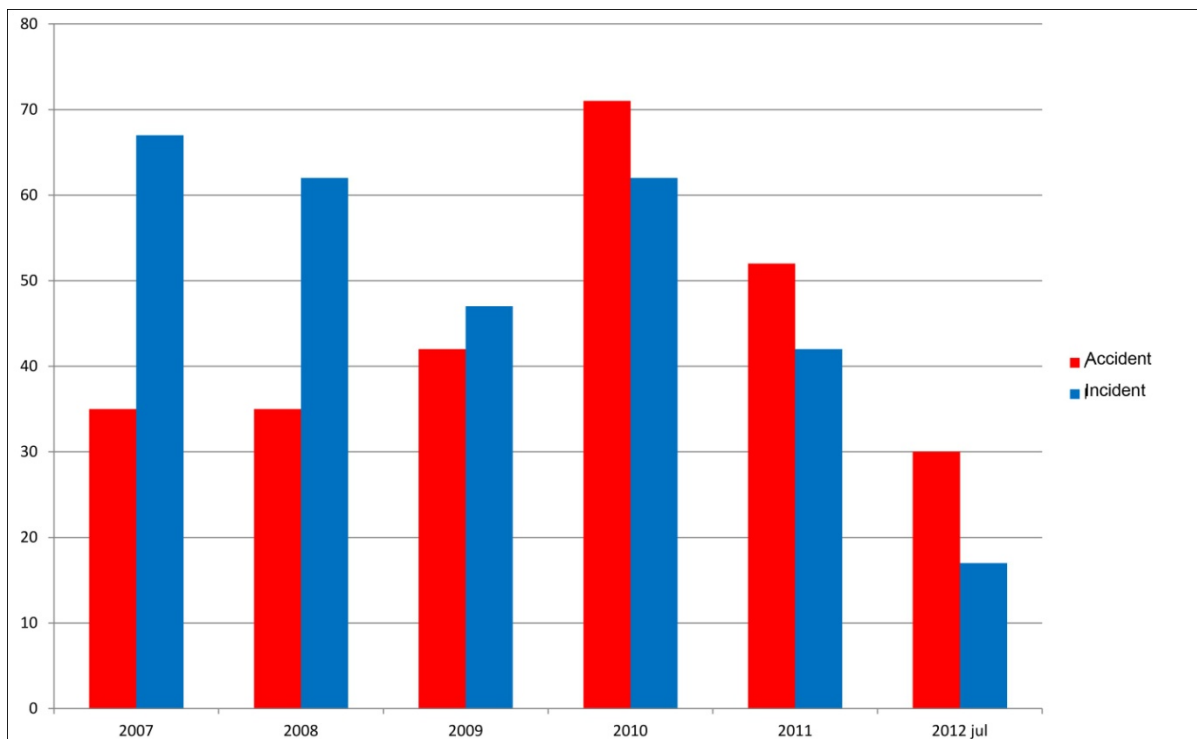
3. Accidents and incidents, Sweden January 2007 – July 2012. Guided vehicles.

The statistics show that the use of guided heavy vehicles is one of the greatest risks of catastrophic events in the railway today.
