WHERE NEW TRAIN SETS MEET INFRASTRUCTURE WITH LACK OF TECHNICAL BARRIERS.

Kurt A. Olsen

Accident Investigation Board, Norway (AIBN)

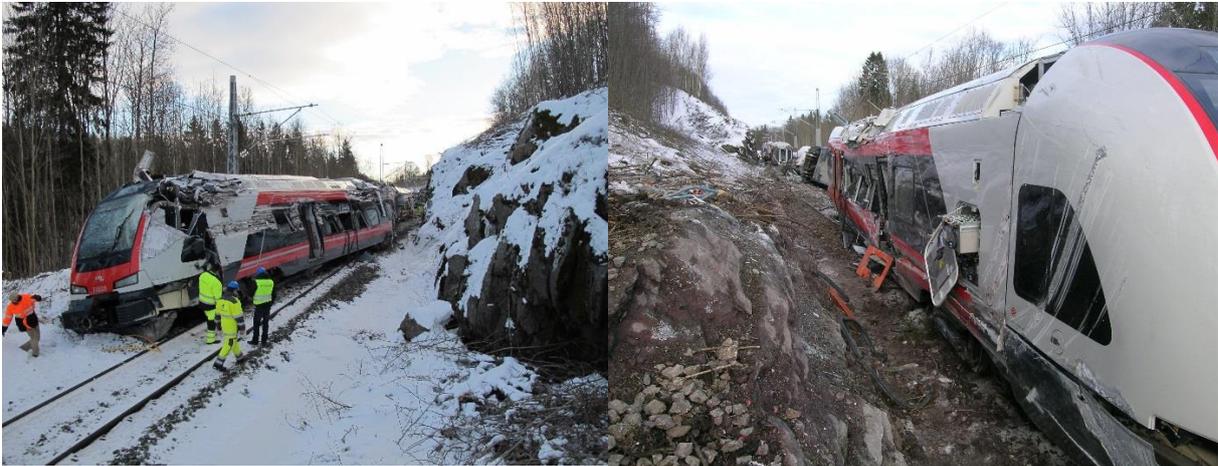
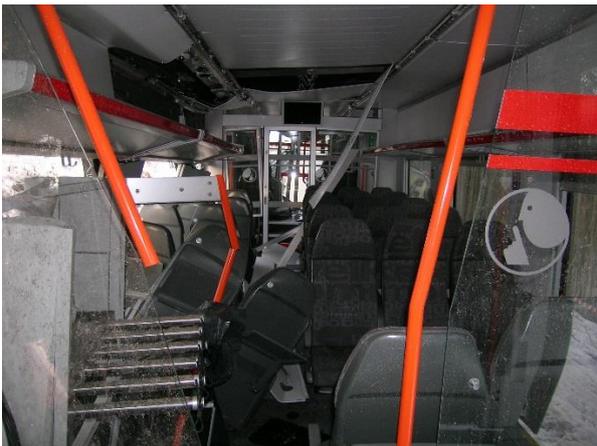
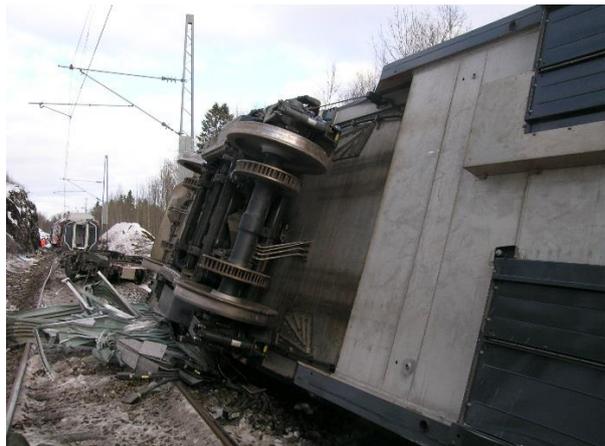
The train set involved was totally wrecked in the accident, and none of the carriages could be removed using the tracks; they had to be divided up and removed using cranes and lorries. Approximately 150 metres of track, sleepers, cable ducts, signal cables and catenary masts had to be replaced.

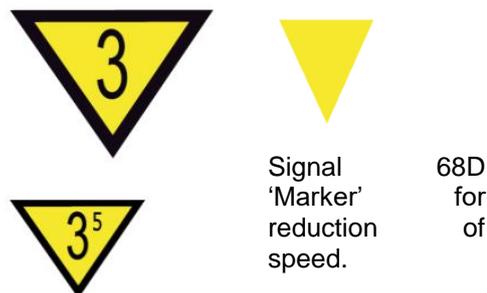
The marker from which the speed reduction applies was correctly located, but is not intended to be sufficient to warn the driver to brake if braking has not already been initiated. The distance between the 'Reduced speed' and the 'Marker' was approximately 1000 metres. The AIBN was not able to establish what distracted the driver's attention for the four or five seconds during which the speed reduction sign was visible.

The roll-over accident took place when passing a station area and running into a right hand turn. The speed sign stating the speed on the departure route from the station was missing. This sign would have repeated the line speed for the section of track, and made it clear to the driver by how much the train was overspeeding as it approached the first curve.
