MANAGING HUMAN FACTORS IN HONG KONG THROUGH A RISK-BASED APPROACH

Railways Branch, Electrical and Mechanical Services Department,
Government of the Hong Kong Special Administrative Region

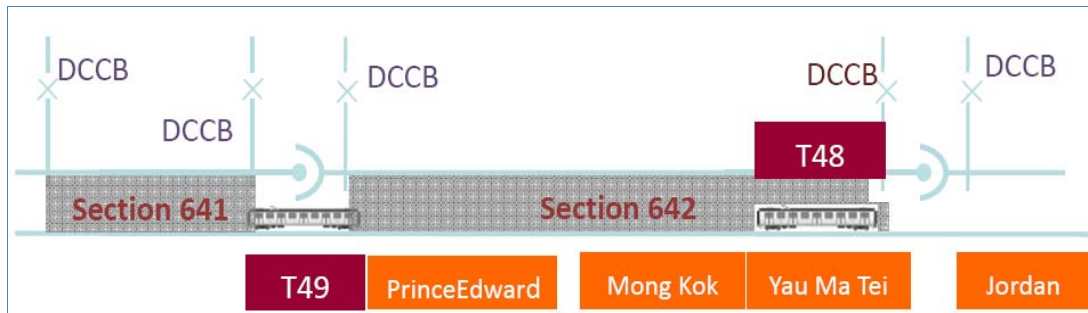
Figure 6: Schematic showing the electric circuits

Our investigation found that a small carbon chip had broken off from a carbon brush inside the DC traction drive motor, causing an electrical short-circuit fault. The magnitude of the fault current

exceeded the rupture capacity of the train-borne circuit breaker and the circuit breaker was damaged. The overhead line traction supply circuit breaker was also tripped. While train T48 was stopped at the Yau Ma Tei Station with its pantographs raised, train T49 traveled through the two traction supply sections behind it (i.e. Section 641 and 642) and swept through the section insulator resulting in two more short-circuit faults.

The traffic controller at the Operation Control Centre (OCC) asked the captain of train T48 to lower the pantograph to isolate the fault. The train captain did not press the pantograph-down button thoroughly as instructed (and thought that the pantograph had been lowered). Based on the train captain's incorrect report on the pantograph status, the traffic controller then instructed the power system controller to reclose the DC Circuit Breaker (DCCB) to resume the traction supply. Of course, the

traction DCCB then tripped again. Without further checking, the power system controller made a second attempt to close another DCCB a few seconds later, but failed. As a result of five consecutive electric short-circuit faults, the overhead line overheated and burnt out. It then took a further 2.5 hours to re-connect the overhead line.

At least two human errors occurred during this incident. The first was that the train captain did not correctly report the pantograph status to the traffic controller. The second was that the power system controller made a second attempt to reclose the traction DCCB before asking the platform supervisor to check the pantograph situation on site.

- (i) Replace the train-borne circuit breakers with new ones of higher current rupture capacity;
- (ii) Install a visual indicator in the driving cab to confirm to the train captain the position of the pantographs; and
- (iii) Review and revise the operation control procedure for closing traction supply circuit breakers to provide clear steps for operators to follow.

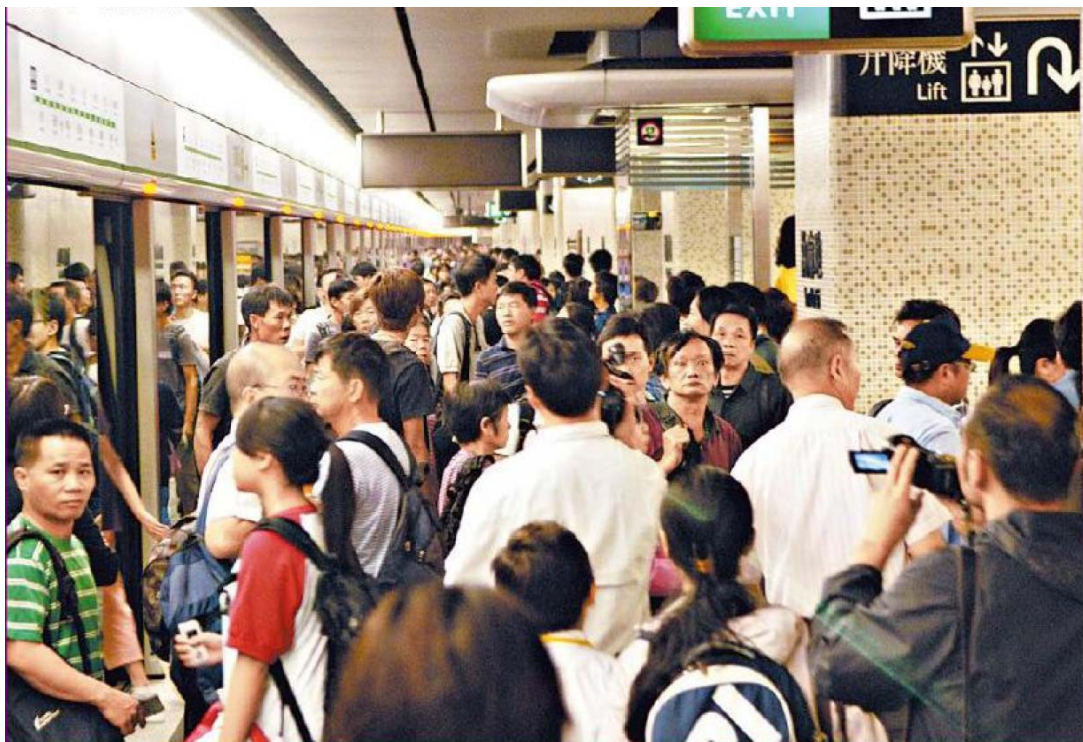
The overhead line between Prince Edward Station and Yau Ma Tei Station was burnt out as a result of repeated short-circuit faults in the morning of 21 October 2010. The Tsuen Wan Line train service at Yau Ma Tei Station was suspended for three hours and 100,000 passengers were affected during morning peak hours. Figures 6 and 7 show the schematic of the electric circuits and the congestion at Yau Ma Tei Station during the incident.

Figure 7: Congestion on the Tsuen Wan Line platform at Yau Ma Tei Station

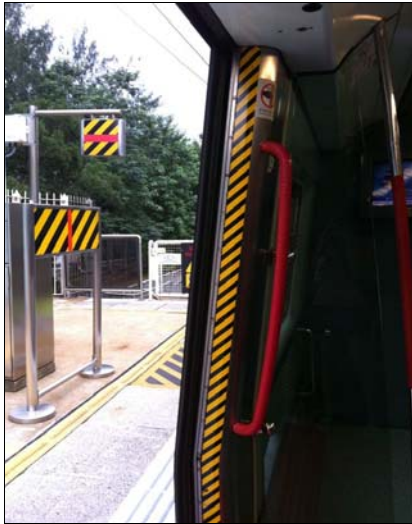
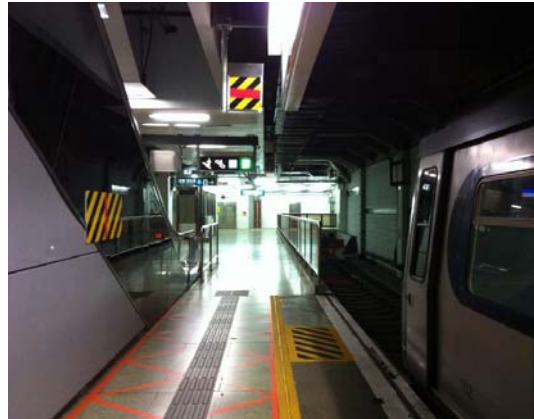
On 8 January 2012, a portion of a passenger train on the East Rail Line stopped short of the platform stopping mark and yet the train doors were opened. Although the incident caused no passenger injury, we investigated the near-miss in view of the potential safety threat.

It is not uncommon for trains to stop in an inaccurate position. As a general rule, however, the train doors will not be opened until the train captain has confirmed that the train is in the correct position. To activate the door by-pass switch in the case of any emergency, the authorisation of the operation control centre (OCC) is required. In this incident, the train captain did not identify the train stopping position and used the door by-pass switch without authorization.

Figure 8: Vertical stopping mark on the East Rail Line

Figure 9: Vertical stopping mark at Hung Hom Station

Following this incident, a refresher training programme was specifically developed to remind train captains to be vigilant in identifying the train stopping position and to reinforce the correct procedure for operating the door by-pass switch. We also recognized that the environment and human-machine-interface were the performance shaping factors in this incident. To facilitate the checking of proper train position, a vertical stopping mark was installed at each platform end (as can be seen in Figures 8 and 9) and a reminder label was also posted near each train's door by-pass switch. Furthermore, the door by-pass switch was relocated to a new position in the cab console so that it was not so easily assessable to the train captain, thus helping to avoid inadvertent operation.
