MANAGING RAIL RESOURCES & INFRASTRUCTURE TO RESTORE AND MAINTAIN OPERATIONS IN THE AFTERMATH OF MAJOR EARTHQUAKES

Peter Steel

Phillip O'Connell

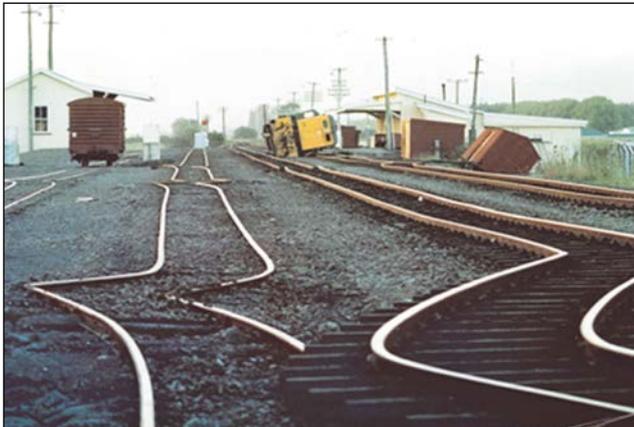
The Inangahua Earthquake of 1968 and the Edgecumbe earthquake of 1987 both delivered shaking that was severe enough to derail and overturn rolling stock.

Figure 1: Inangahua Earthquake, 1968

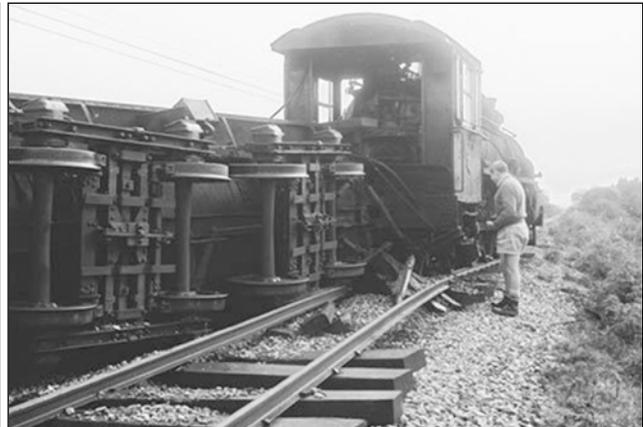
Figure 2: Edgecumbe Earthquake, 1987

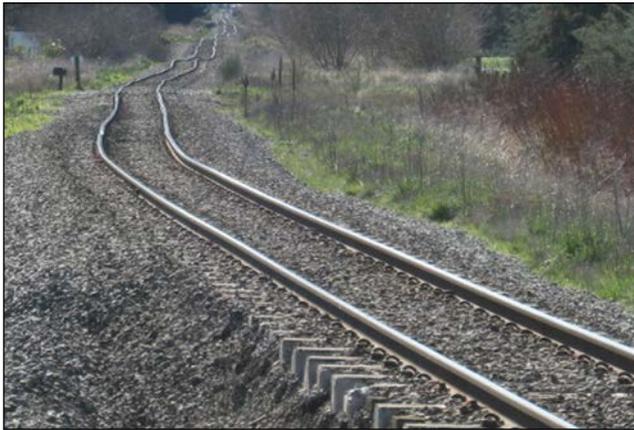
- Severe liquefaction and lateral spreading of embankments between 0km to 10km MSL and 0km to 20km on the MNL resulting in vertical and horizontal track geometry issues.
- Abutment movement caused by embankment liquefaction to Bridge 18 MNL closed the track until the bridge approaches, abutment and rail buckling in the vicinity was repaired in the following days.
- There was a severe track buckle at Rolleston across the fault trace where the track gang removed 26 metres of rail and replaced it with a 20 metre length. A light locomotive stopped immediately short of this buckle after the earthquake.

Figure 4: Main North Line Track Damage

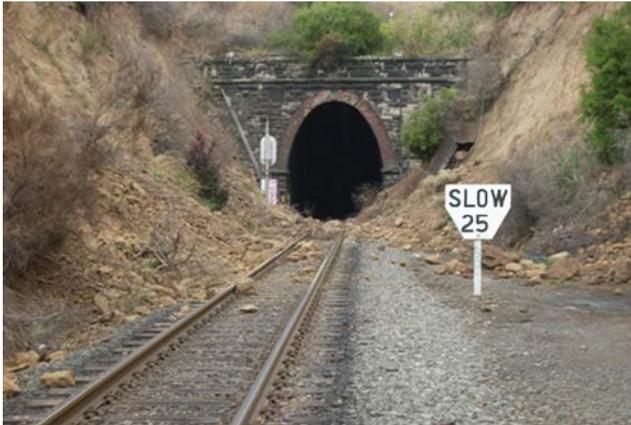
Figure 7: Lyttelton Tunnel West Portal

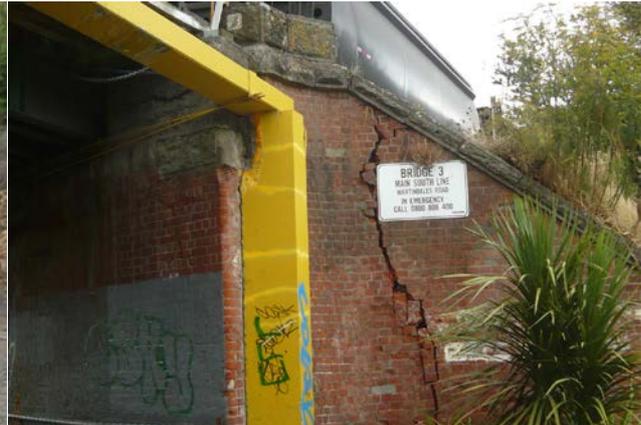
- Bridge 3 on the Main South Line in the Heathcote valley close to the epicentre had its brick abutments shattered. A train had been passing over the bridge during the earthquake and had derailed on the bridge
- There had been abutment movement caused by liquefaction affecting bridges on the MSL between Middleton and Lyttelton.
- There had been embankment slumping affecting the track between 0.0km to 10.0km MSL and 0.0km to 20.0km MNL
- At the Port of Lyttelton there had been significant rockfalls onto the railway corridor from the cliffs around the edge of the port area.
- There had been a number of slips near the portals of the Lyttelton tunnel
- A wagon had fallen into the wheel lathe pit at the Addington depot
- Other depot areas, particularly the Lynwood depot had suffered liquefaction and building damage.

Figure 8: Bridge 3 MSL Abutment
