Malahide Viaduct Collapse

21st of August 2009

RSC/RAIU:

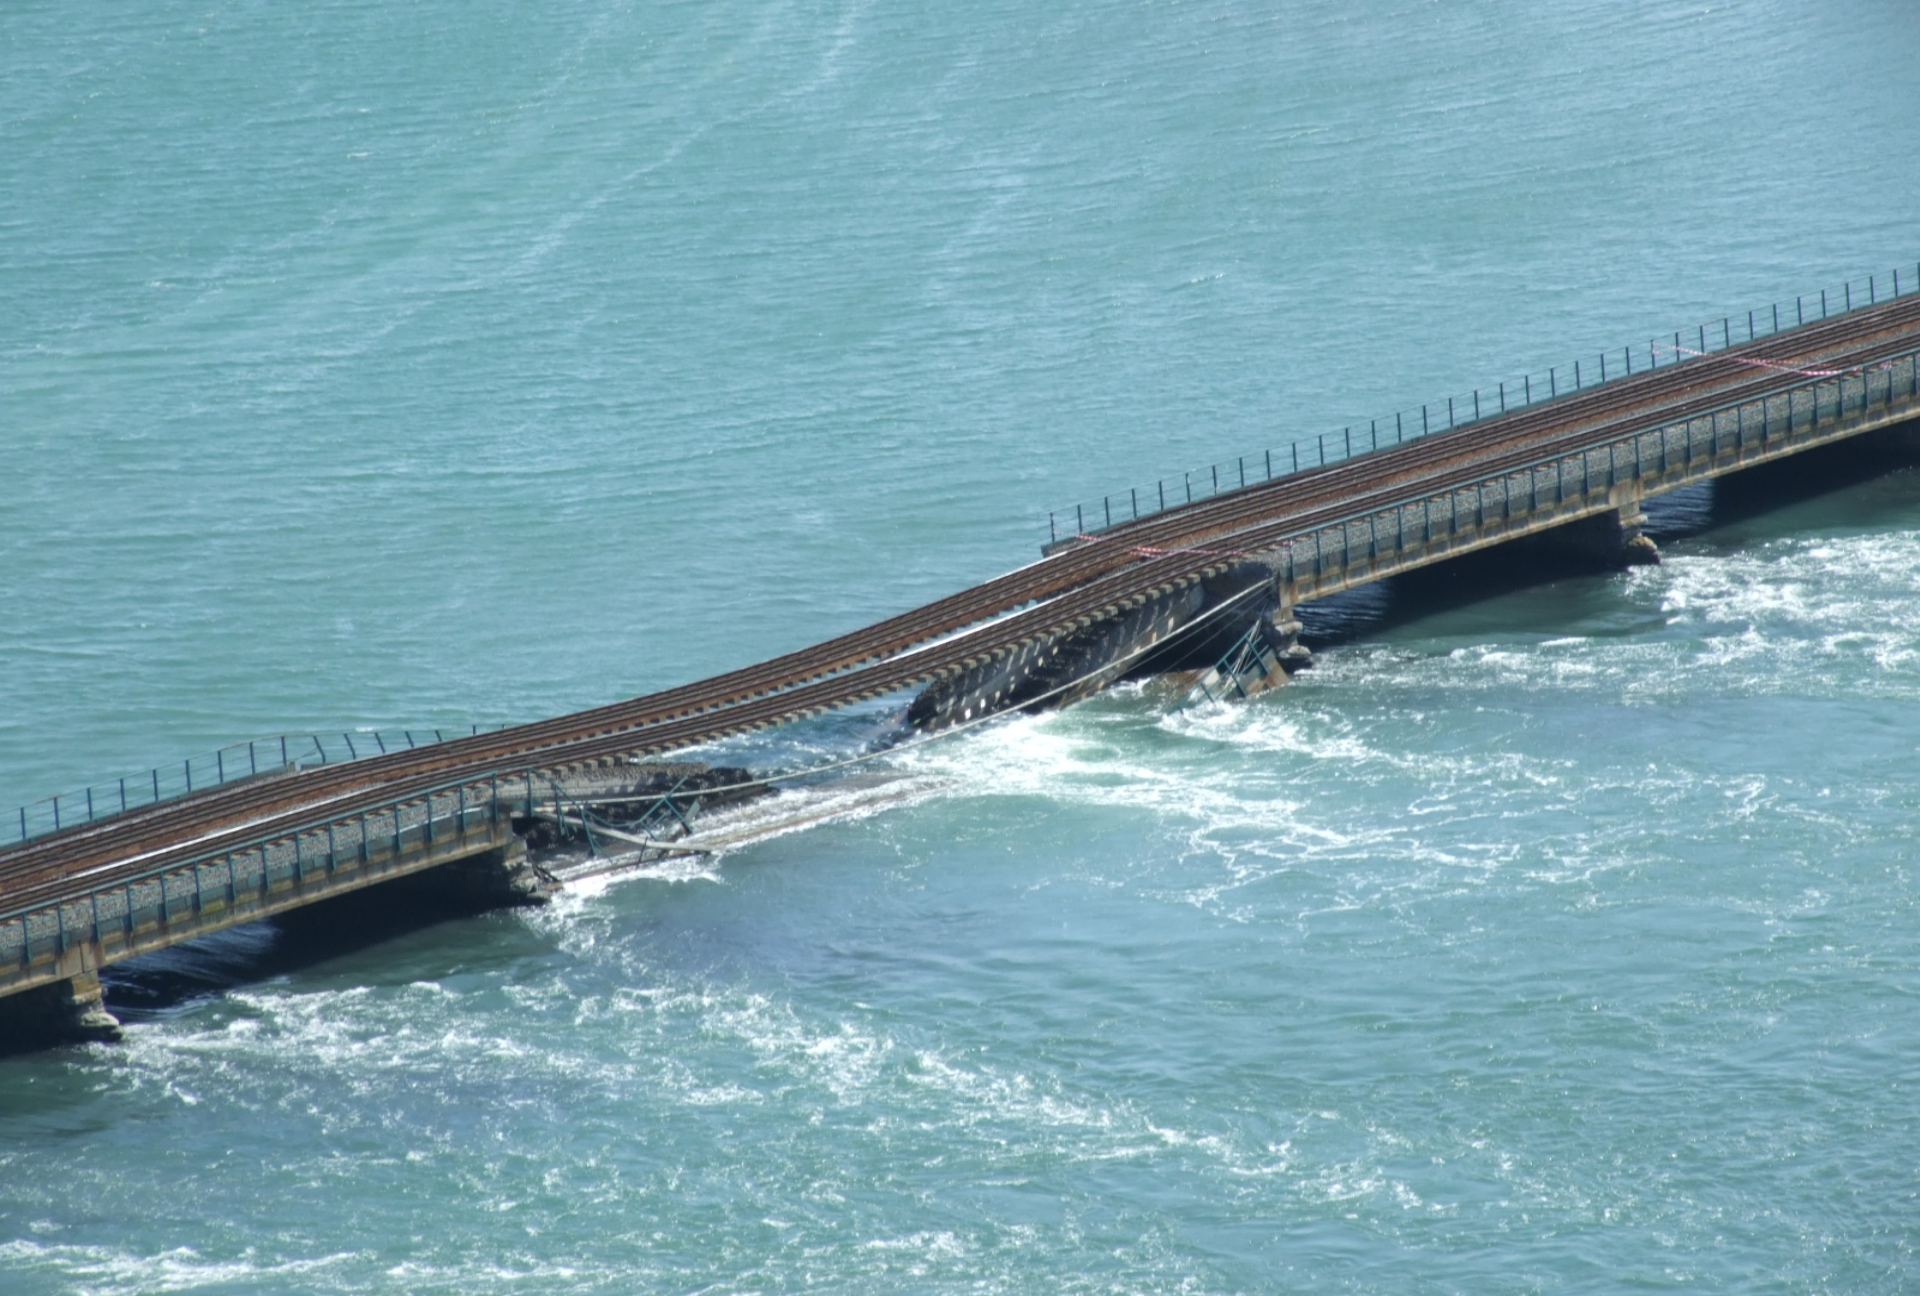
- No alignment problems identified in recent inspection/monitoring
- 17.50 Pearse/Dundalk passed c. 18.20 with no observed problems
- 18.07 Balbriggan/Connolly passed c. 18.21-22, driver noted partial collapse of 'down' line
- Driver of 18.07 stopped in Malahide and walked back to inspect by which time (*15 minutes?*) both lines had substantially failed
- **Failure was 'catastrophic'**

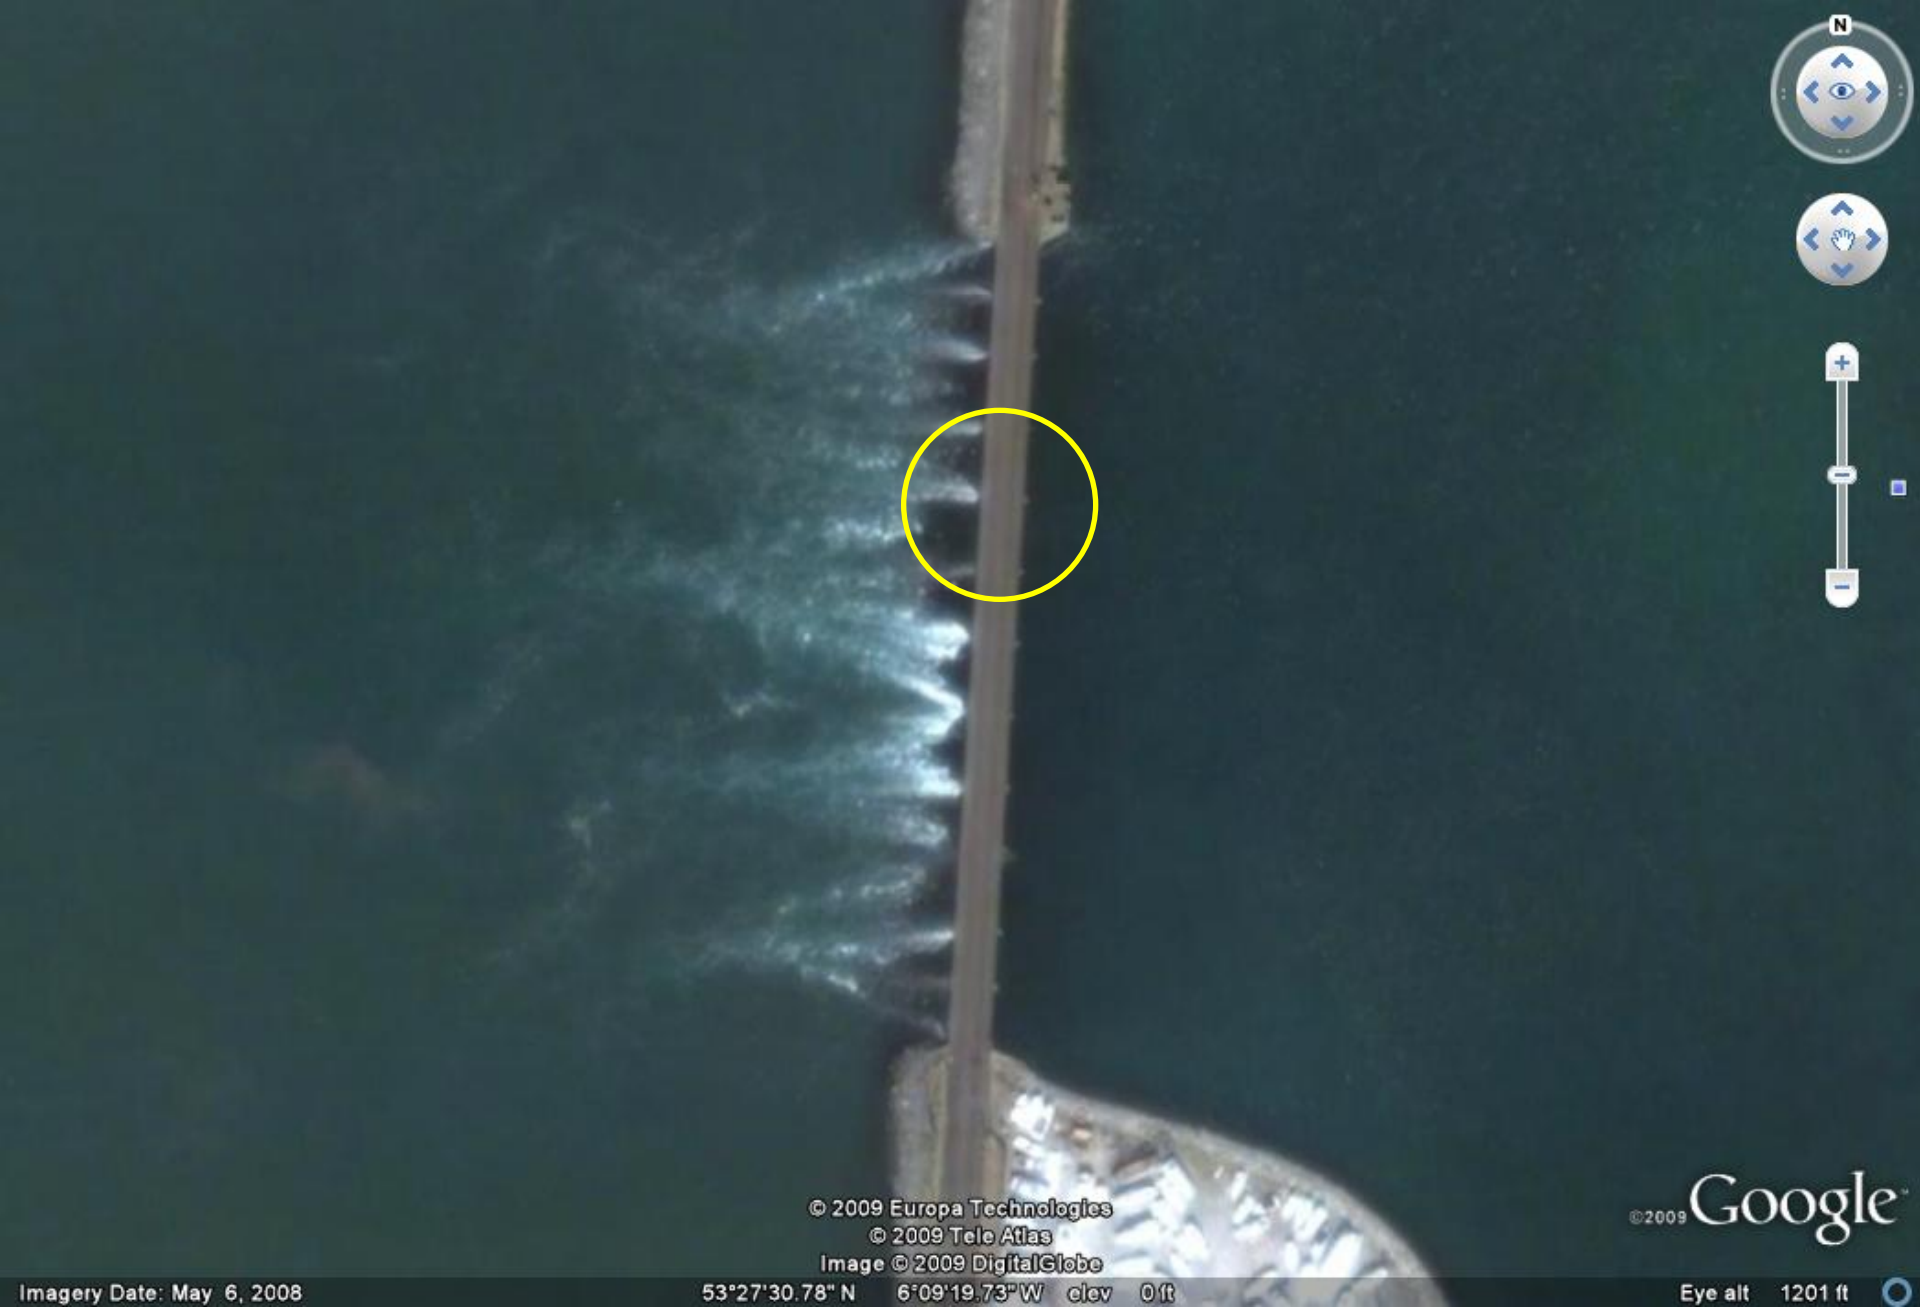
- Subsequent to construction of timber viaduct stones placed to protect piles/piers forming c. 40m wide submerged embankment.
- Current piers;
 - 11 'identical' cut stone
 - date from 1860 reconstruction
 - founded c. 4.5m below rail level on submerged bank of rock
 - foundations are within the tidal range (*approx ½m above mean sea level*)
