Risk management of Operators Interpretation of Information from New Technology

Two freight trains (9207 and 6032) collided on a straight section of track on the single track line between the stations Arnemark and Piteå on 21 September 2016. Train 9207 was proceeding under clear signals at normal speed (90 km/h) while the other train, 6032, was travelling under speed restrictions (driver required to be able to stop the train within the visible distance of track, max 40 km/h), after being permitted to proceed past signal at "Danger" when leaving Piteå.

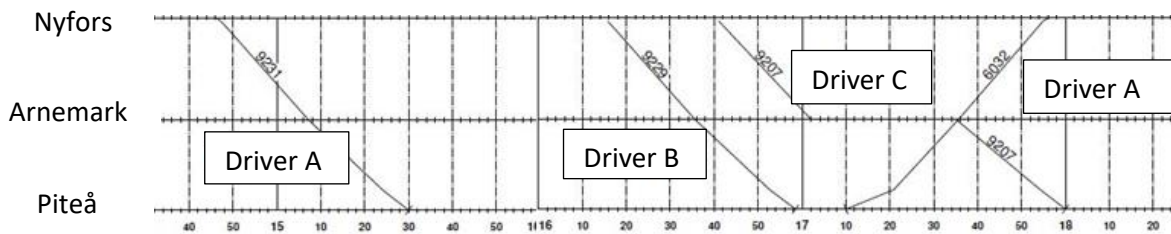
Figure 1 shows the original train plan for Nyfors – Piteå the current day. Train 9207 (Driver C) was planned to wait to meet train 6032 (Driver A) in Arnemark.

Figure 1. The original train plan for Nyfors – Piteå the current day .

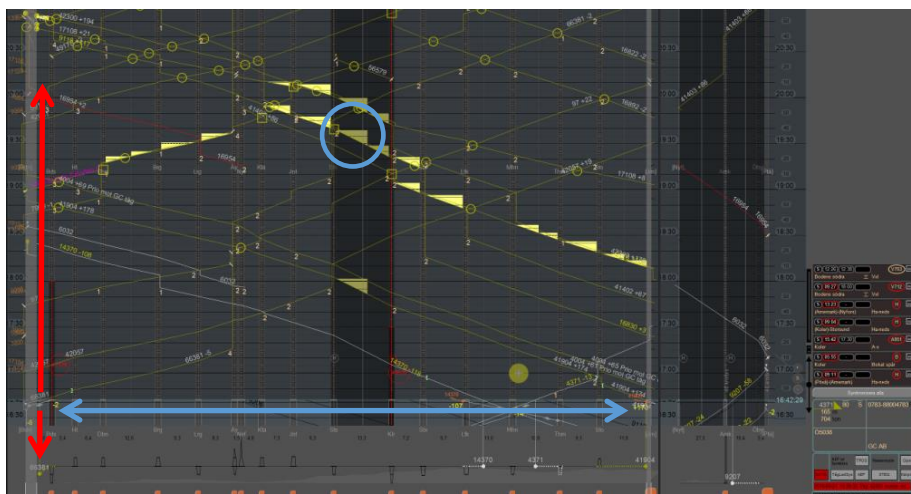
Figure 2. STEG. The red arrow upwards shows present to future and the red down arrow shows the past. Along the blue arrow is the stations on the line. The trains are represented by yellow lines and the yellow triangles are a help function to avoid train conflicts.

From the logs of STEG, it is clear that the traffic controller the hour before the accident was focused on what would happen later. The timeline on the screen was far down, which limited his ability of simultaneously monitor the outcome of the planning. The traffic controllers strong focus on planning ahead to solve conflicts can thus have caused the monitoring part of the tasks to suffer.

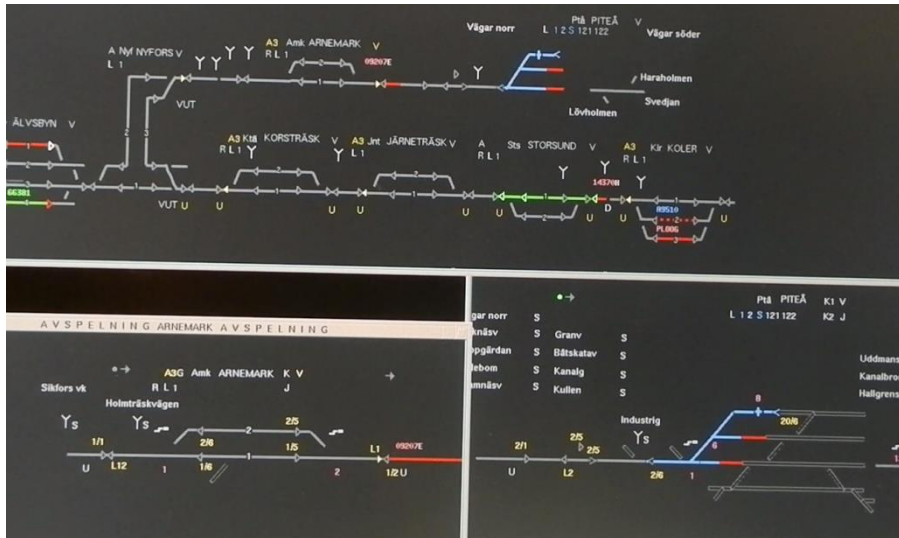
Figur 3. Traffic control system “Argus”.
