Dublin to Cork railway line - Formation remediation and ballast cleaning program

Presented By - Mick Danaher

Infrastructure Manager, Dublin Division

Irish Rail

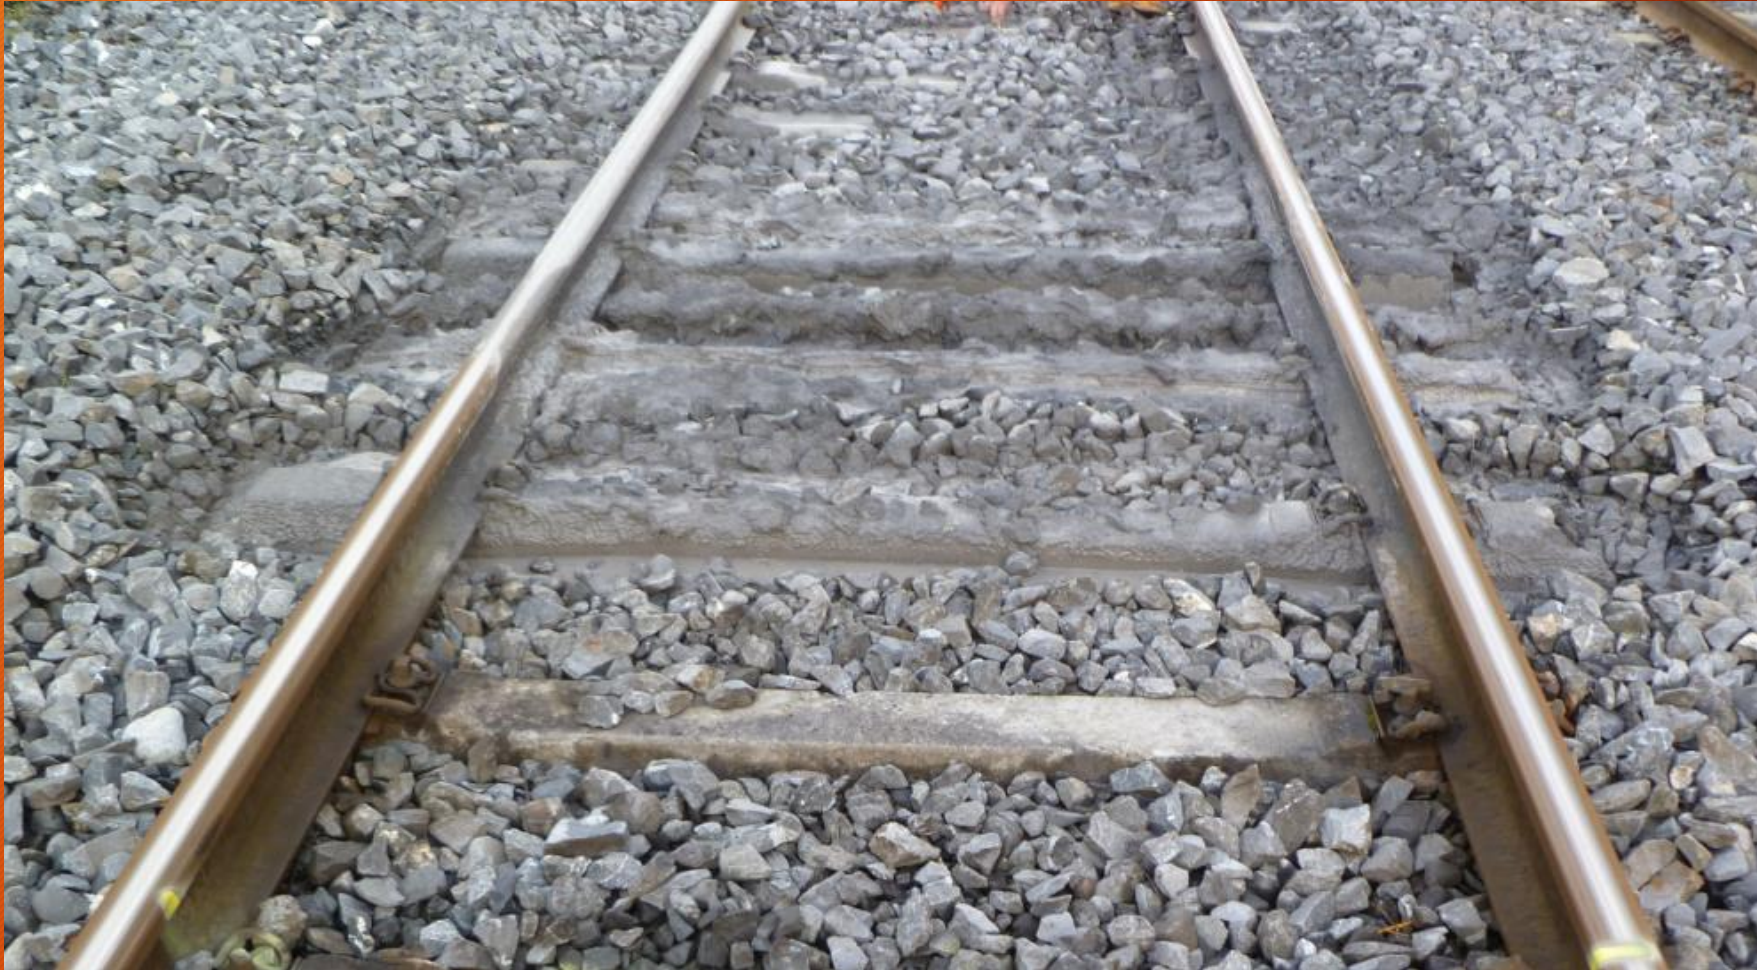
- In 2013 and 2014, following decades of under investment, it became apparent that the Dublin to Cork Railway Line was facing a crisis from an operational and potentially safety perspective.
- The ballast and formation generally, as well as the vertical alignment of the track had degraded to such an extent that maintenance costs were increasing, whilst performance in terms of sustainable and reliable line speeds were decreasing.
- Following the submission of a business case to the Department of Transport Tourism and Sport (DTTS) additional funds to address this issue on a multiannual basis was sought and approved
- Some 140 miles of track was targeted as requiring early intervention.

Dublin to Cork line formation remediation - Formation failure

- The solution was a targeted formation renewal project, including the installation of new ballast to current standards, the installation of drainage and improvement of the track geometry, particularly its gradient and vertical curvature.
- The funding level of €10 million per year was to be spent on a risk ranked basis with the worst formation sections of track being attended to first.
- The deployment of the 'Plasser and Theurer' Ballast cleaner (model RM 90) was selected as the central tool to excavate the track formation.
- A project team, under a dedicated project manager, was established.

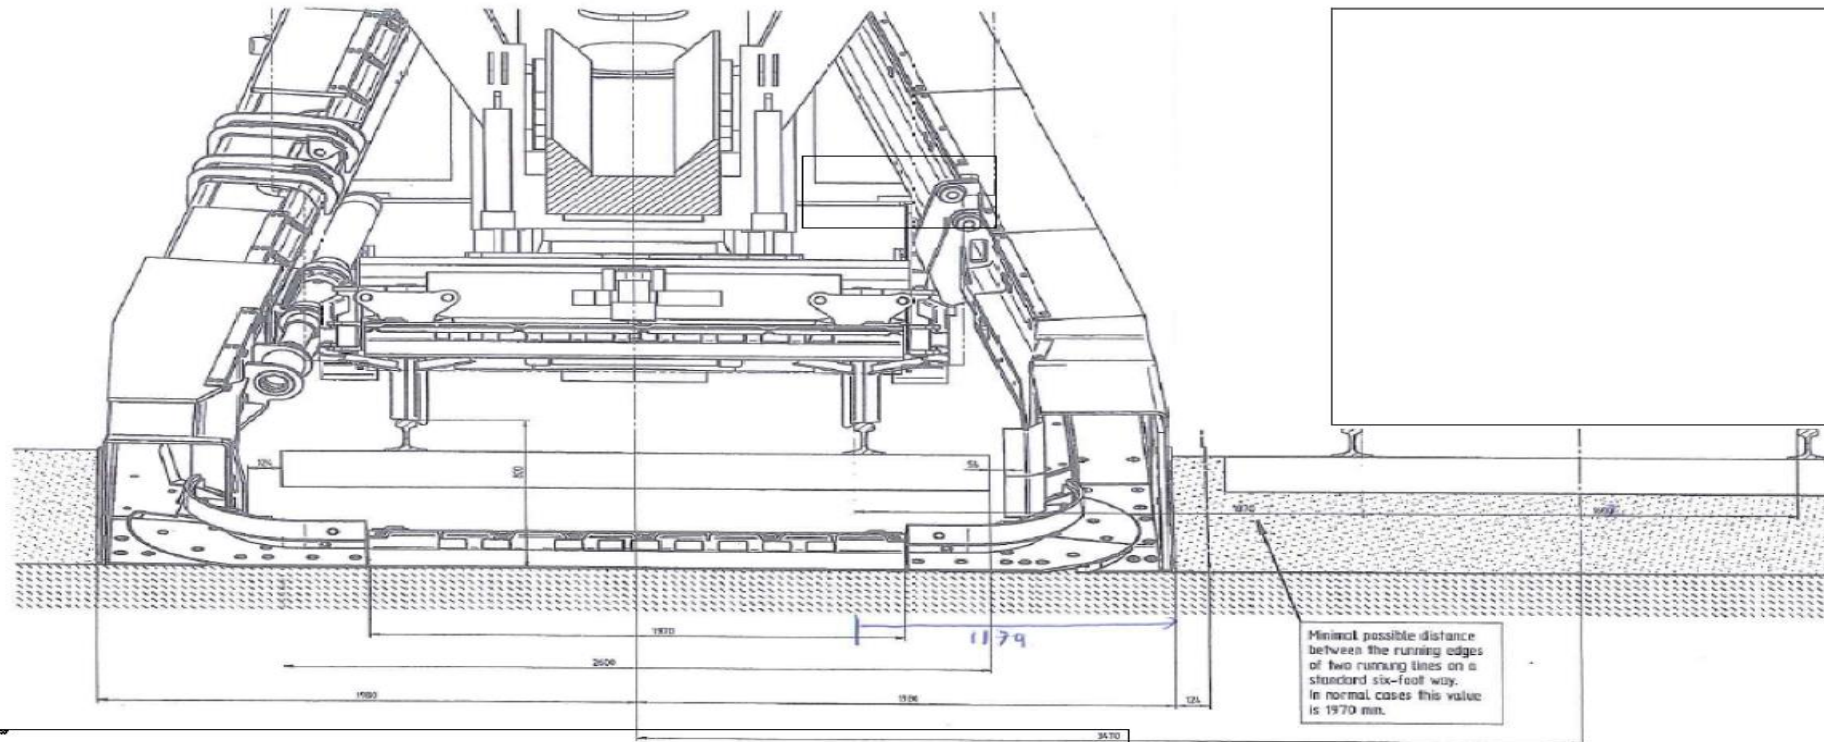
Dublin to Cork line formation remediation - Controlling clearances

Minimum 6ft = $1179 + 100 + 647 + 124 = 2050$ RE to RE

Minimum 6ft = $1179 + 100 + 647 + 56 = 1982$ RE to RE

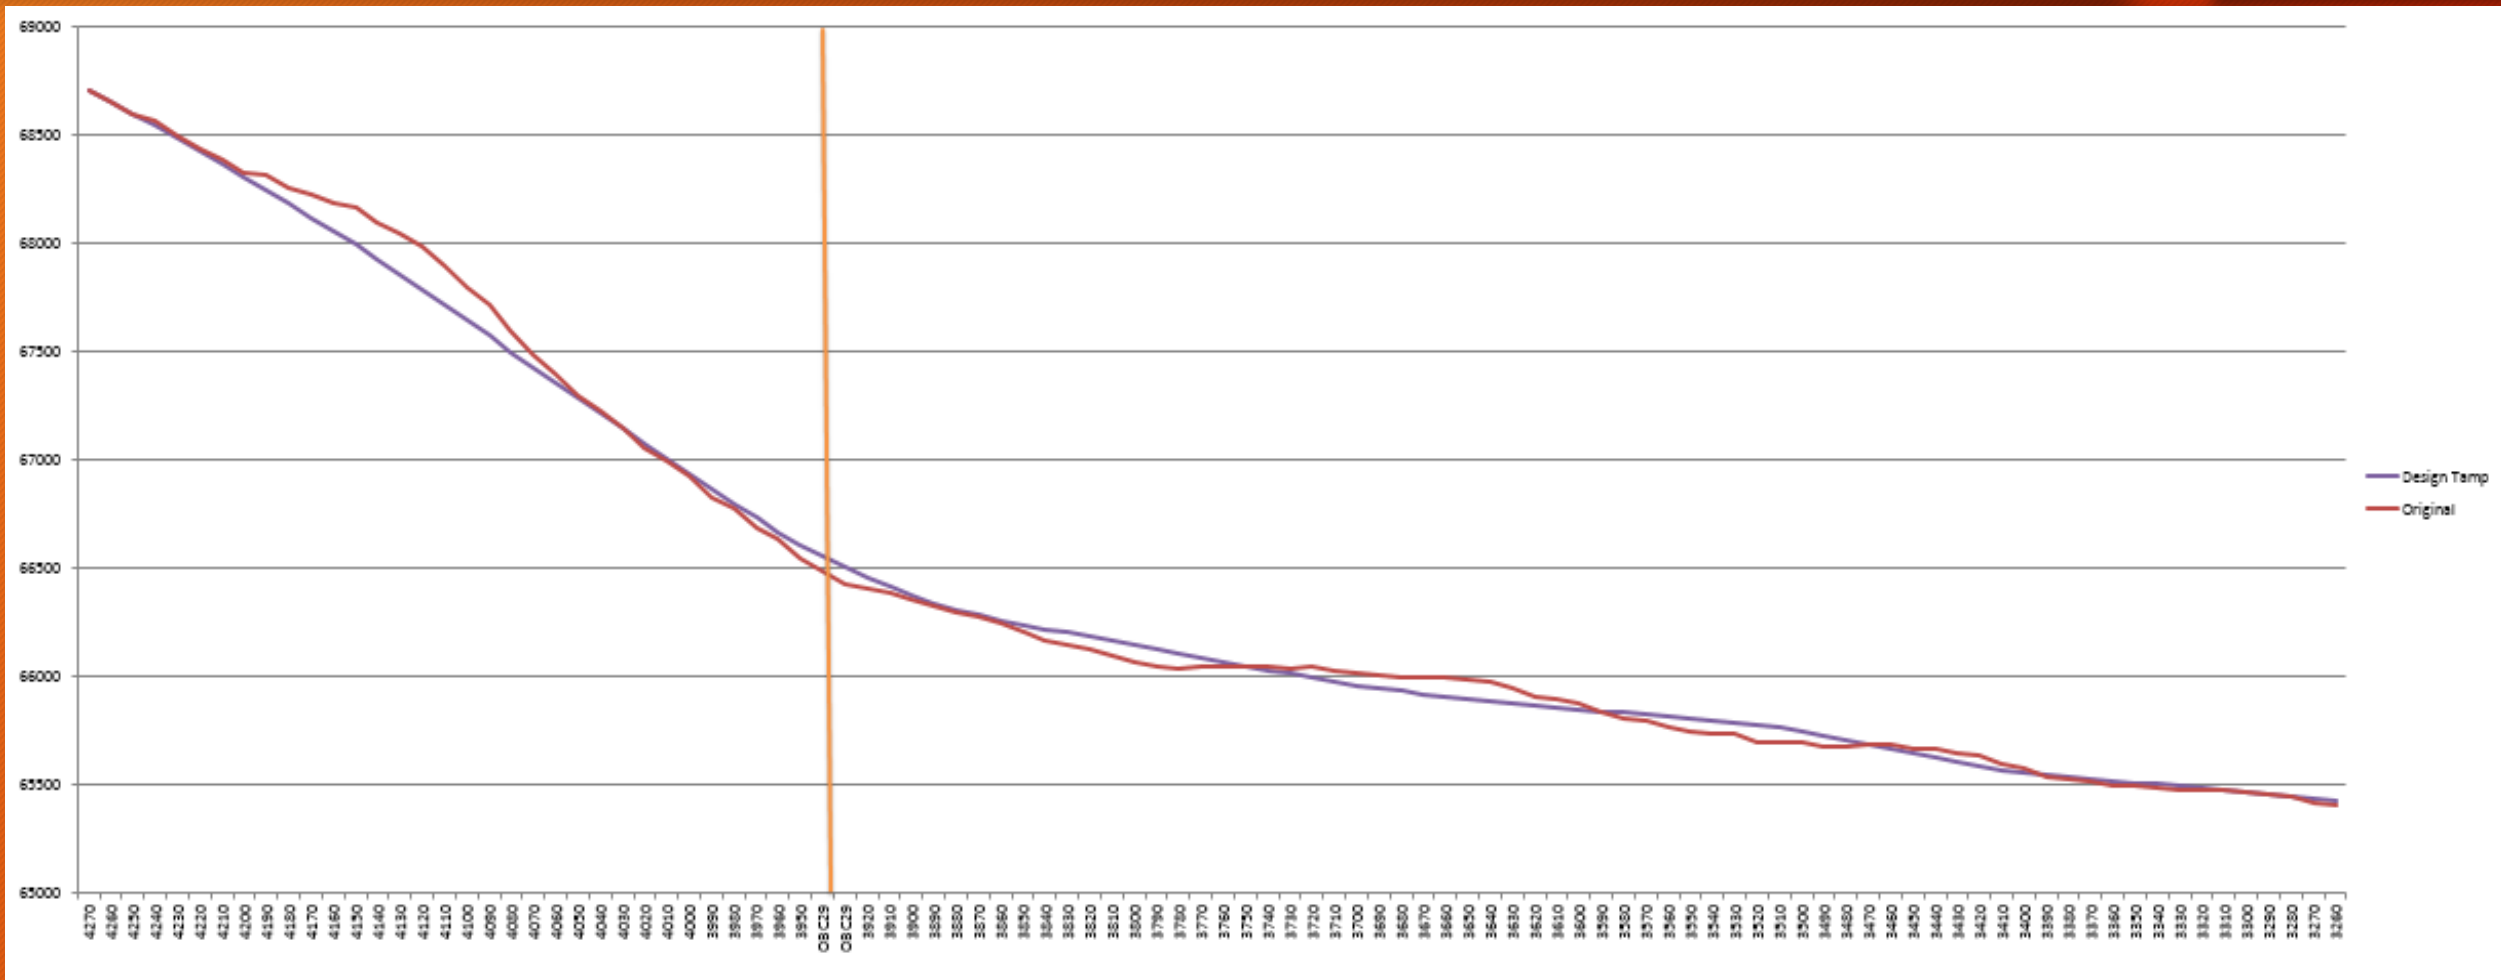
Straffan UP Road (12 ½ to 13 ¼ MP) - completed October 2016

Vertical Geometry

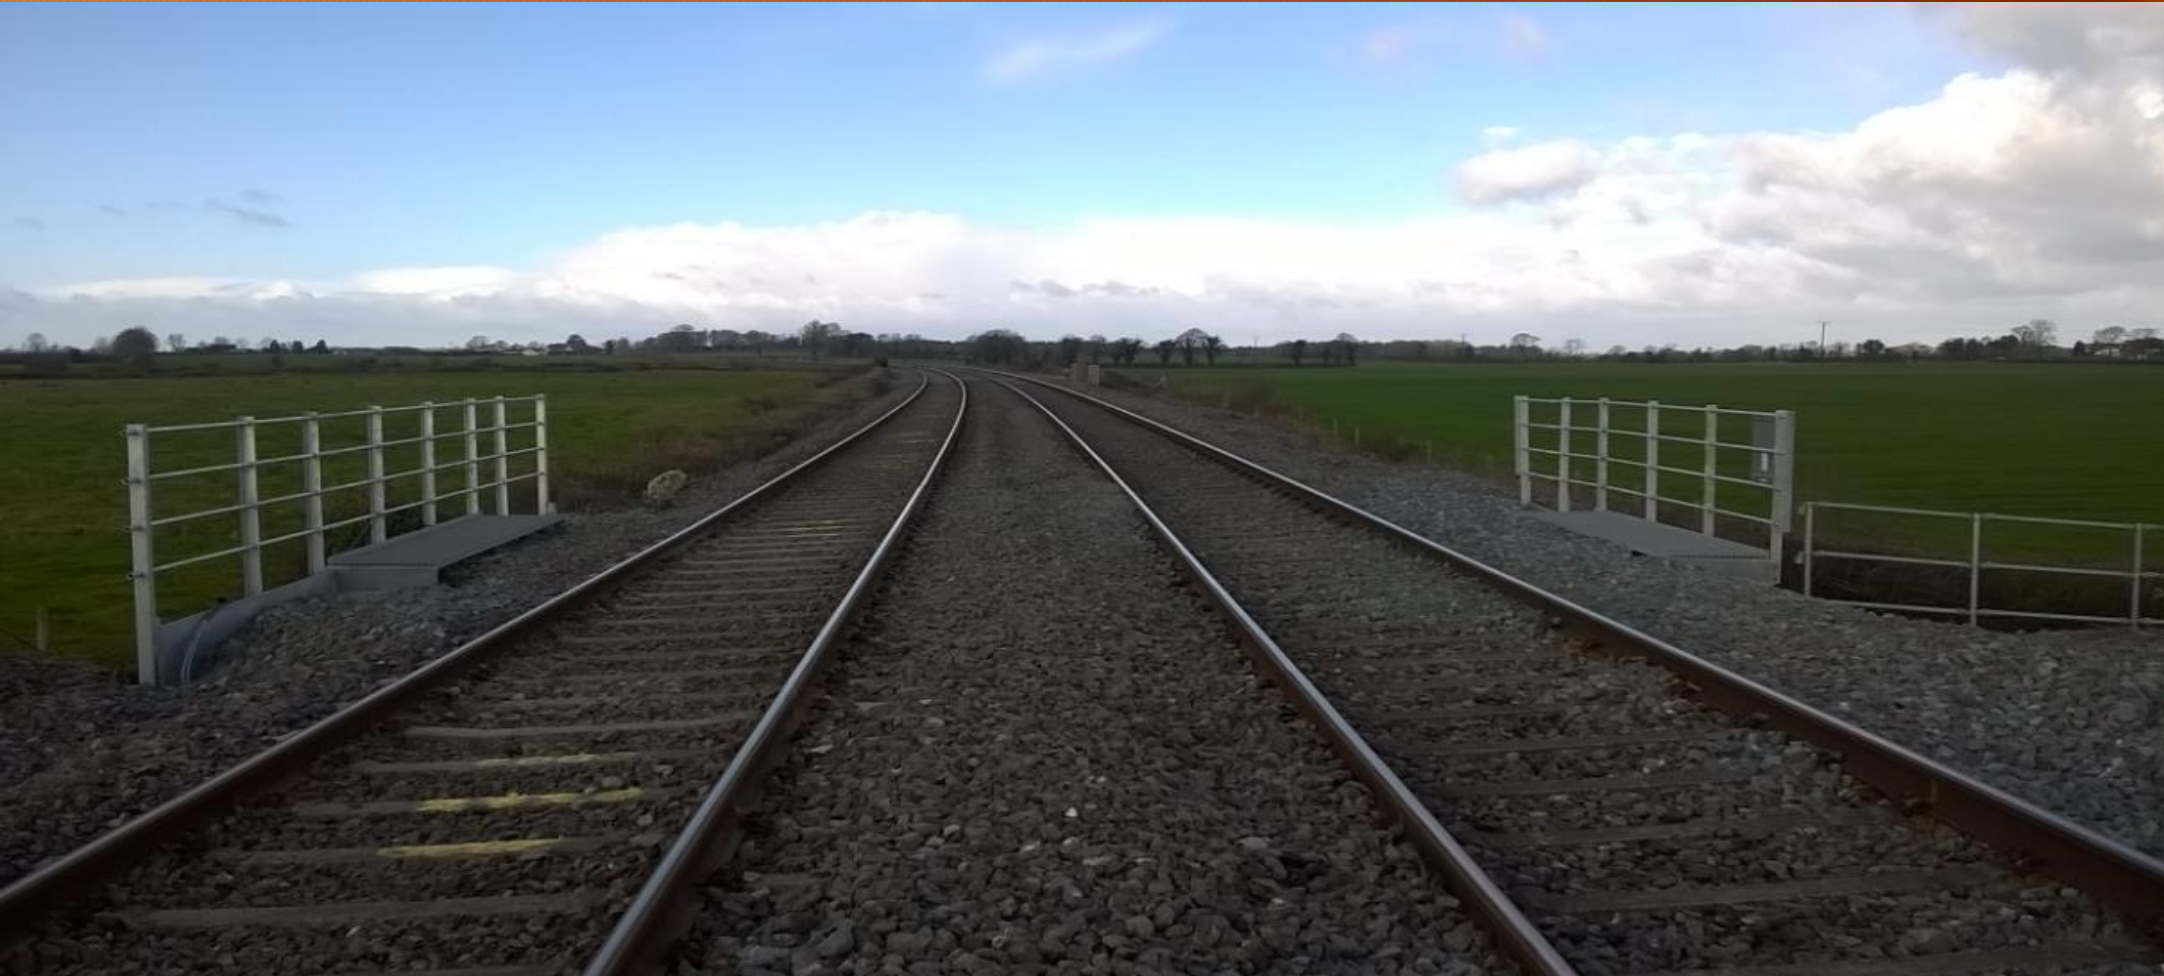
Bridge Ballast Guard & Walkway Upgrade

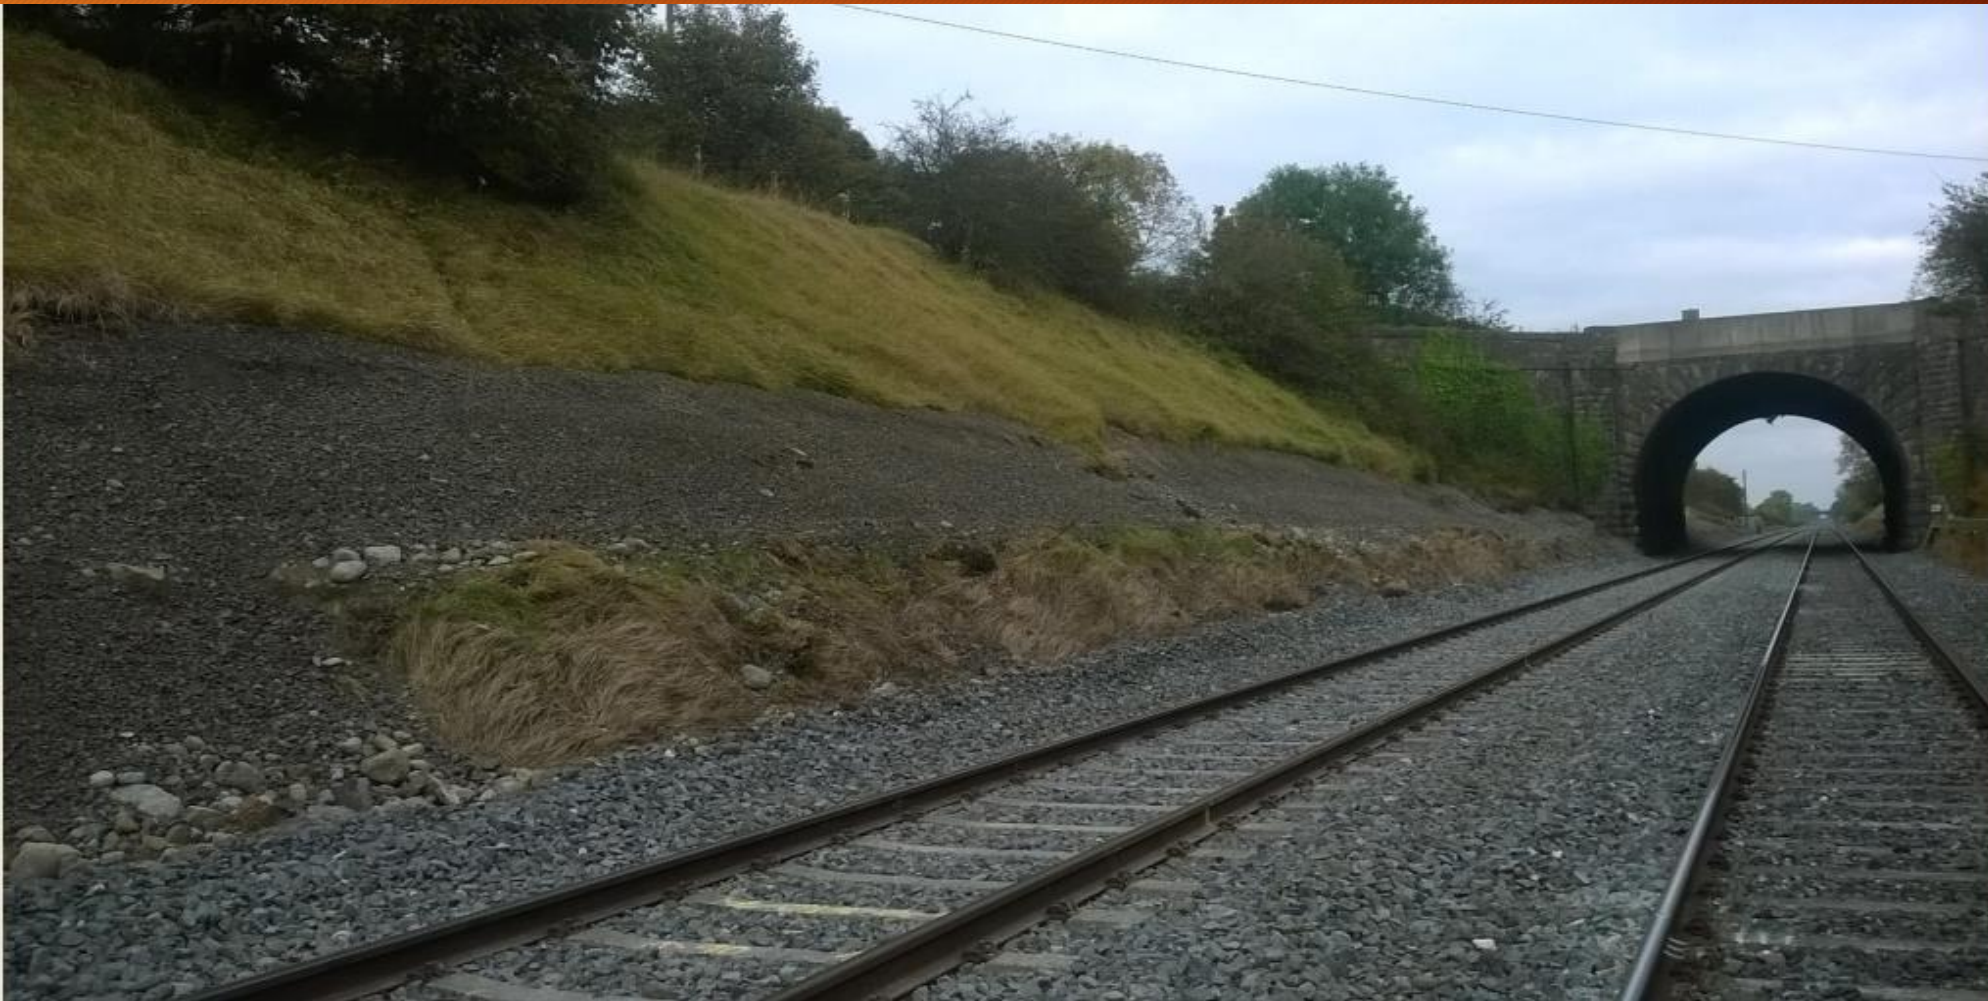
Regraded embankment post ballast cleaning
