# FAURE LEVEL CROSSING COLLISION, CAPE TOWN, SOUTH AFRICA

## A CASE HISTORY

**Dick Arnold**

Railway Safety Regulator, South Africa

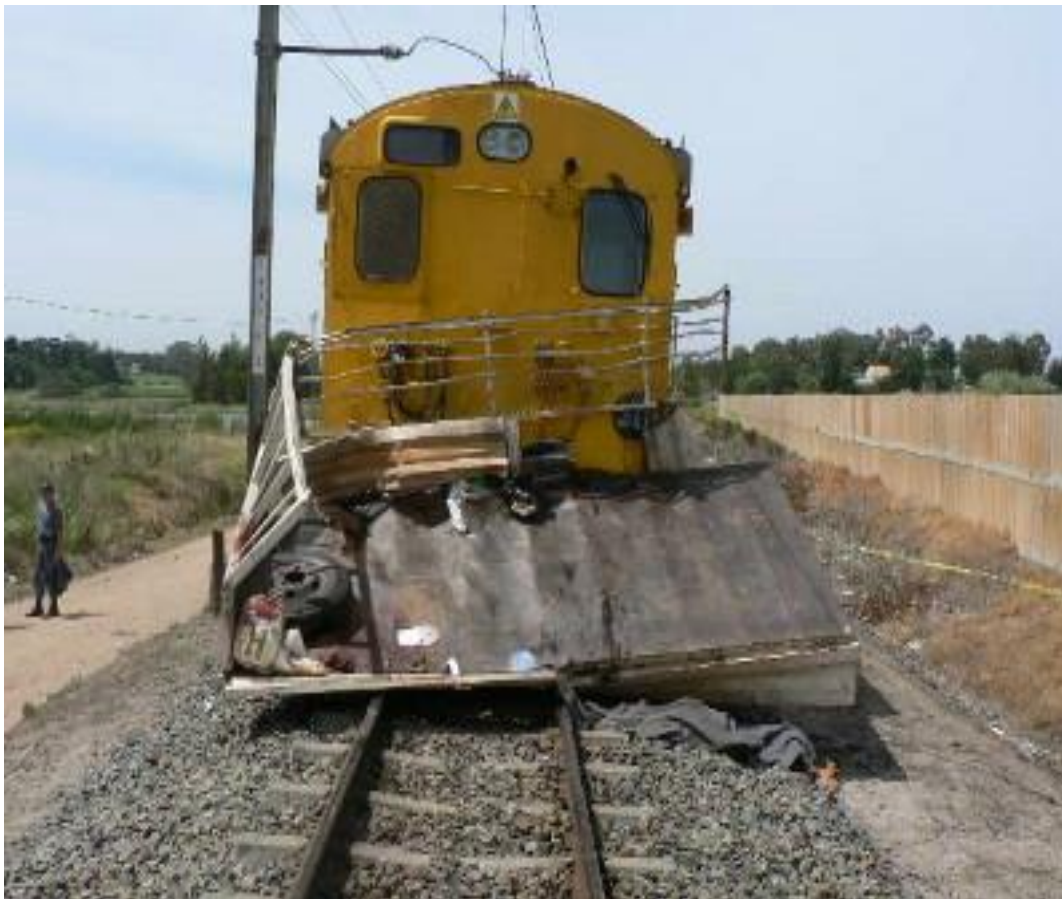
**Figure 1: Train came to a stop 500 metres from the point of impact**

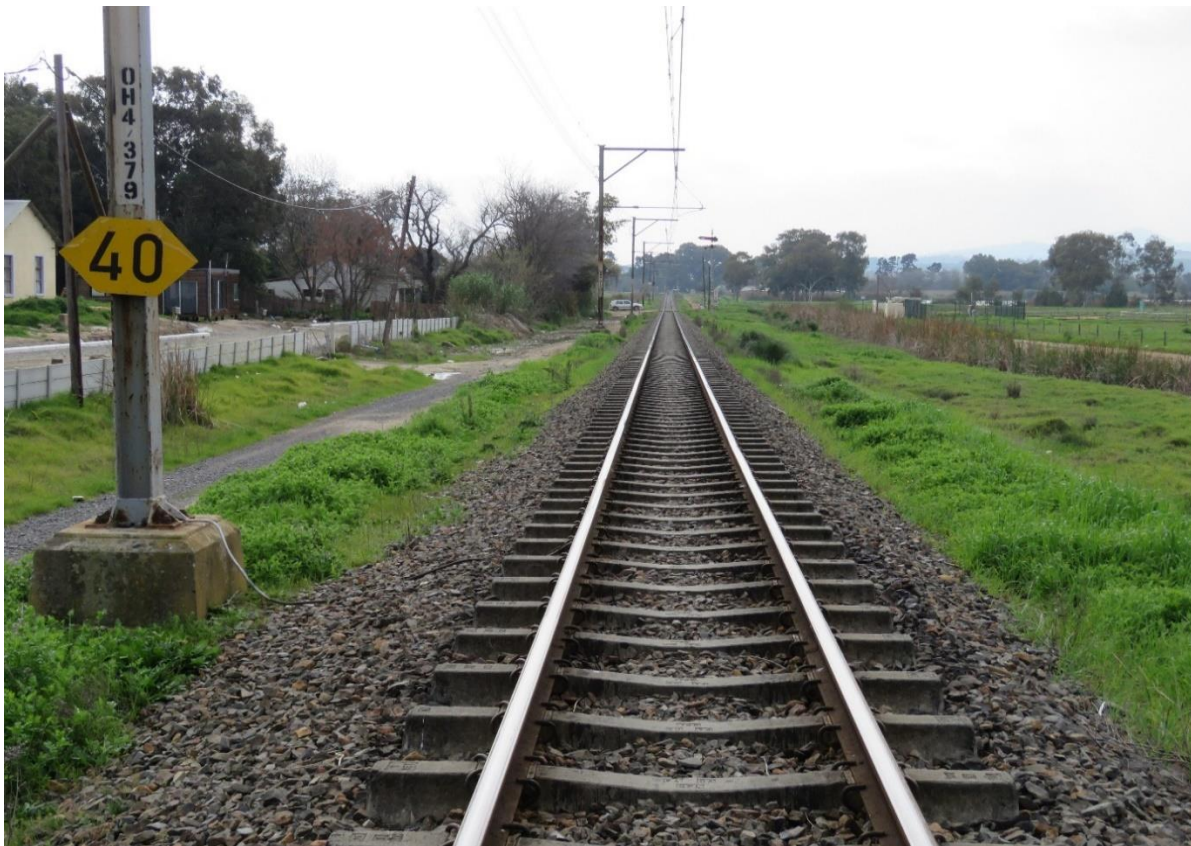
**Figure 2: This is the view that the train driver would have had of the crossing from the second whistle board (125m). A vehicle, which has stopped at the crossing, can be seen in the distance  
The 40km/h speed board was erected after the accident on the instruction of the RSR**

- **Carry out a comprehensive Risk Assessment at this crossing**
- **And in the interim to impose an immediate speed restriction on this line of 40km/h**

The reason for choosing the figure of 40km/h was that if a train driver does an emergency brake application at the second whistle board (125m) while travelling at 40km/h, the train will come to a stop before the crossing. See figure 5 below.

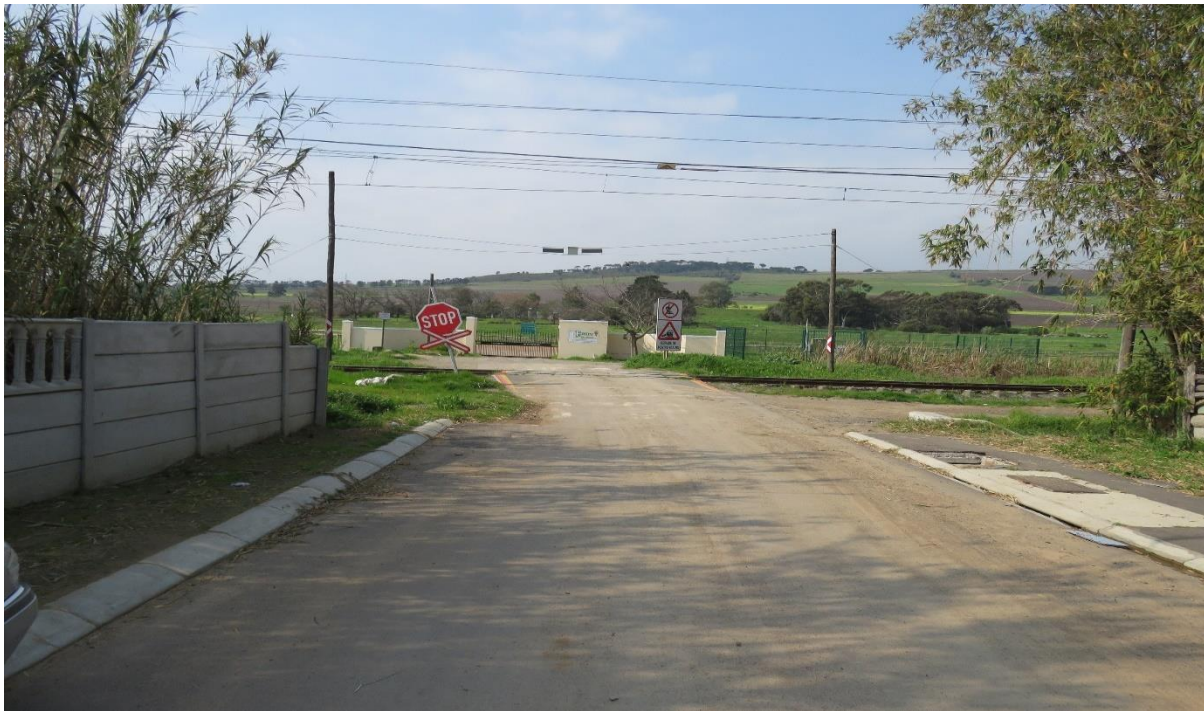
**Figure 3: The road approach to the crossing is lined with walls and vegetation**

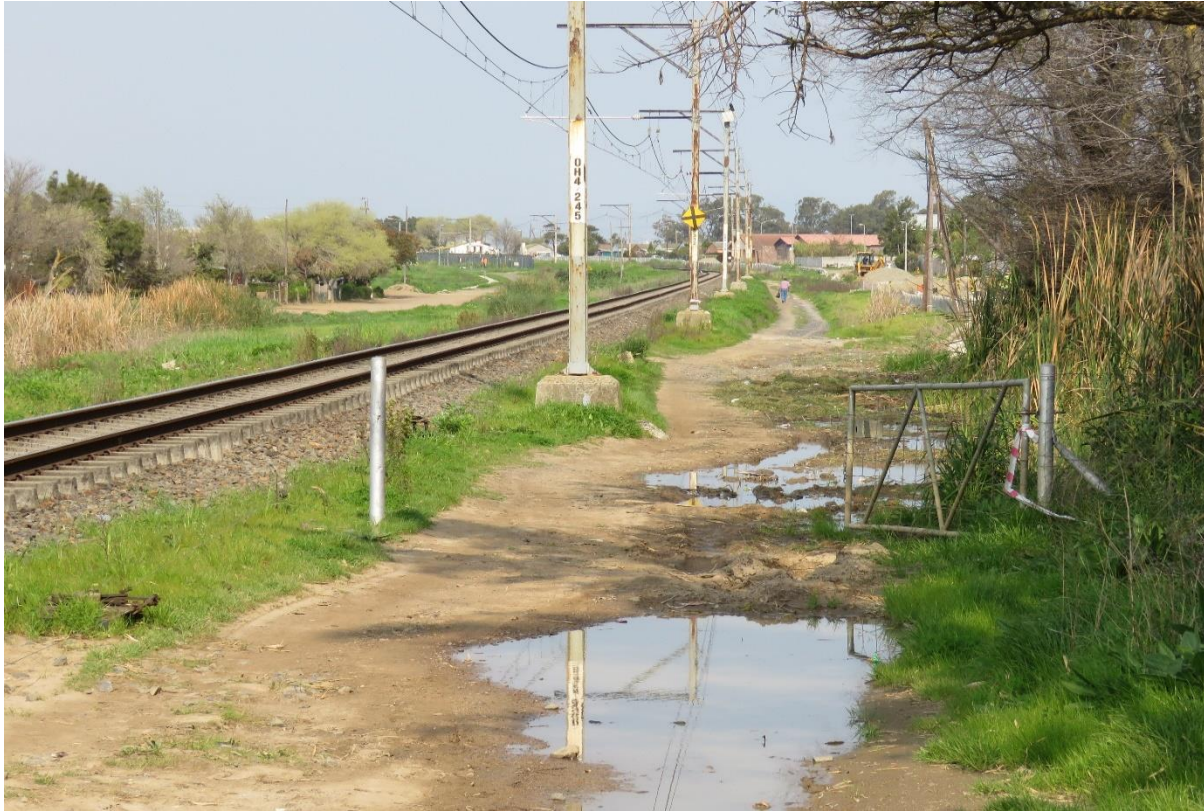
**Figure 4: The sight distance to approaching trains from the road stop line is excellent**

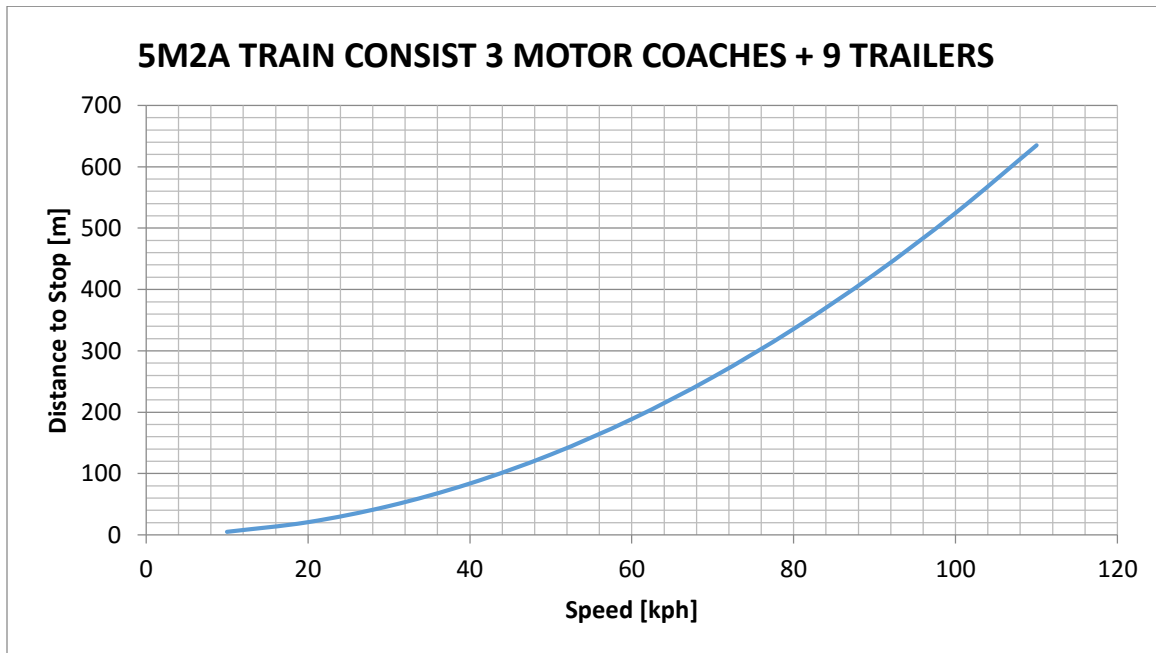
**Figure 5: Train Stopping Distance vs Speed**
