Lessons from the Nabeta Railroad Crossing Accident Investigation

Japan Needs an Equivalent of the
NTSB To Prevent Similar Accidents

The Railroad Crossing Accident

Date and Time : April 2, 2009 09:25

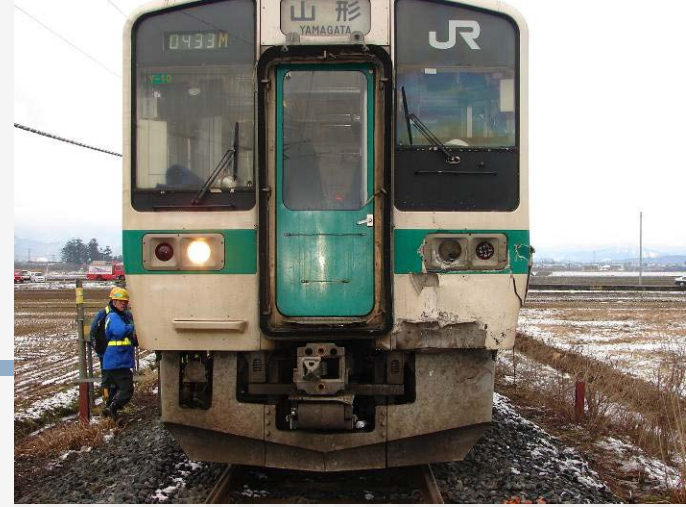
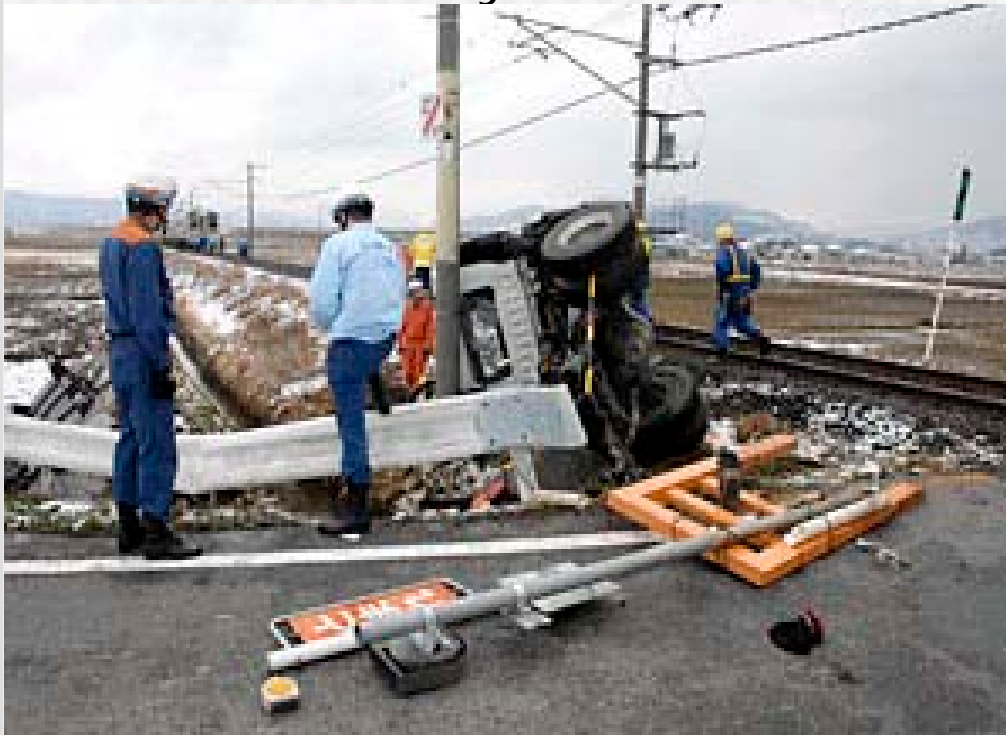
Location : Nabeta Railroad Crossing between Takahata Station
and Akayu Station

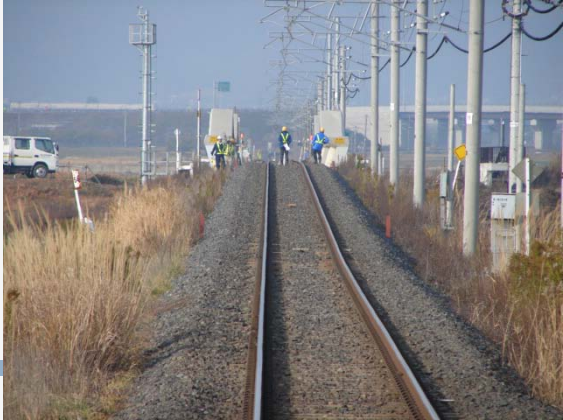
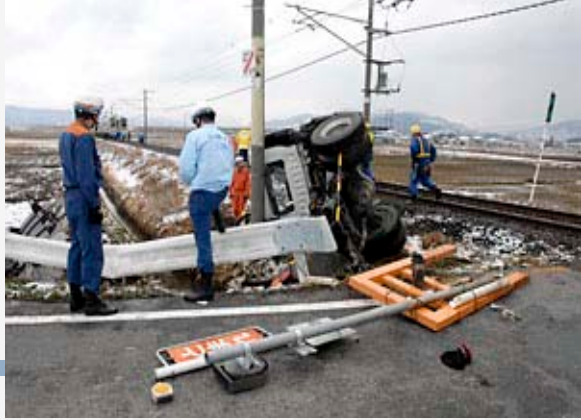
The Circumstances of the Accident

The railroad crossing in question is equipped with a warning alarm and crossing gate, and is situated on a 1-km section of straight track. There is an obstruction alarm device.

- **The train driver may have failed to notice the signal flashing, because:**
 1. The layout of the railroad at the scene of the accident had been changed due to the rebuilding of the bridge
 2. It may have been difficult to see the signal before passing the bridge because it was hidden by a line of electric poles

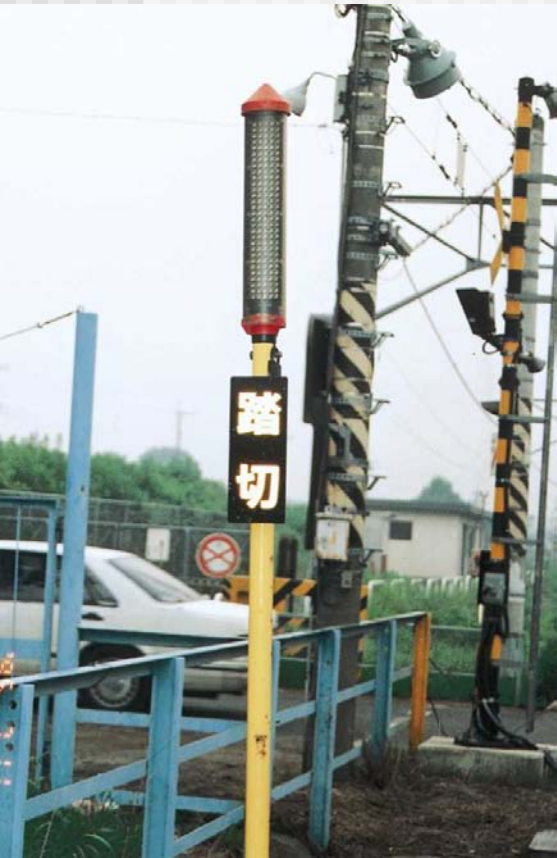
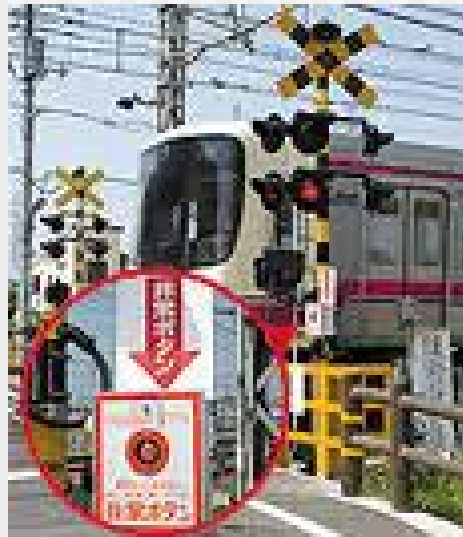
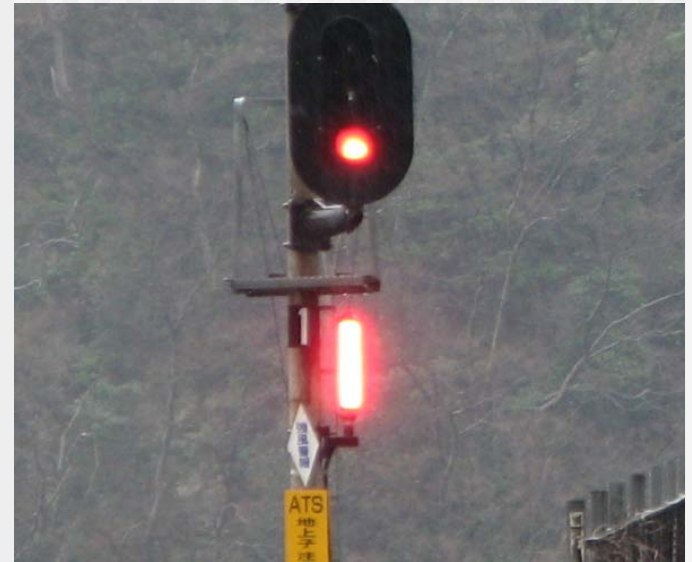
Obstruction Warning Signal

There is an obstruction alarm device in place, which can be activated by pressing a button when something abnormal appears in the crossing. There is also an obstruction detecting device which automatically senses obstructions. Both devices set off flashing obstruction warning signals to notify train drivers that there is an unusual situation on the railroad.

- There were problems with the visibility of the obstruction warning signal

- ✧ That signal was inspected and no problems were found
- ✧ The inspection does not include a test of whether it can be seen from 800 meters away
