IRSC 2011 Paper

Interfacing old and new technology

Managing the hazards of railway technological interfaces

Alan Ross, Principal, A&K Ross Associates Pty Ltd

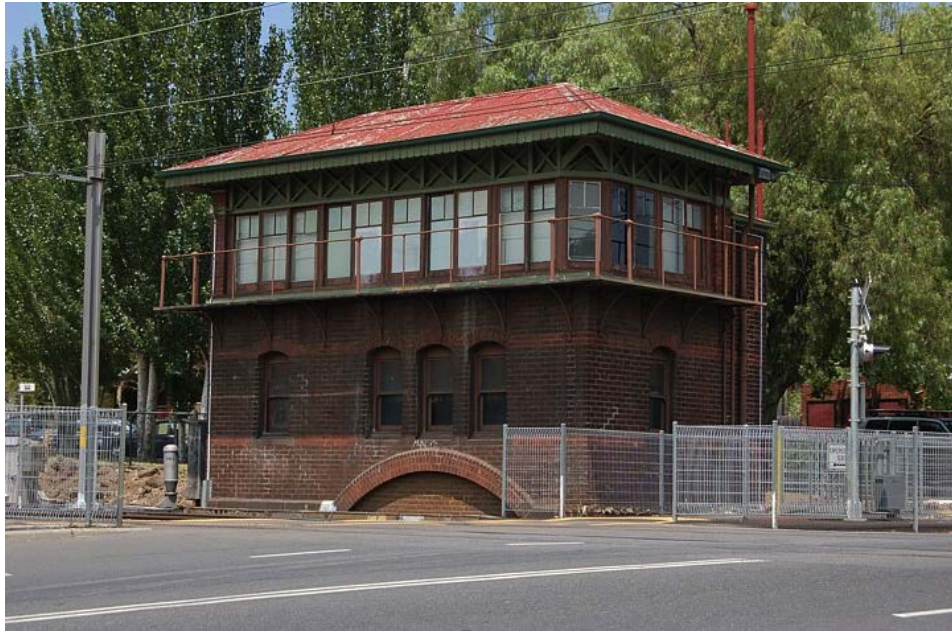
Figure 1 Kensington Signal Box, Melbourne

Kensington Signal Box, circa 1887, with the 19 lever 'cam and tappett' interlocking lever frame that was installed in 1918 and is largely unchanged since then. Some would call this a heritage railway, rather than one of the busiest locations on the Melbourne metropolitan rail network! The implications of this interface of old and (relatively) new technology is very obvious and it has caused significant problems.

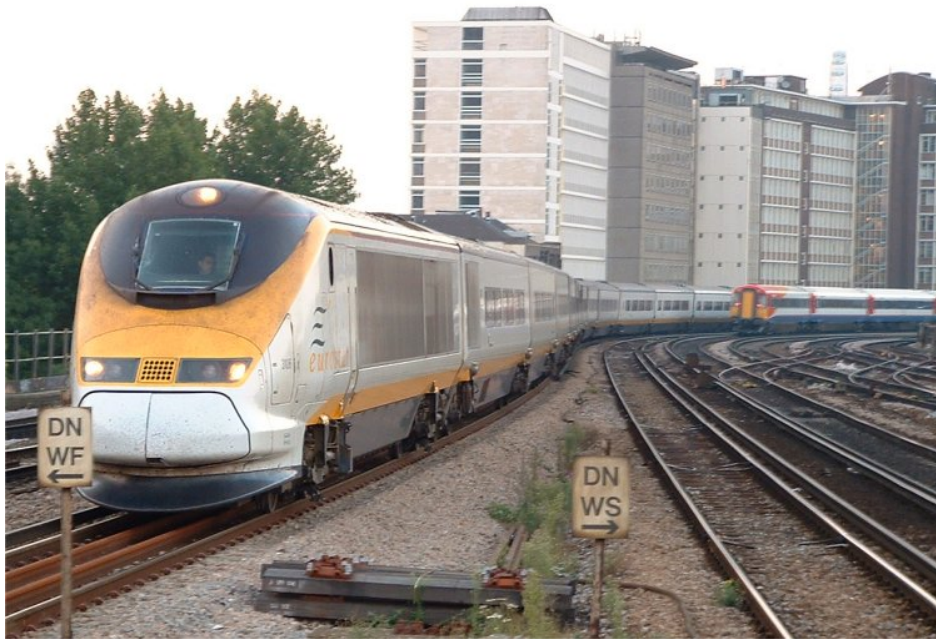
Figure 3 Eurostar departing Waterloo on the old southern third rail system

In my experience the most interesting example of old and new technology was Eurostar. When the Eurostar service was first introduced in 1994 between London, Paris and Brussels it placed a highly complex state of the art electric train on to an antiquated third-rail commuter system that provides a traction power at 750 V DC. The trains had facilities to operate on up to four different traction power systems, the other three using one of two different pantographs for collection of 25 kV AC, 3kV DC or 1.5kV DC. The transition from one system to another required a degree of vigilance from the driver. There were cases of failure to retract the third rail pickup 'shoe' in France and also failure to lower pantographs in England, both resulting in significant infrastructure damage and service delays.

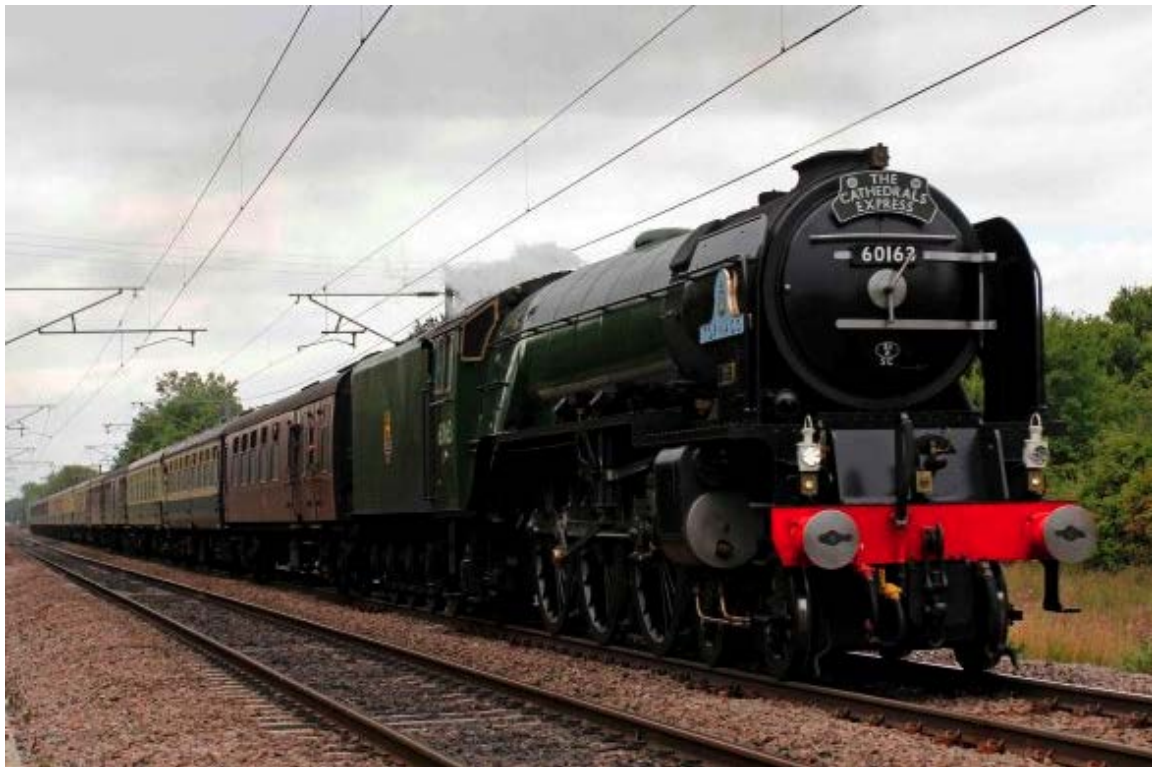
Figure 4 *Tornado*, 'Replica' A1 steam locomotive

example of the interface of old and new technology, in many different ways, but let us focus here on the TPWS fitment. TPWS was installed on *Tornado* during the build of the brand new steam locomotive and was thus designed in from the start.

Tornado has TPWS unit Thales Model Number 606108-01 Mod strike 4 that was installed at Darlington in July 2008. The picture shows the TPWS Control Unit and PSU as fitted, under the driver's seat.

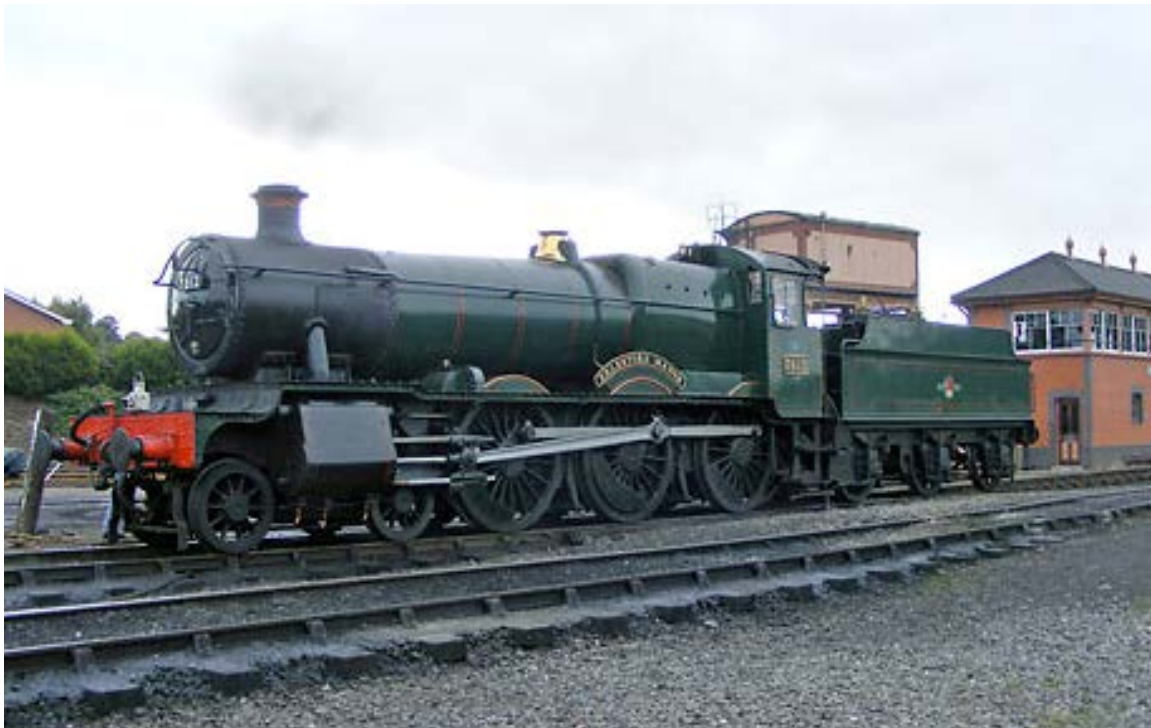
Figure 5 Manor Class 'Erlestoke Manor', built 1939, TPWS fitted 2008

All other mainline authorised steam locomotives in UK (the much older real heritage locomotives) are TPWS fitted.

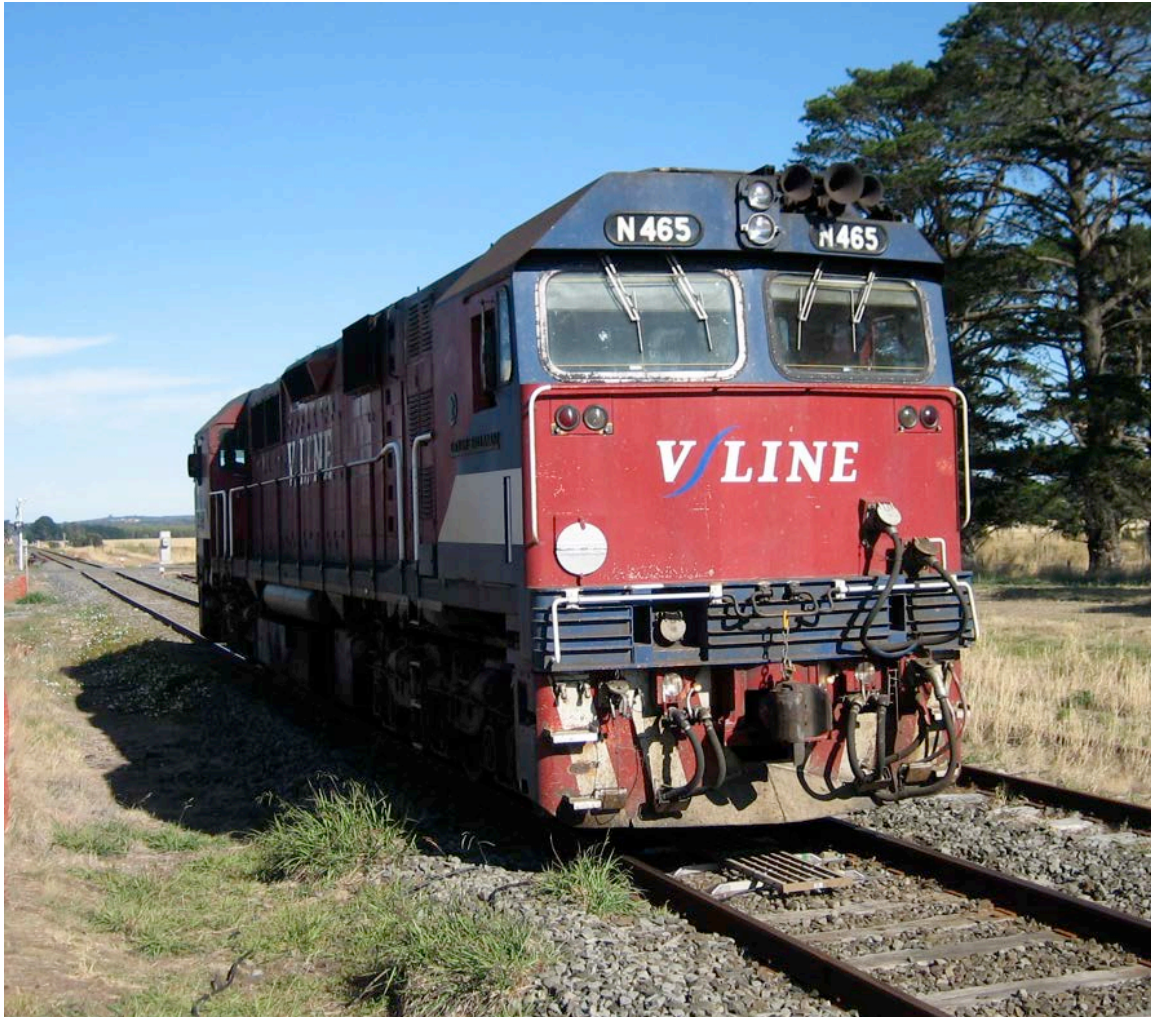
Figure 6 Trials of TPWS in Victoria, Trewalla, 2005

In 2005/6 four regional rail corridors in Victoria were upgraded to 160km/h running. As part of that upgrade a decision was made to install TPWS, identical to the systems used in the UK.

TPWS achieves about 60% of the safety gains of Automatic Train Protection (ATP) for about a tenth of the cost that, from a 'so far as is reasonably practicable' risk reduction viewpoint, is a 'no brainer'. It is now installed on the four main regional rail corridors and all passenger trains that operate these corridors. The plan is to further install TPWS within the metropolitan area of Melbourne at selected high-risk locations such as junctions. Metropolitan electric passenger trains are protected by mechanical train stops but regional diesel powered trains revert to total reliance on the train driver in the metropolitan area.
