Stability Analysis of Turnouts in Continuous Welded Rail Track

Ralph Zhang* and Dr Helen Wu**

* Civil engineering of North South Corridor, Wagga Wagga Office, Australian Rail Track Corporation

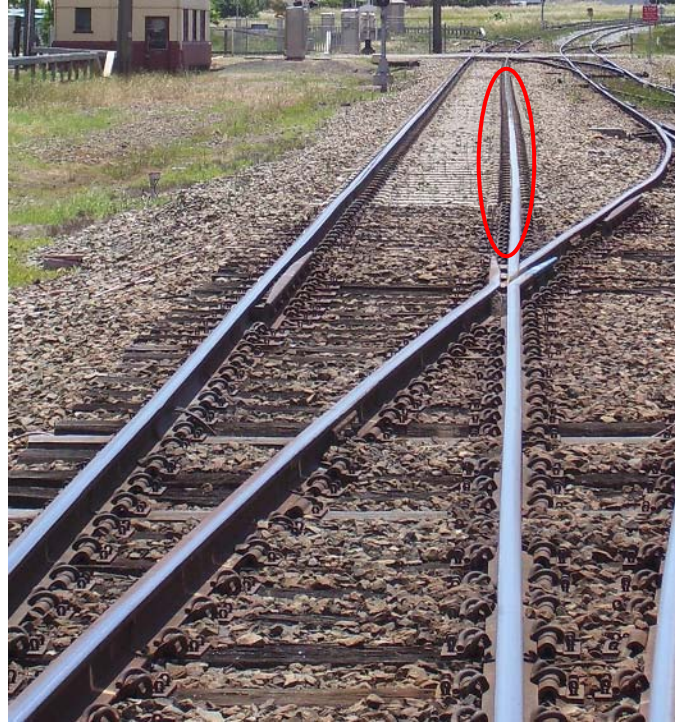
Figure 1: Misalignment behind the crossing of turnout

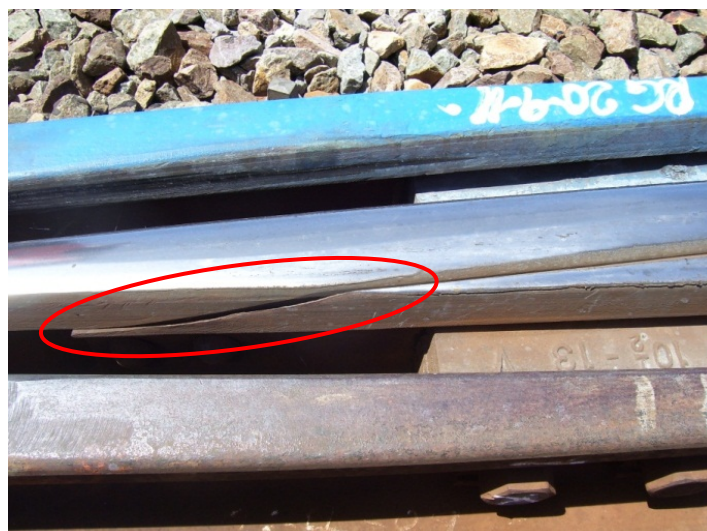
Figure 2: Relative creep (gap) between splice rail and point rail at the crossing area

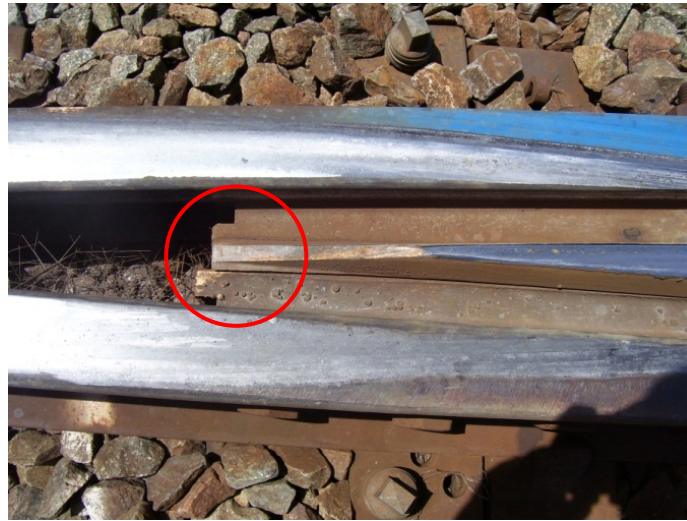
Figure 3: Left and right chocks unevenly creep at the toe of point rail

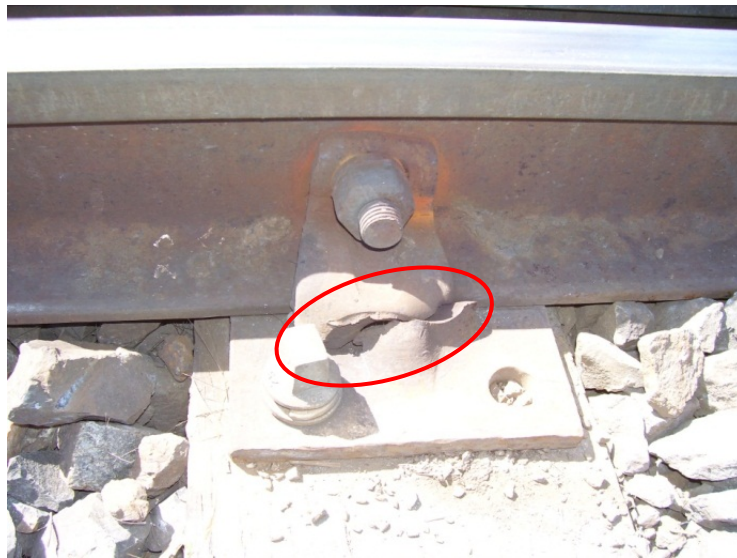
Figure 4: Rail chair broken and creep in the longitudinal direction (Evidence of rail creep within the turnout)

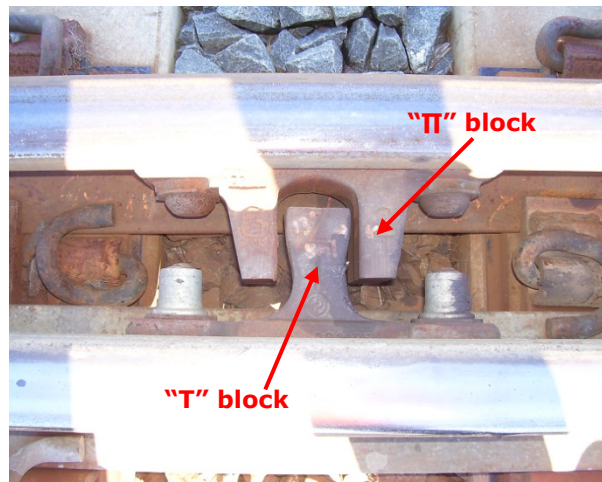
On the Main South line, there are three types of anti-creep devices manufactured by Vossloh Cogifer, VAE, and PRE. The Vossloh Cogifer turnouts use one set on each pair of switch and stock rails as shown in Figure 5.

Figure 5: The anti-creep device of Vossloh Cogifer turnout

One of the most important functions of the anti-creep device is to transfer the thermal load. It consists of two parts a “Π” block and a “T” block, as shown in Figure 5. There are gaps between these two blocks, usually from 4 mm to 7 mm. When creep occurs between the switch and stock rail under thermal force, the two blocks will move closer in one side and away on the other side. With the increasing of the thermal force, these blocks will contact each other on one side, and then thermal stresses are transferred from the switch to the stock rail via the anti-creep blocks, as shown in Figure 7.

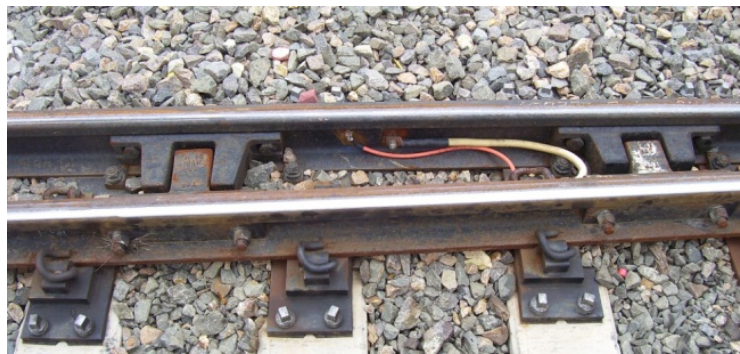
For the VAE concrete-bearer turnouts, the two sets anti-creep devices are applied on the Main South Line, it has two devices on each pair of switch and stock rails, as shown in Figure 6.

Figure 6: The VAE turnout's double anti-creep device

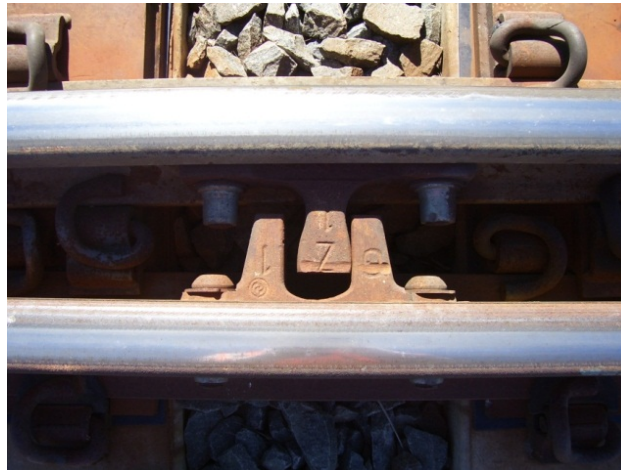
When inspecting the Vossloh Cogifer turnouts or the VAE and PRE concrete bearer turnouts, which are welded in the CWR track, special attention should be paid to the condition and position of the anti-creep devices. If the anti-creep devices are damaged or its components are in the incorrect position, for example, the "T" block very tightly against one side of the " Π " block, as shown in Figure 7 and 8, this means creep is occurring at the stock rail, switch, or both. In addition, for the structural mechanism within the point area, in this situation, the straight stock rail is not only under the longitudinal stress from the CWR track, but also under the turnout stress transferred by the switch.

Figure 7: The anti-creep device of Cogifer turnout in the wrong position (e.g. the “T” block very tightly against one side of the “U” block)

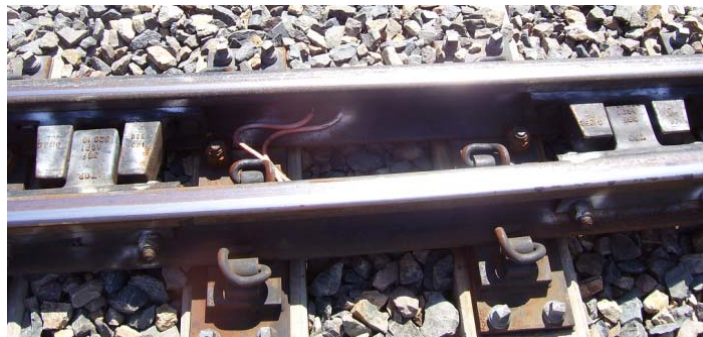
Figure 8: The anti-creep devices of VAE concrete sleeper turnout in the wrong position (e.g. the “T” block very tightly against one side of the “U” block)

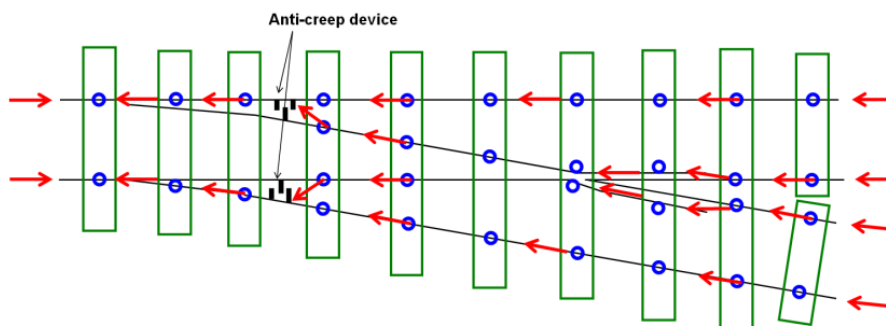
The longitudinal stress distribution within the turnout area is generally uneven. However, the longitudinal thermal stress transfers through a turnout is quite similar for the both fixed-crossing turnouts and switchable-crossings turnouts. The transfer of the thermal longitudinal stress within the turnout area is, as shown in Figure 9.

Figure 9: Schematic diagram of a turnout (the arrows represent the direction of thermal force transfer within the turnout when the ambient temperature is increased)

From Figure 9, it can be seen that the direction and route of thermal force is transferred from the rear of a crossing to the toe of switch. The force goes through the crossing and is transferred longitudinally along the closure rails, then goes to the stock rails of the switch via the connection devices at the rear of the switch (for concrete bearer turnouts the device is the anti-creep devices). In addition, with the thermal force going through the closure rails between the crossing and switch, the rail may creep in the longitudinal direction together with the bearers. During the above procedure, part of the thermal force can be transferred to the

stock rails via the heel blocks or anti-creep devices which are located at the end of switch rails. Hence, the structural design of the thermal force transfer devices (such as heel block and anti-creep devices) plays a very important role in ensuring the stability of the turnouts which are located in the CWR track.

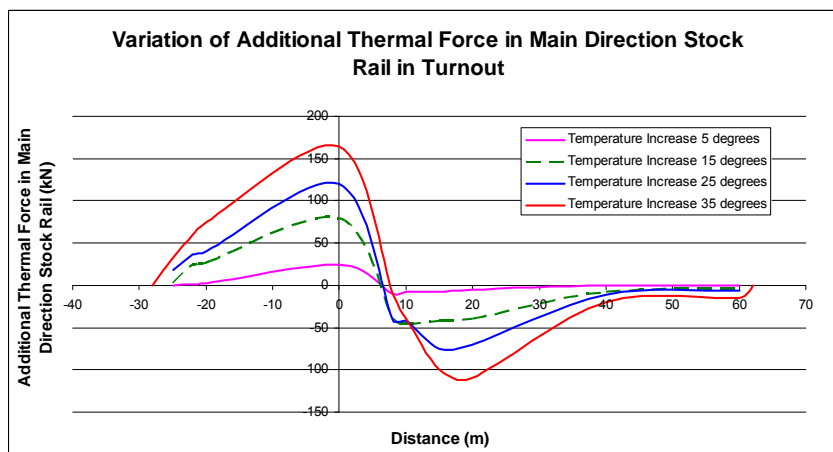
When the rail temperature changes from 5°C to 35°C, the additional thermal force changes in the main stock rail and its influence range is shown in Figure 10, and its variation with the change of rail temperature is shown in Figure 11.

Figure 10: Variation of additional thermal force in the main direction stock rail in turnout

In Figure 10, the zero point of the coordinate is the end/rear of the switch. It can be found that the maximum extension load caused by the temperature increasing is exactly located at this location. It should be noted that for a range in rail temperature, changing in the turnout from 5°C to 35°C, the two steel blocks of the anti-creep device do still not contact each other.

From the above two figures it can be seen that the additional thermal force in the stock rail will increase with the increasing of the rail temperature. The increasing rate of the additional force is about 22.9% to 26.7%. At this stage the two blocks of the anti-creep devices have not moved tightly against each other on one side and the ratio of increase slows down. However, once the two blocks are against each other, the ratio of the additional thermal force increase is intensified. In addition, with the increasing of the rail temperature, the influence length of the additional thermal force is also extended.

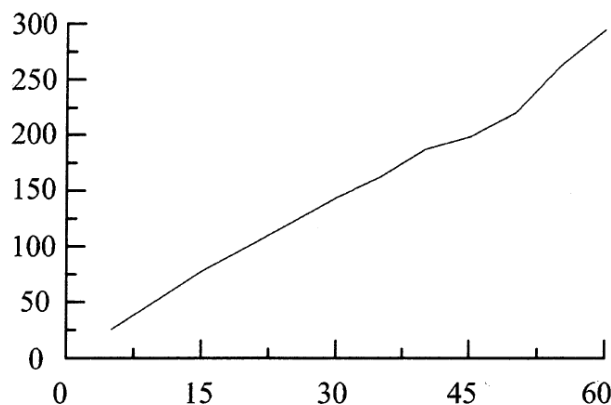
Figure 11: The variation with the changing of rail temperature

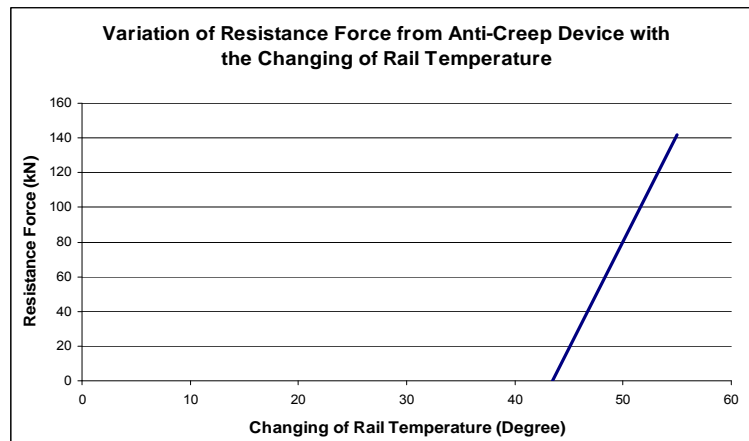
From an in-field measurement and numerical study conducted overseas against a No.12 fix point turnout (with a structure similar to the Vossloh Cogifer turnout), it was found that the anti-creep device tightly contacted only when rail temperature change is 43.5 °C. When the rail temperature increased to 55°C, the longitudinal force at the anti-creep device is 142 kN, as shown in Figure 12.

Figure 12: Variation of resistance force from anti-creep device with the changing of rail temperature

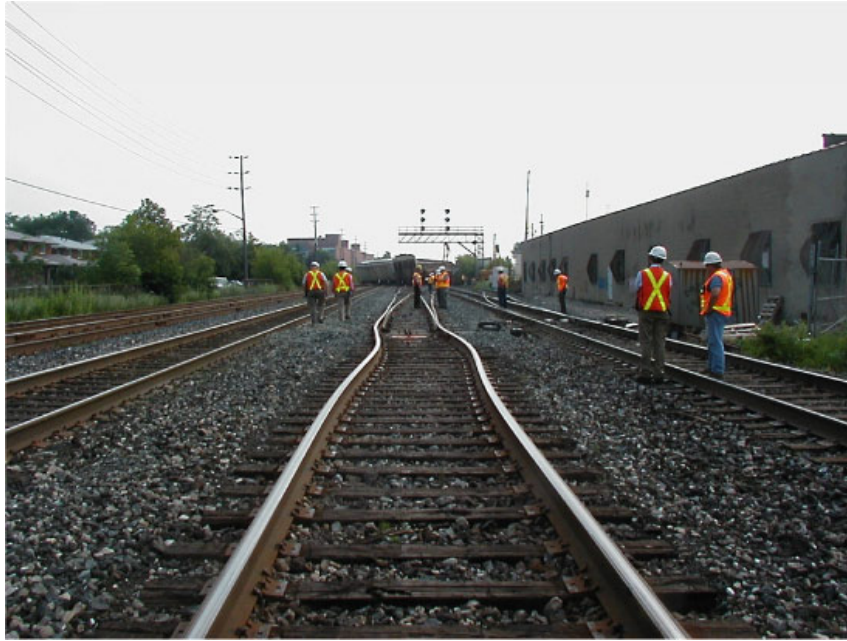
With regards to the turnouts which are welded in the CWR track, especially for the turnouts which directly connect with the long welded rails, they are usually under very high thermal stress which is transferred by the CWR in the longitudinal direction. If the actual neutral temperature of the adjacent CWR module is significantly lower than design levels, the huge longitudinal stress will cause the turnouts to become unstable or the turnout structure not square. The worst situation is because of the longitudinal stress within the adjacent CWR module is very high and its transfer is blocked by the turnout as a fix-point (because of the four-rail structural feature of the turnout), the track buckling may happen in front of the turnout out, as shown in Figure 13.

Figure 13: Track buckle in front of the switch of turnout

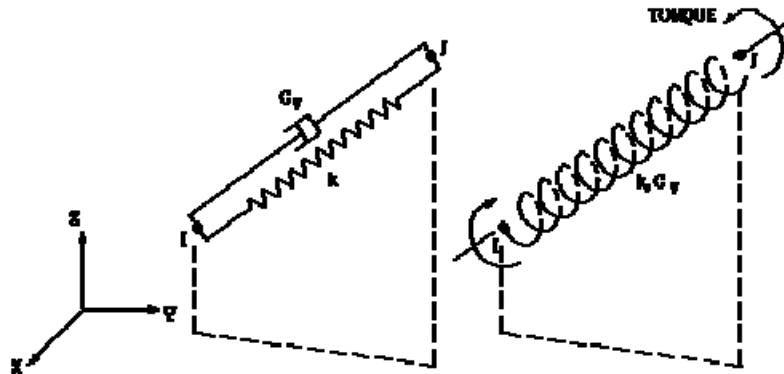
Lateral and longitudinal resistances of ballast on each bearer are simulated by using the combined spring-damper with different specified equivalent input stiffness values. The torsion capability of the spring-damper element is fixed. These elements are directly connected with the beam element of concrete sleepers in the longitudinal and lateral directions.

Figure 14: Combined spring-damper element (COMBIN 14) used to simulate the ballast resistance on concrete sleeper

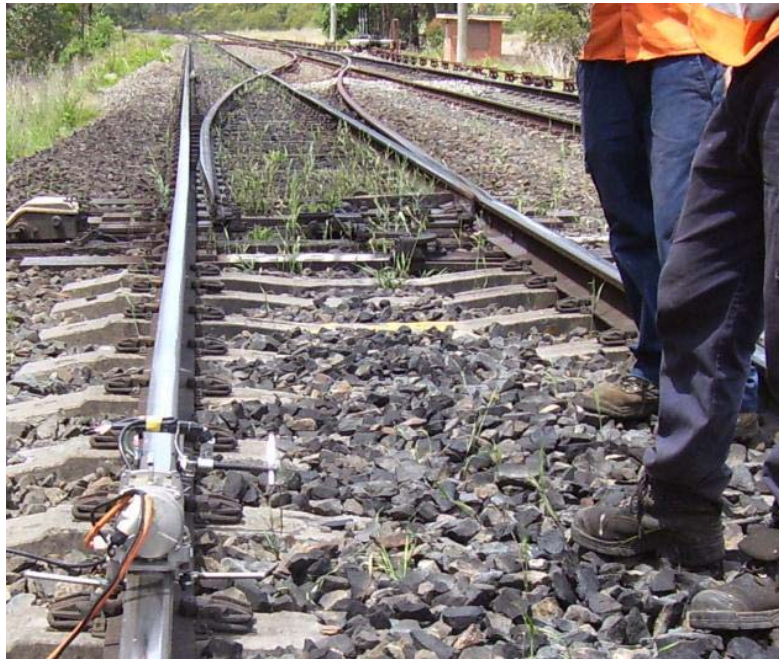
The Non-destructive method for stress-free temperature (SFT) testing on the turnout in CWR: To understanding the details of the SFT at the key locations/components of turnout, a non-destructive technology has been used to carry out the in-field testing. The d’Stresen method has a very high accuracy ($\pm 2^\circ\text{C}$) and has been approved by ARTC after a series of successful in-field verification.

Figure 16: The d'stresen method

A large number of results from d'Stresen measurement and testing works in recent years have shown that the d'Stresen system is a sophisticated and cost effective method of providing accurate and reliable data to monitor the condition of neutral temperature and stress distribution in a railway section. It is also a very useful tool for track maintenance and research on CWR.
