# **Development of a system to detect malfunction by the monitoring of the air spring pressure**

East Japan Railway Company

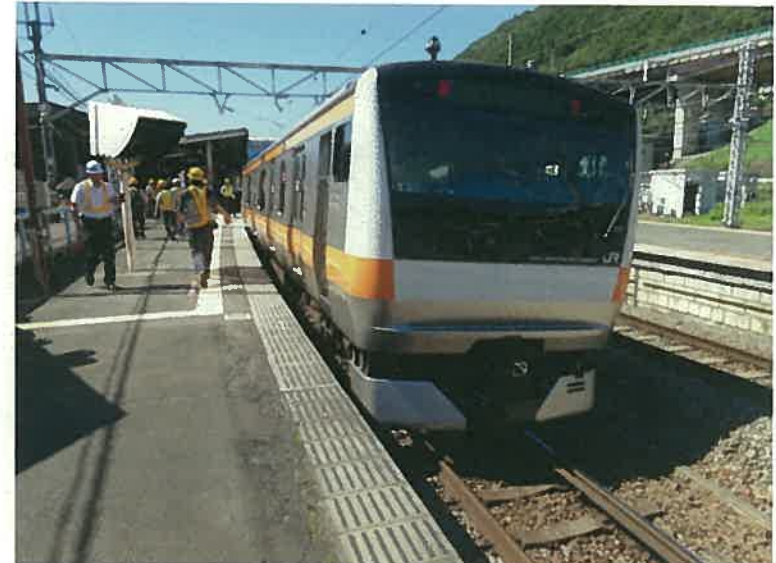
- The train detected derailment just before stopping at the Sagamiko station.
- From checking by the crew, it was found that all the wheels of the rearmost railcar's front bogie were derailed to the left in the direction of travel.

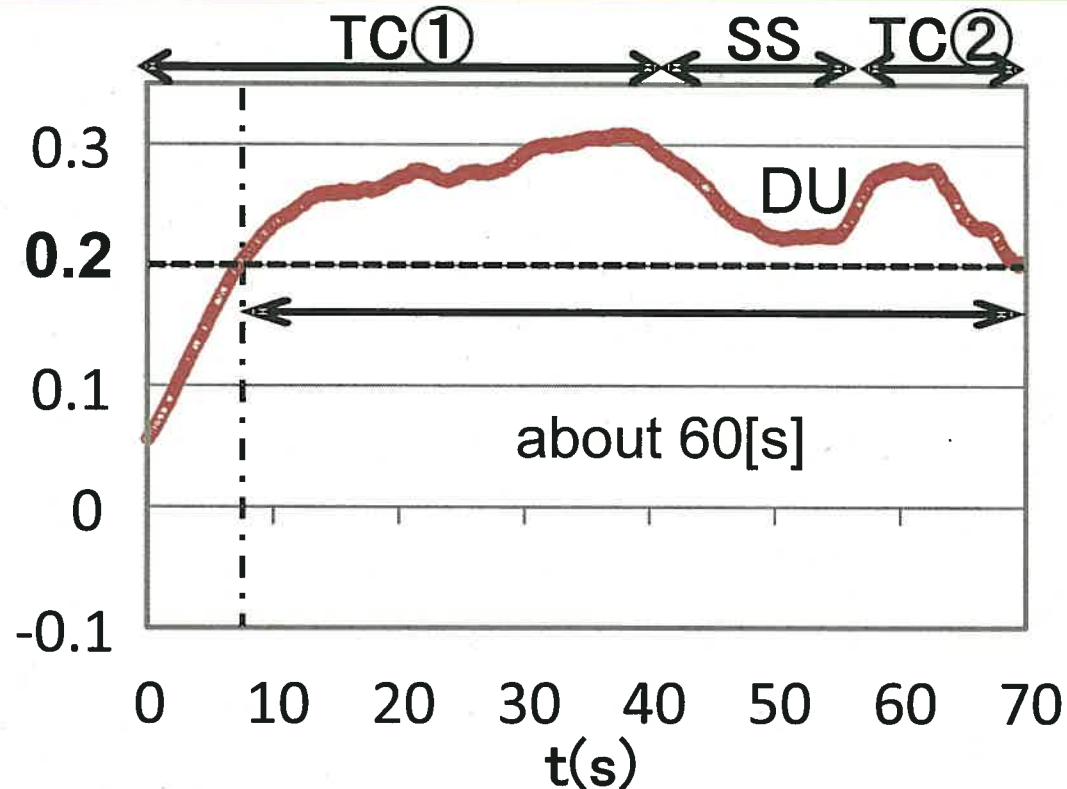
### Measurement result with the longest continuation of $DU > 0.2$

In this example, the train was passing over a transition curve ①(TC ①)  
→ straight section (SS) → transition curve ②(TC ②) at low speed.

DU > 0.2 due to the transition curve may continue even after the train has passed it.

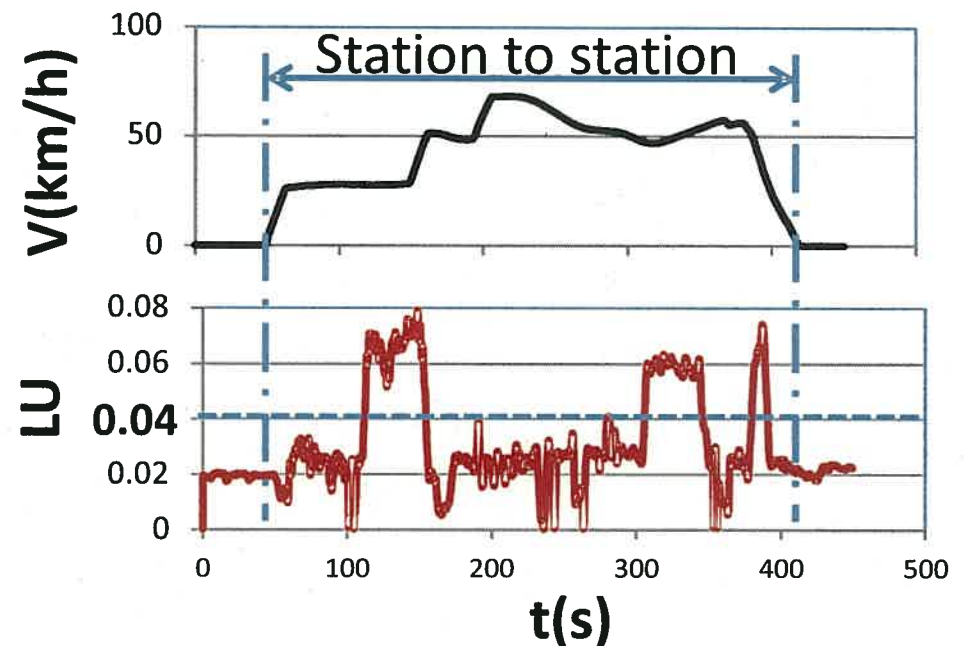
An example of LU measurement

|LU| is normally 0.04 or less.

We decided to exclude sections where  $|LU| > 0.04$  when evaluating malfunction, even if  $DU > 0.2$ .

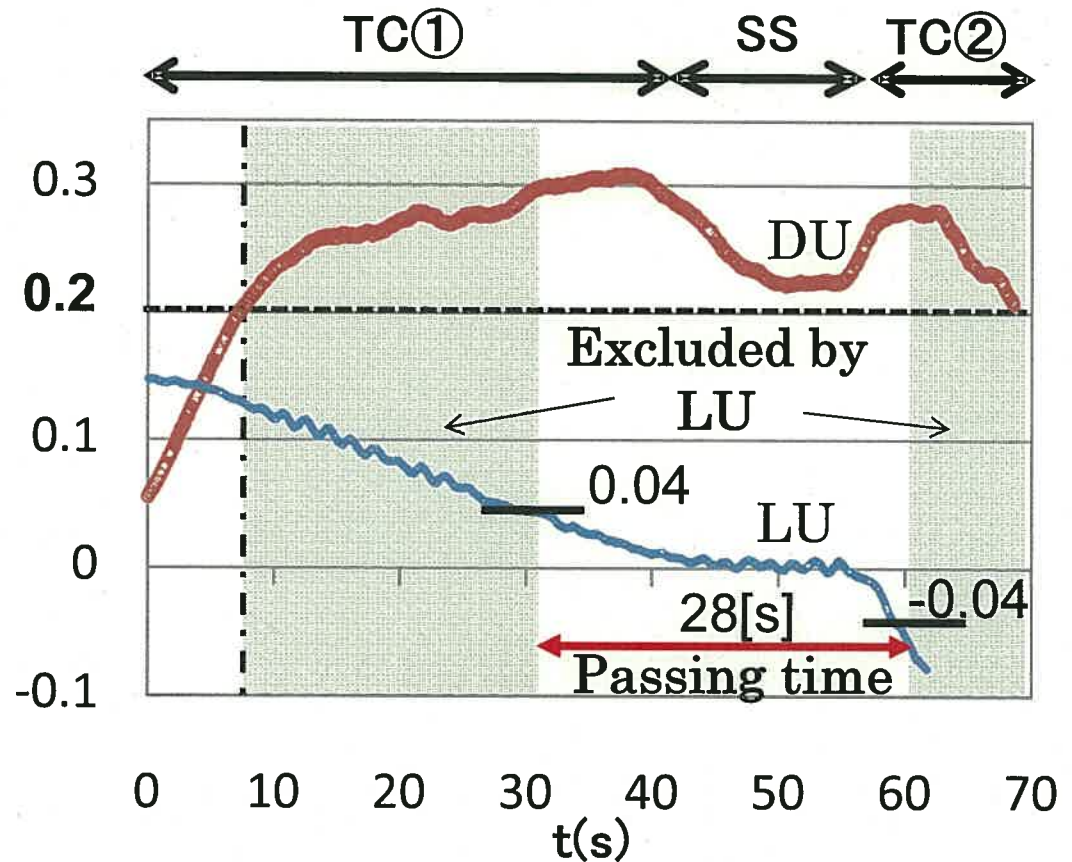
The time from the moment when  $DU > 0.2$  and  $|LU| > 0.04$  to the moment when  $DU > 0.2$  and  $|LU| \leq 0.04$

- Passing time where  $DU > 0.2$  was the longest was 28[s].

- 8[s] in the mid-high speed range.
- 16[s] in the low speed range.

The passing time threshold is determined by adding the margin time.

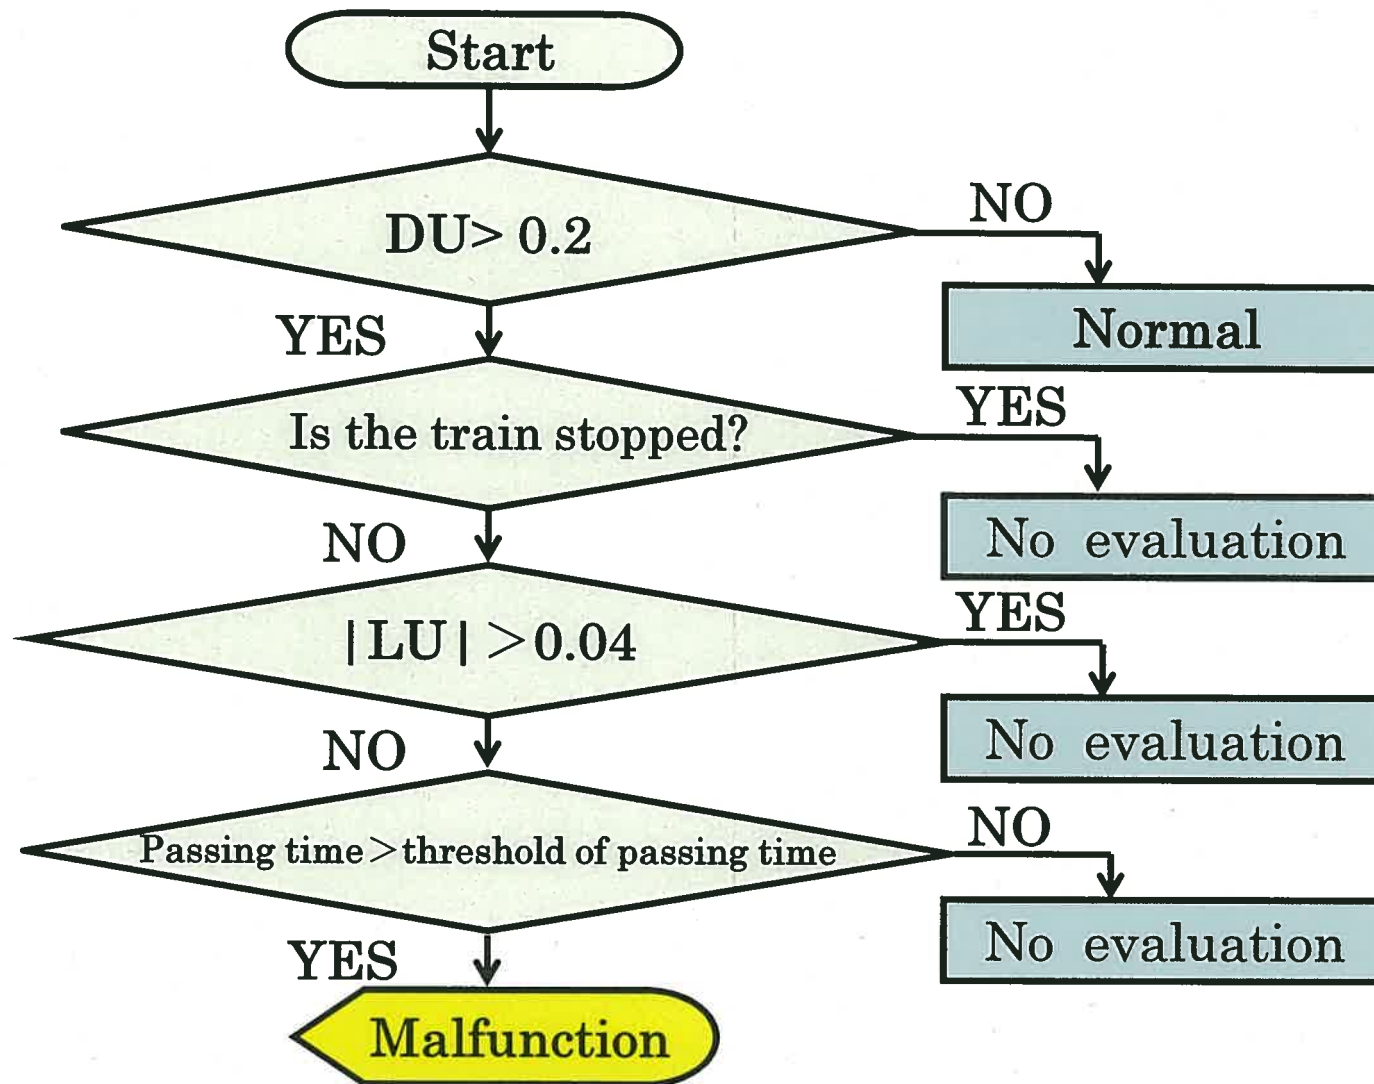
Flowchart for malfunction detection

We devised a method to detect malfunction in air spring devices by diagonal unbalance of monitoring air spring pressure, and verified it based on data of various operating trains.
