# A Study on Railway Accident in Korea

12 OCT. 2021

Aviation and Railway Accident Investigation Board(ARAIB)

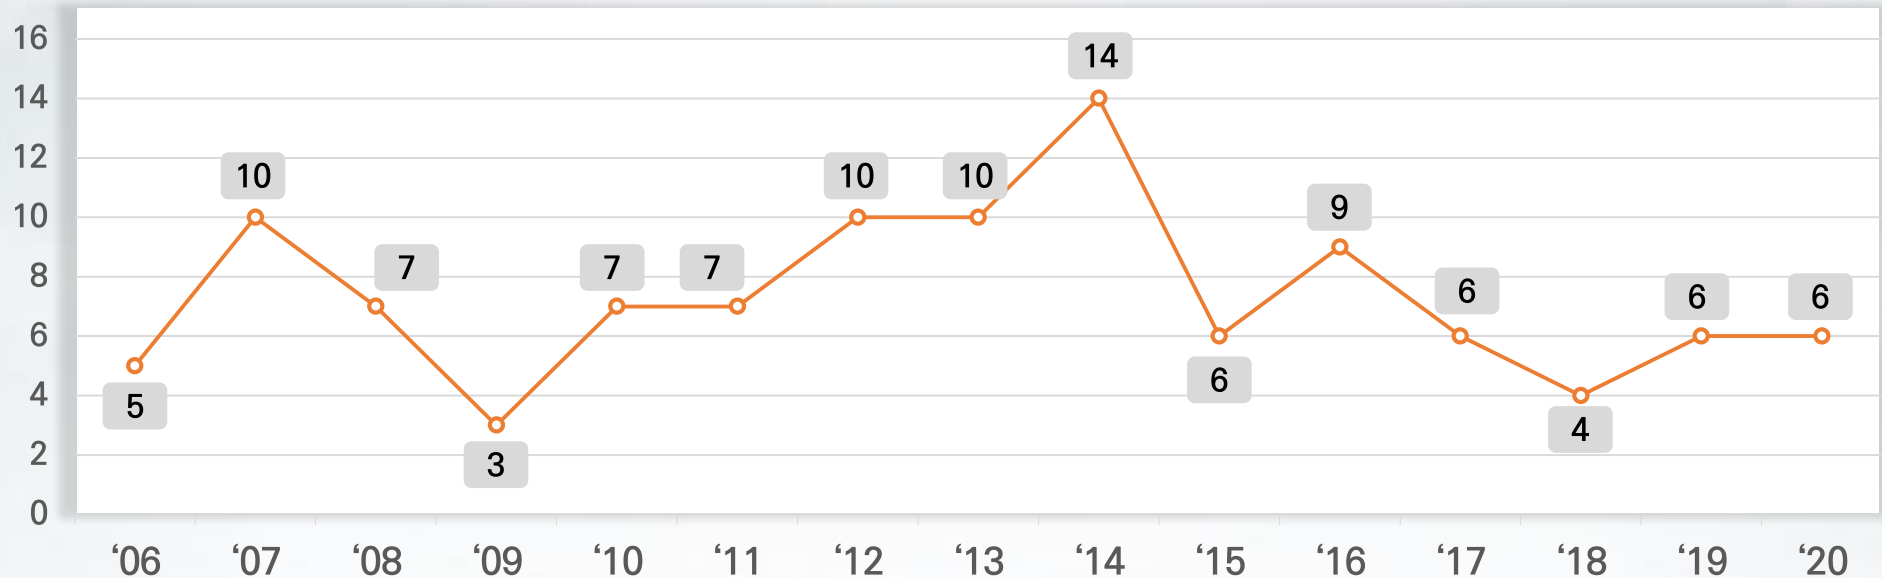
## 1 Status of the Number of Annual Accidents

- ✓ For 15 years Since the Establishment of ARAIB (From July 2006 to December 2020), there have been an average of 7.3 annual accidents.
  - Since the Railway Safety Management System(SMS) was introduced(2013) and implemented(2014) as a part of safety policy enhancement, the number of railway accidents has shown a single-digit number.

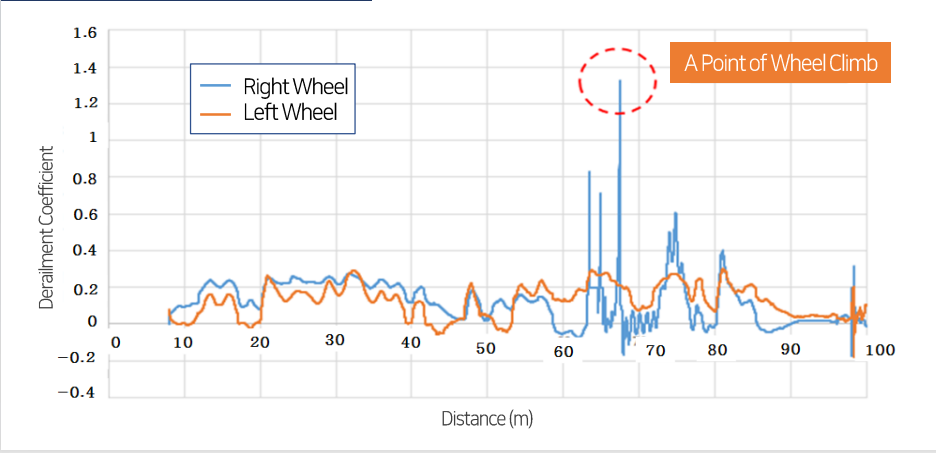
Interpretation Result

\* As a result of interpretation, derailment coefficient of the right wheel was 1.3 exceeding the reference value of 1.2

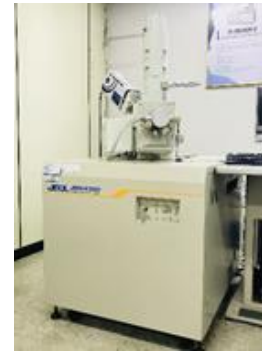
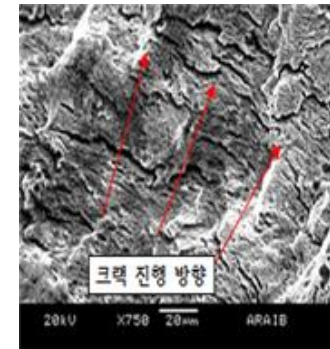
Scanning Electron Microscope

\* Crack's direction of travel checked

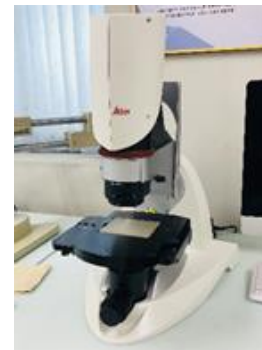
Imaging Microscopy

\* Fatigue crack grown on the surface and propagated to the middle
