MANAGING HUMAN FACTORS IN HONG KONG THROUGH A RISK-BASED APPROACH

Railways Branch, Electrical and Mechanical Services Department,
Government of the Hong Kong Special Administrative Region

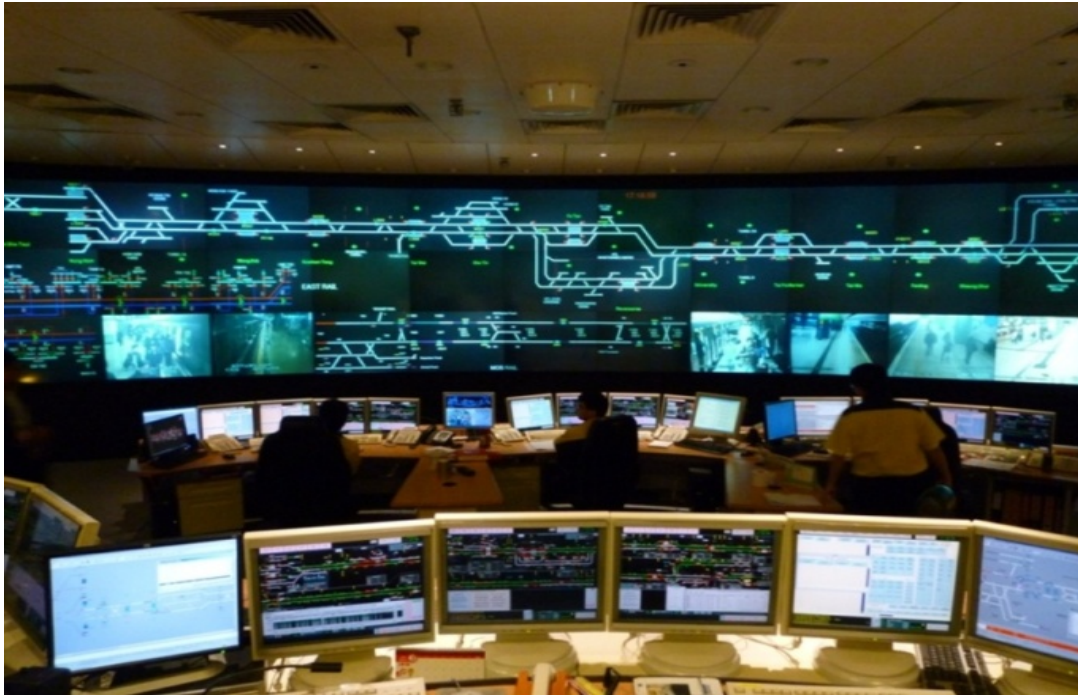
Figure 5: The OCC

On 21 January 2010, the data transmission network at the East Rail Line Operations Control Centre (OCC) failed. This meant that the train controllers at OCC could not track the locations of trains, communicate by radio with train captains or make public announcements, although the signaling system was operating normally, with the Automatic Train Protection (ATP) system continuing to keep trains a safe distance apart. Train services on the whole line were suspended for one hour, and about 30,000 passengers were stranded during the incident. Figure 5 shows the OCC under normal operating conditions.

Our investigation revealed that the incident occurred when a third-party supplier’s computer engineer was conducting a regular software audit to ensure the integrity of the data network. He erroneously executed an off-line software optimisation program before leaving for his dinner break, overloading the data network with junk data and causing the failure.

Subsequent to the incident, the following improvement measures were implemented:
