MANAGING RAIL RESOURCES & INFRASTRUCTURE TO RESTORE AND MAINTAIN OPERATIONS IN THE AFTERMATH OF MAJOR EARTHQUAKES

Peter Steel

Phillip O'Connell

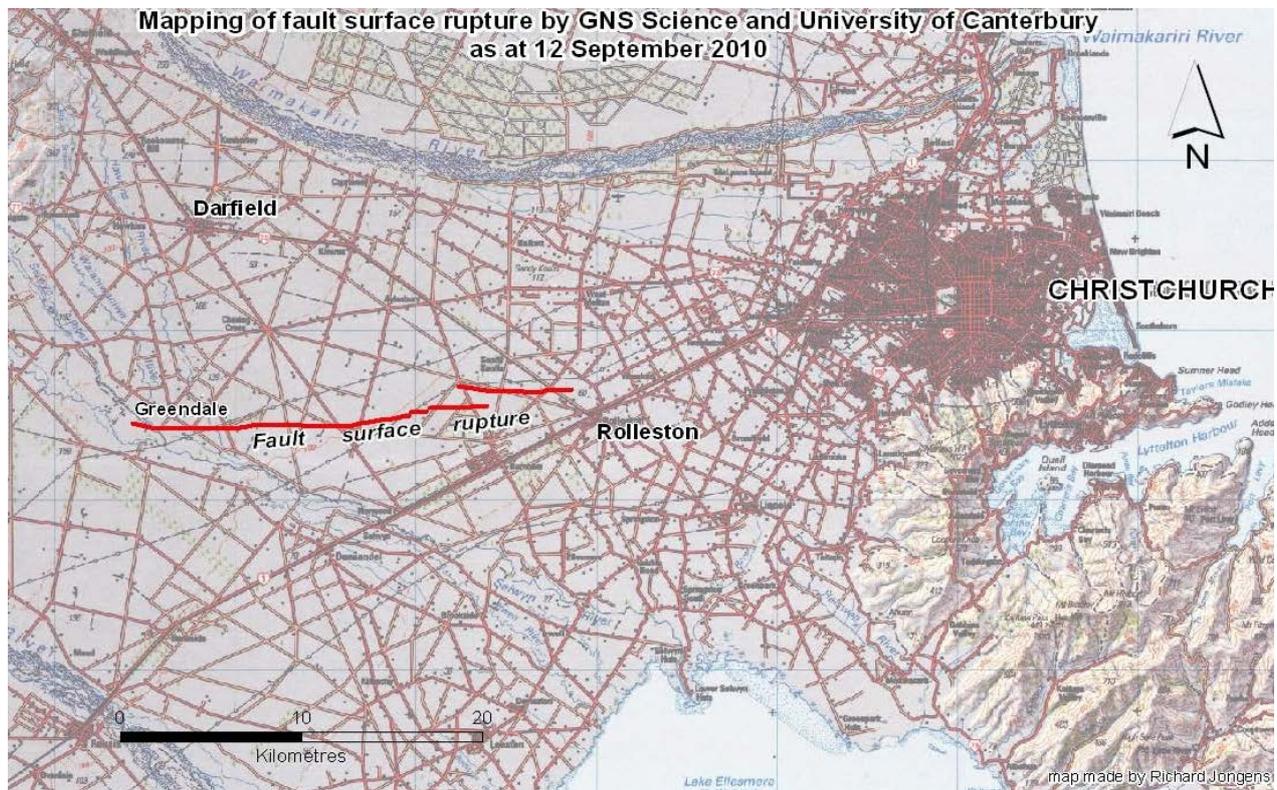
This earthquake "...was caused by the rupture of a fault network deep beneath the Canterbury Plains. The rupture started at 10 km below the surface, and then broke open a 24 kilometre rent across the surface of the plains. In the days following the quake, geologists from the University of Canterbury and GNS Science mapped the location of the surface rent, which extended from Greendale to near Rolleston, and named it the Greendale Fault."ⁱⁱⁱ

Figure 3: Mapping of fault surface, 2010 - source www.geonet.org.nz

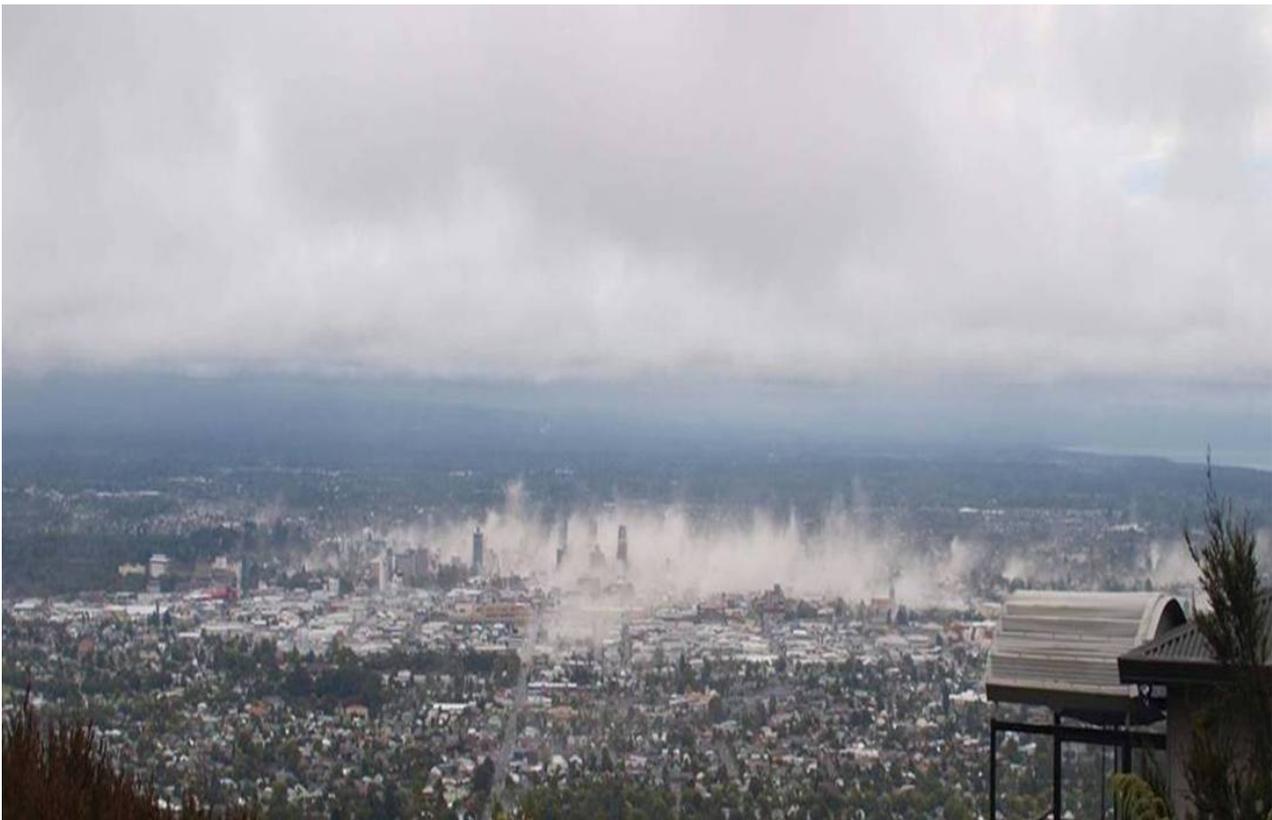
Figure 6: Christchurch City Centre from the Port Hills immediately after the 21 February 2011 event - source: www.stuff.co.nz

This earthquake caused damage and destruction out of all proportion to its magnitude, with 181 dead and damage cost estimates exceeding \$20 billion. The primary reason for this extreme level of destruction was the short sharp nature of the shaking. In comparison with the 45 second duration of the September event, this earthquake was only approximately 10 seconds long but during this period, large areas of Christchurch had vertical ground accelerations of well over 1 gravity were recorded, backed up by widespread observations of cars and other large objects being thrown off the ground.
