Malahide Viaduct Collapse

21st of August 2009

RSC/RAIU:

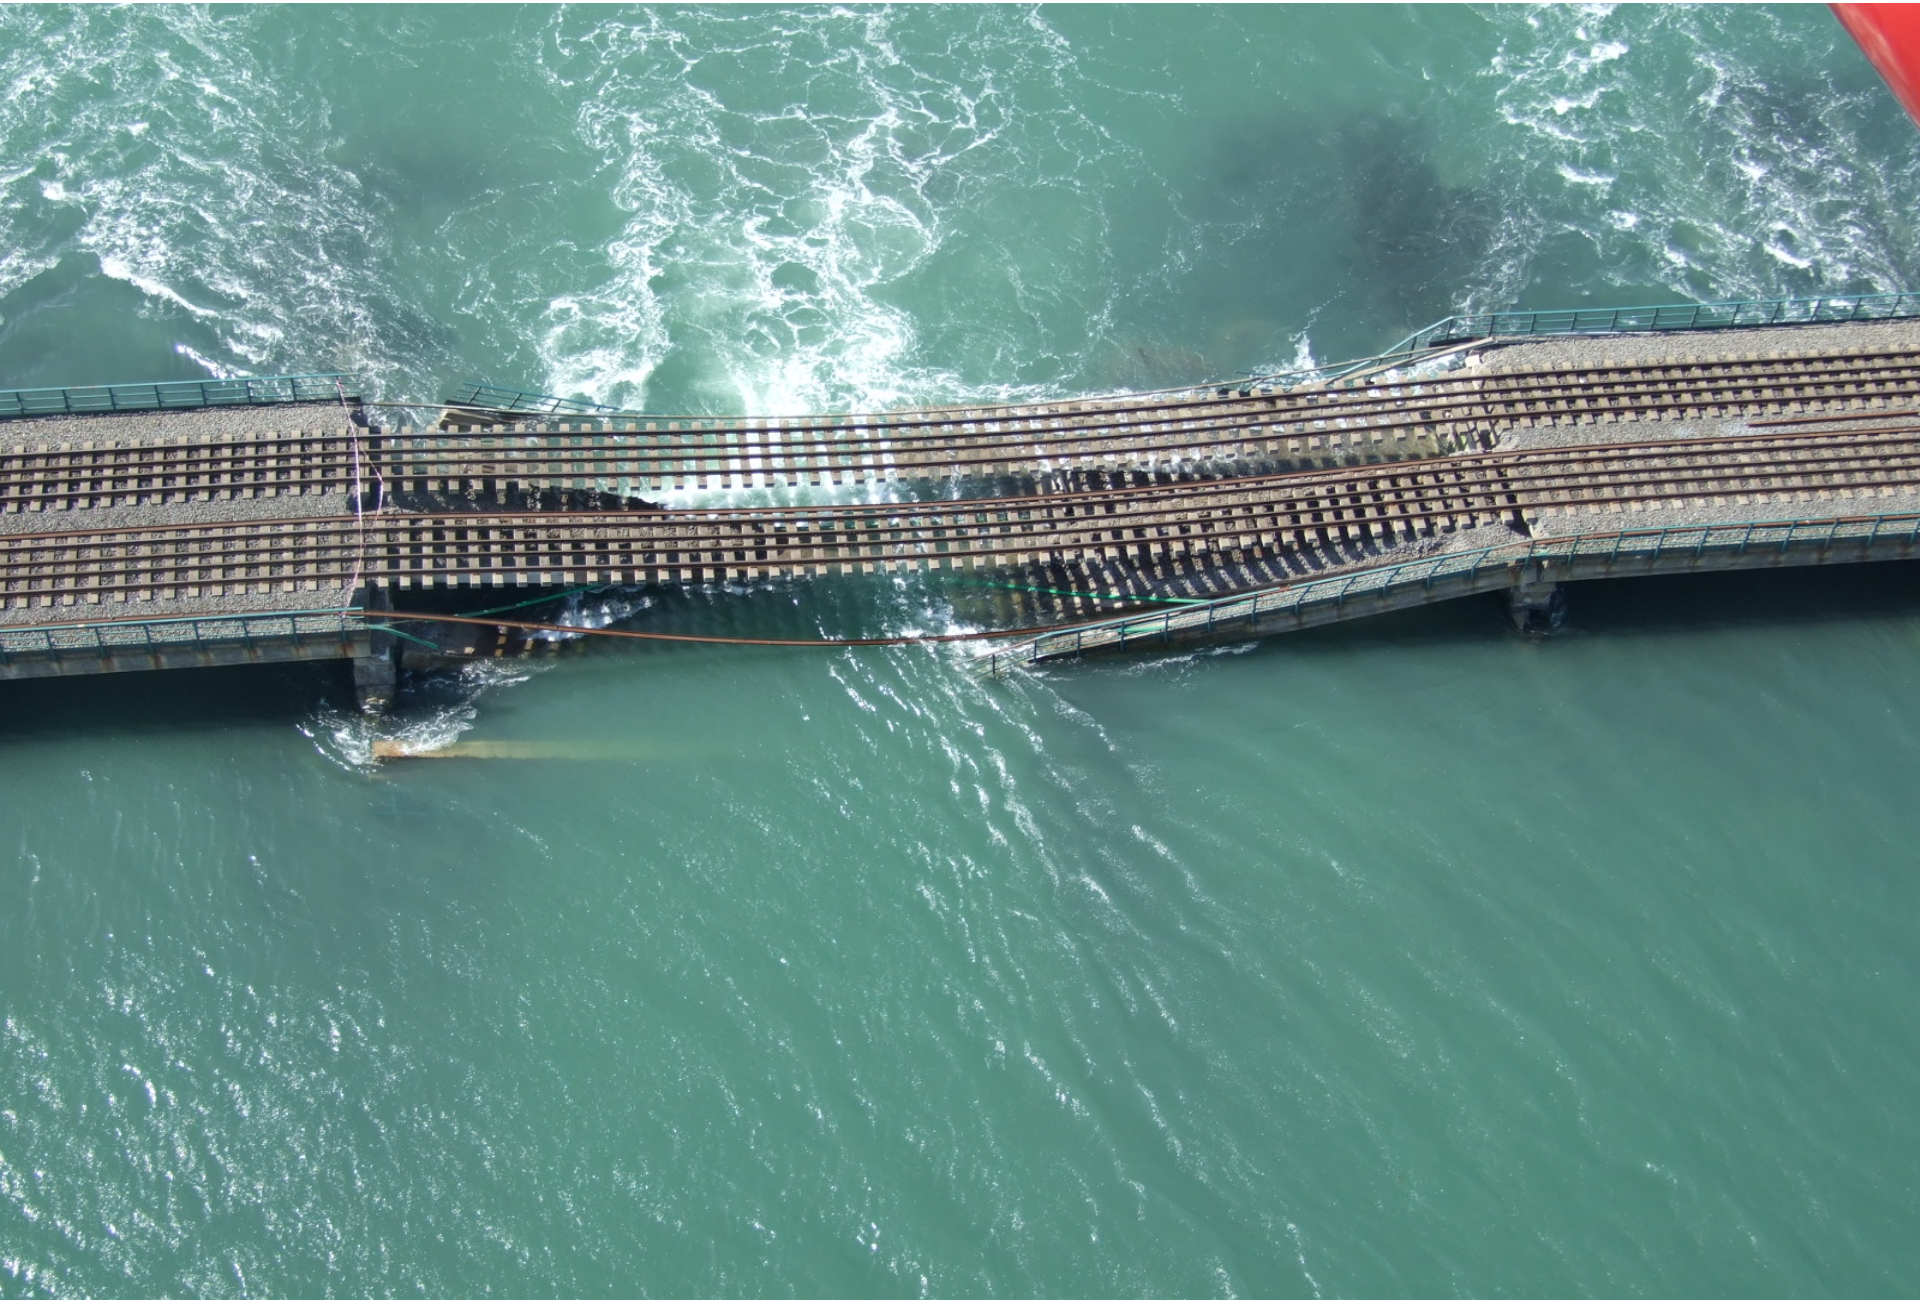
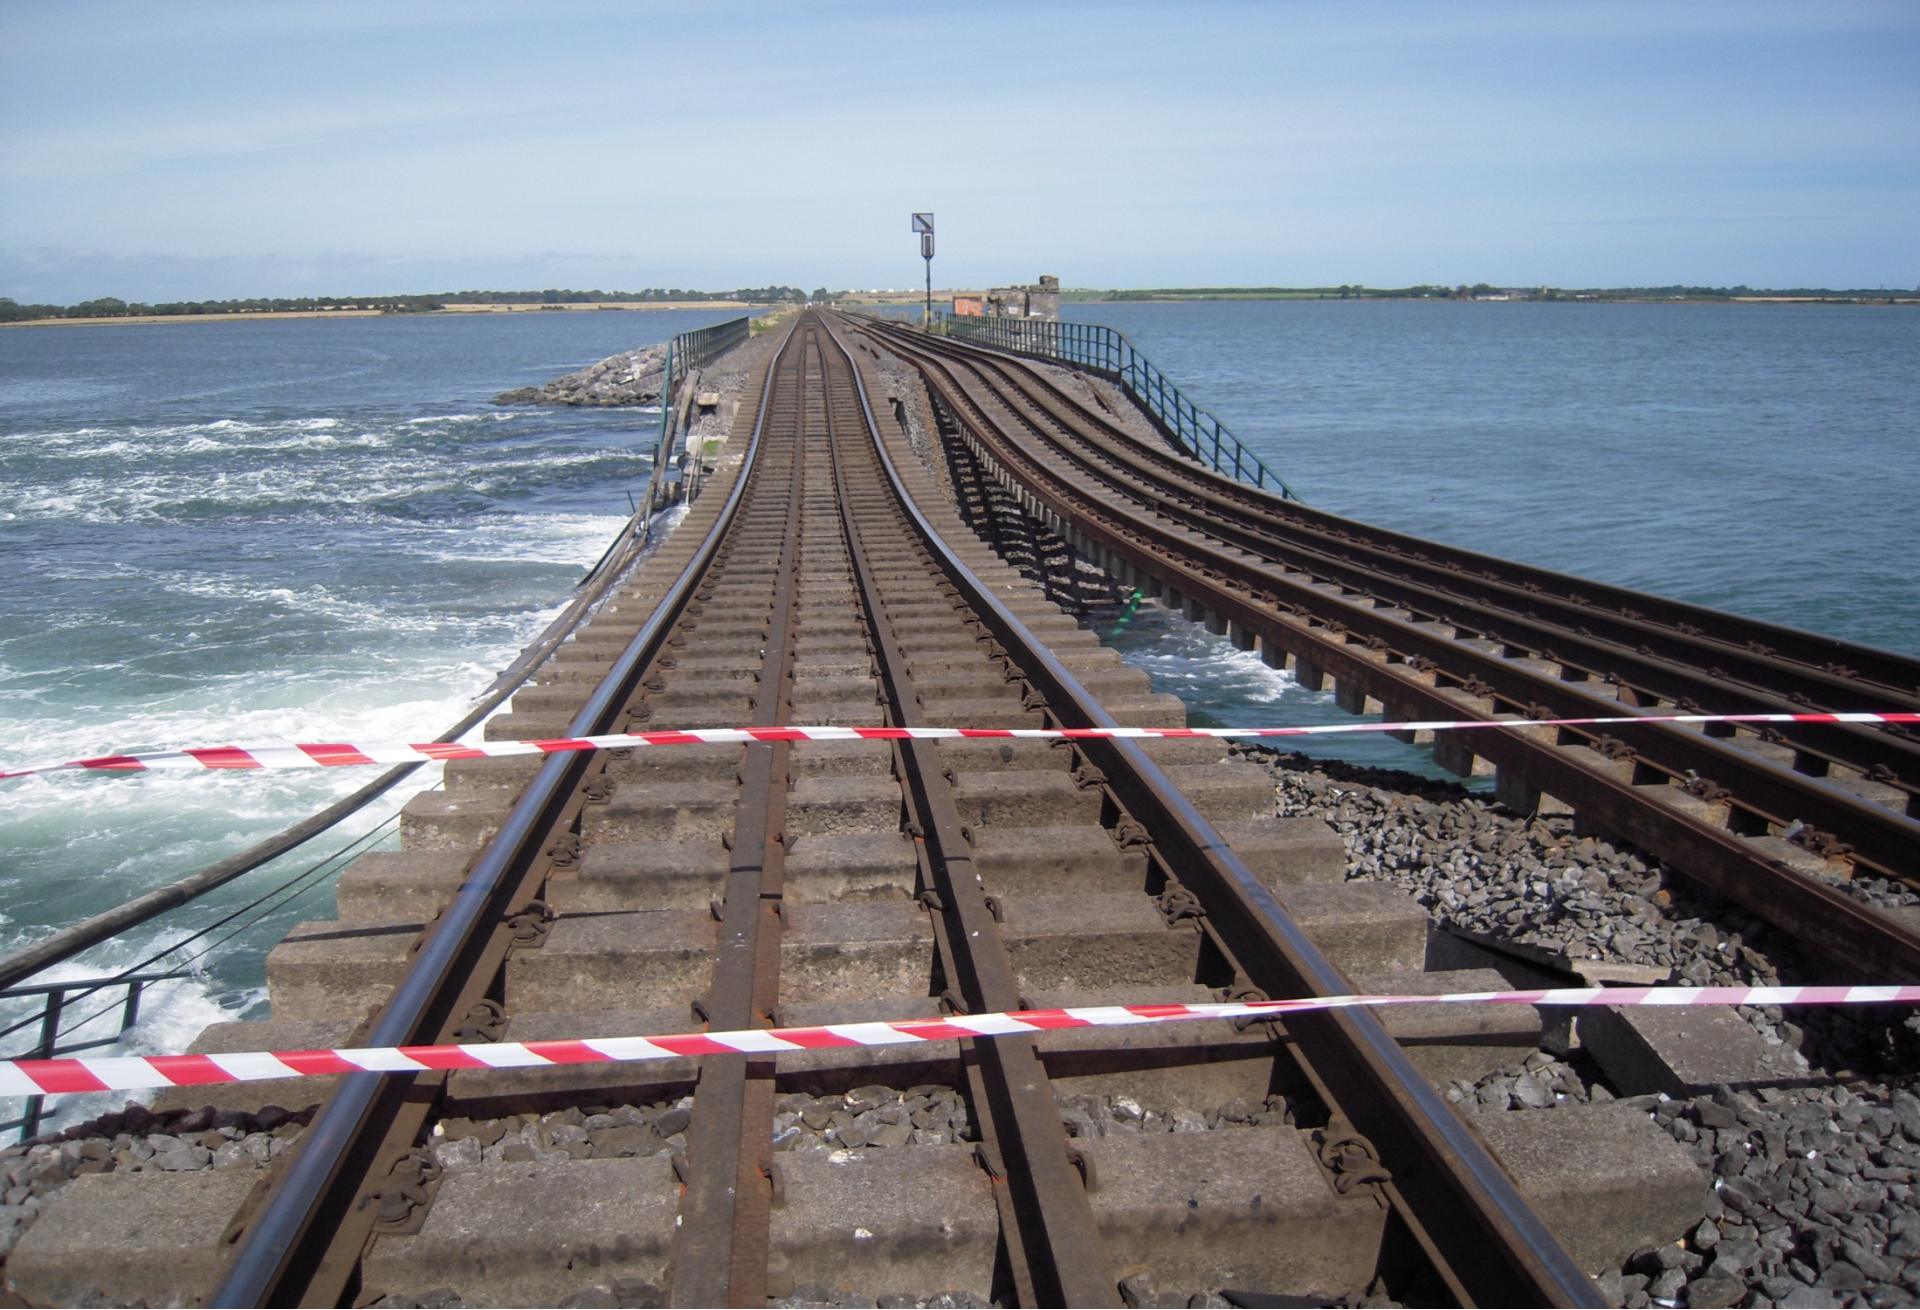
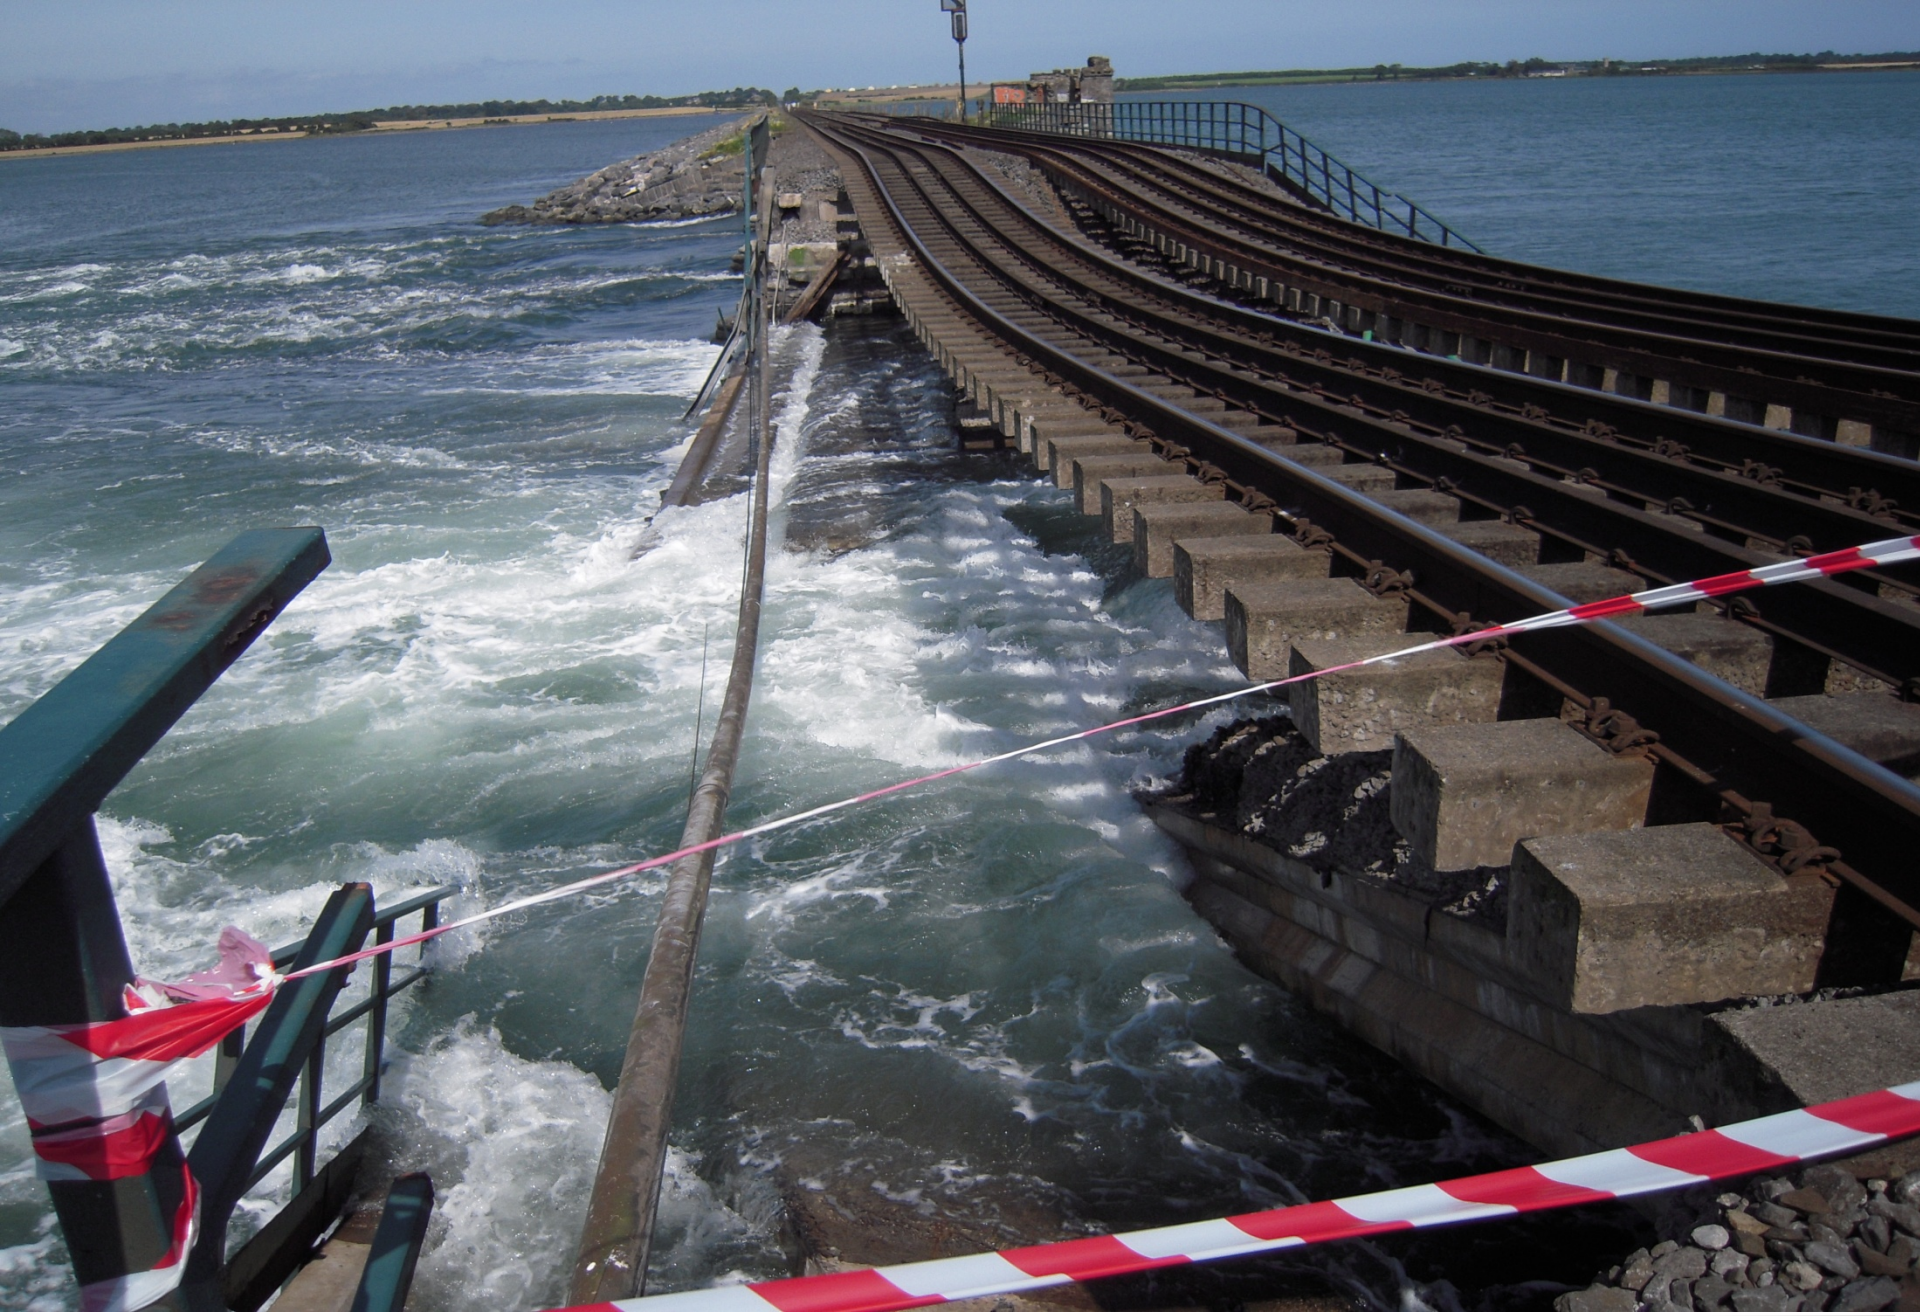
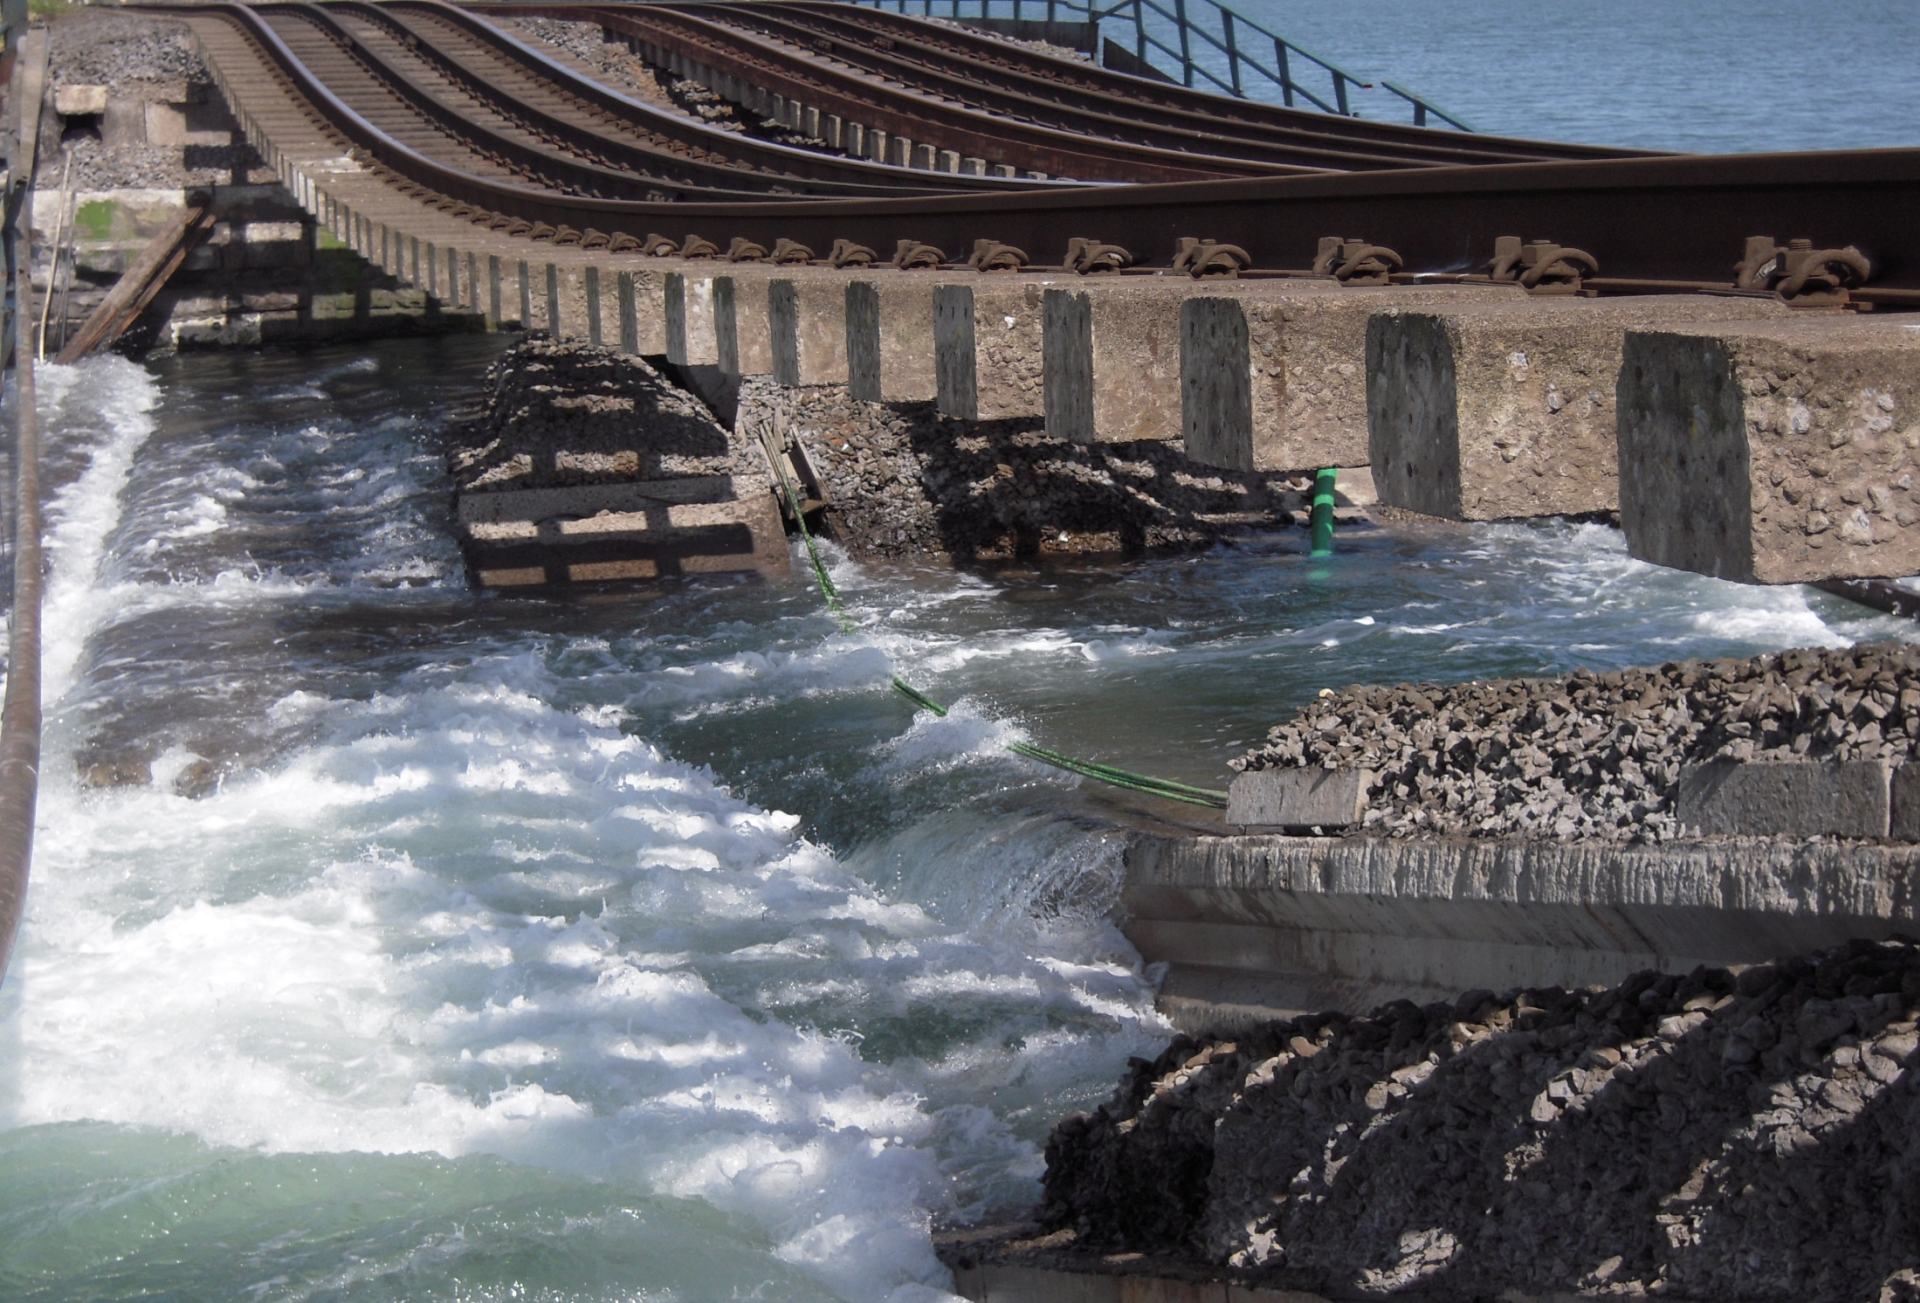
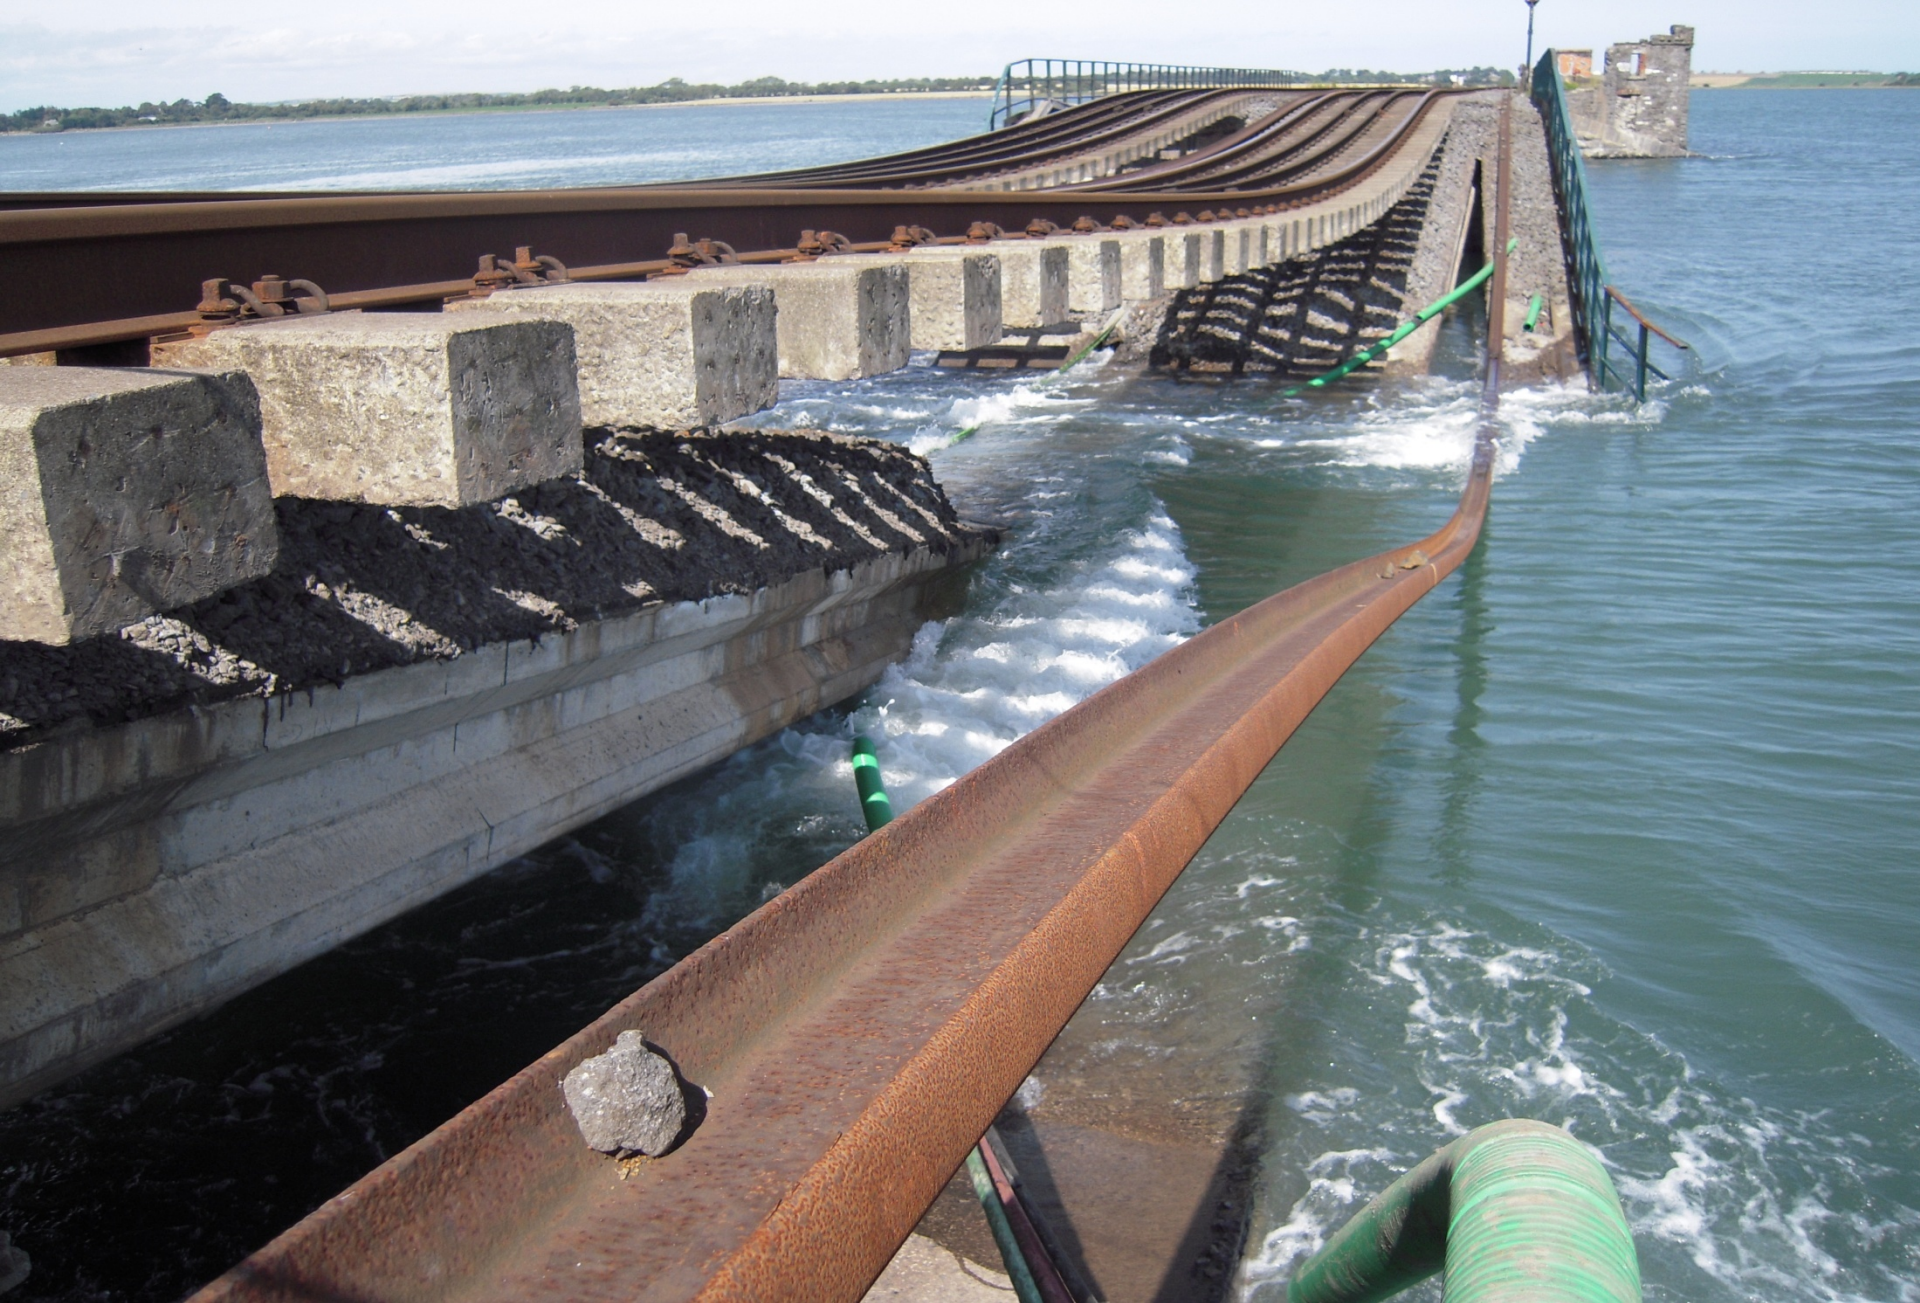
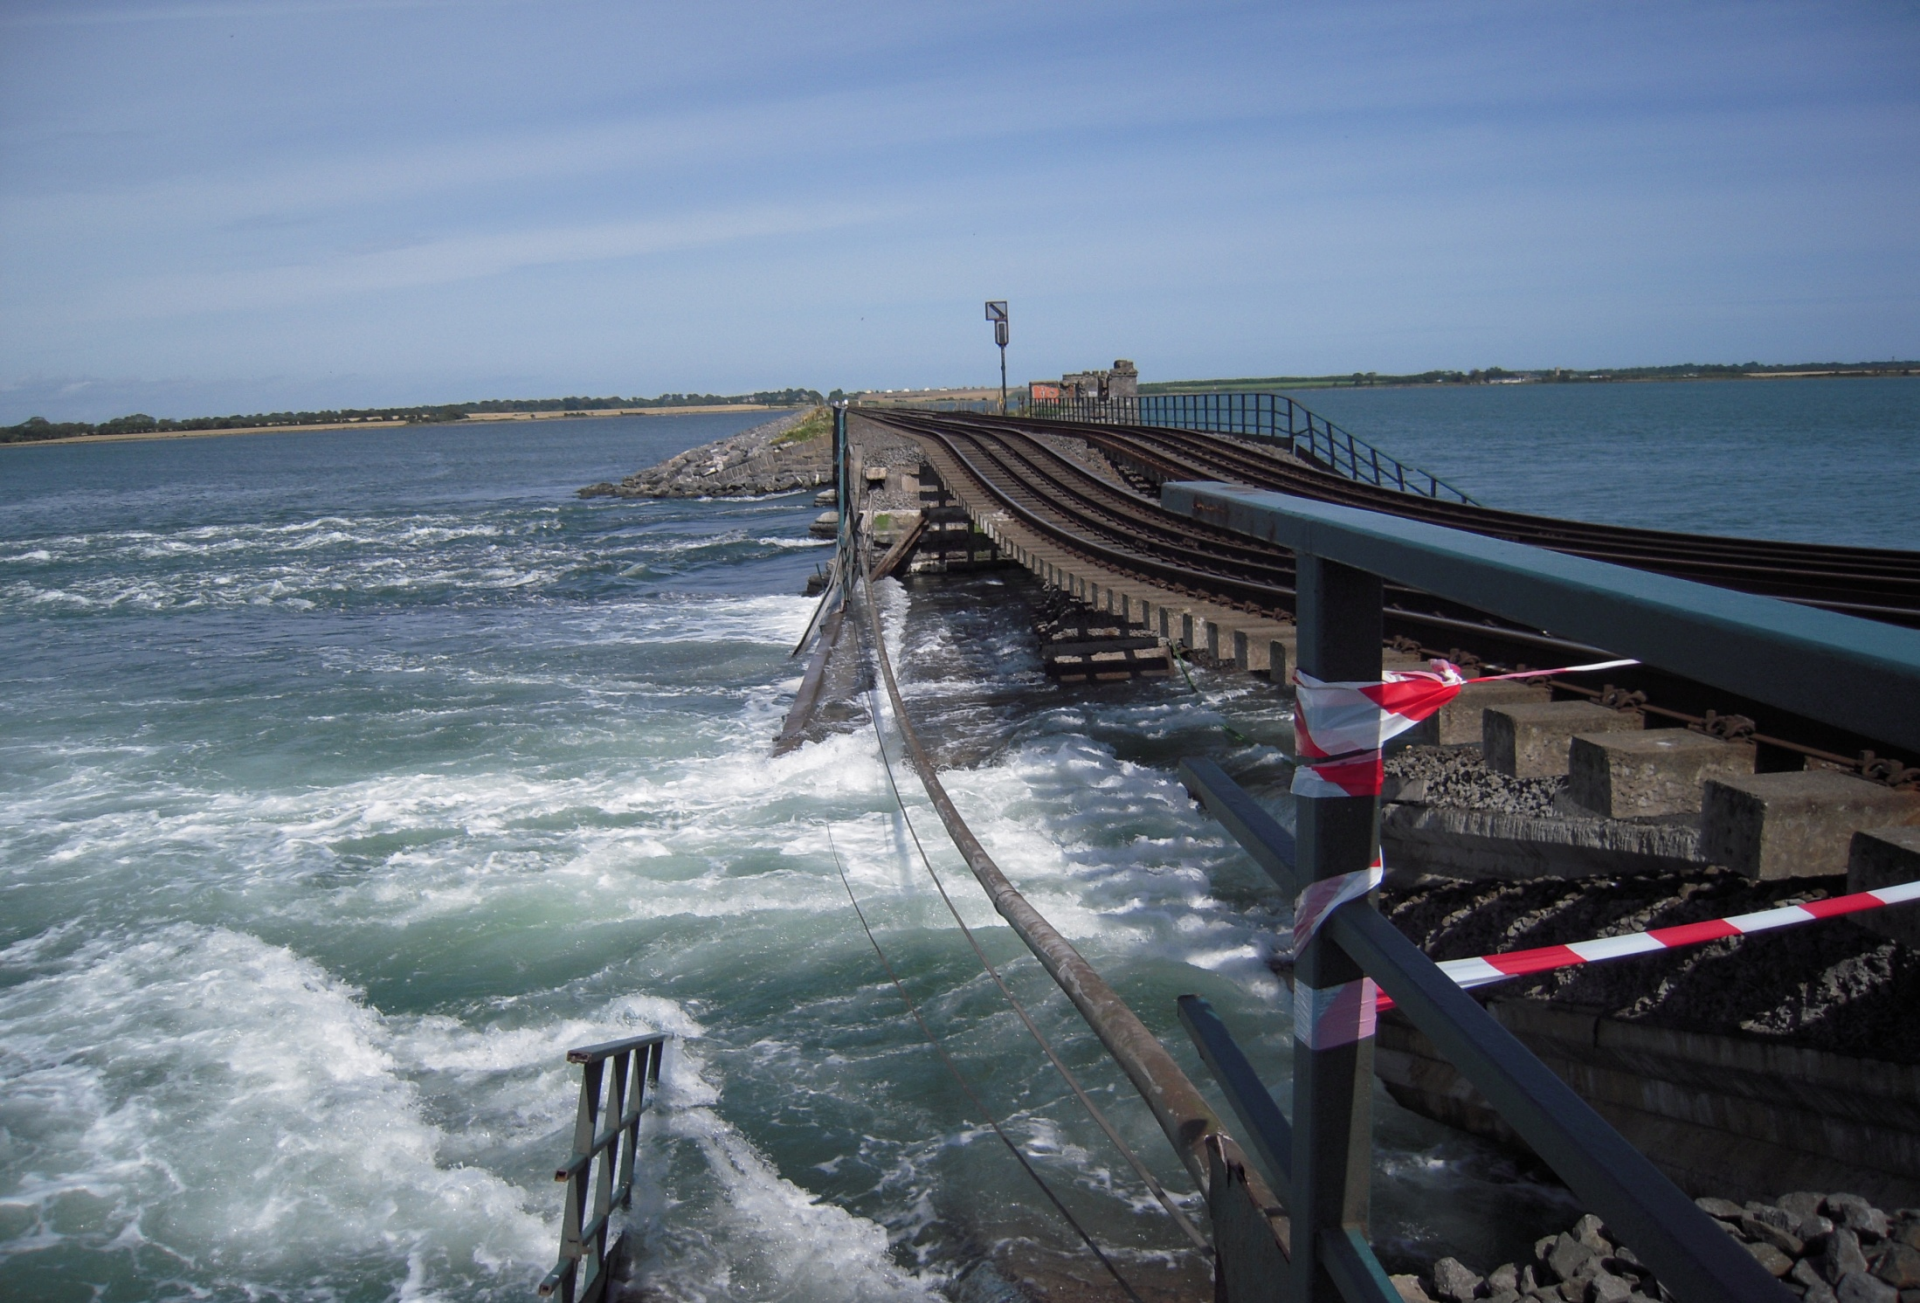
- No alignment problems identified in recent inspection/monitoring
- 17.50 Pearse/Dundalk passed c. 18.20 with no observed problems
- 18.07 Balbriggan/Connolly passed c. 18.21-22, driver noted partial collapse of 'down' line
- Driver of 18.07 stopped in Malahide and walked back to inspect by which time (*15 minutes?*) both lines had substantially failed
- **Failure was 'catastrophic'**

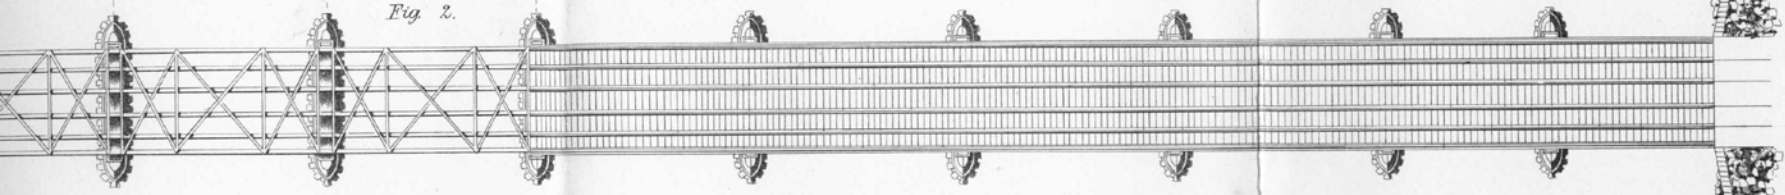
Fig. 2.

NEW VIADUCT

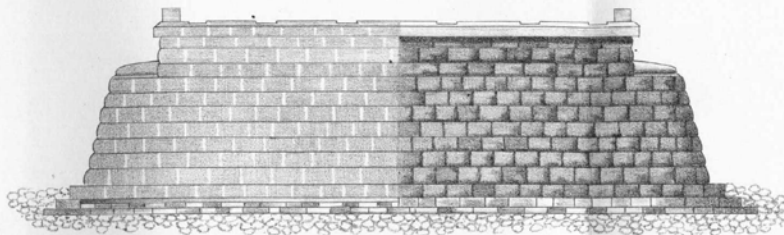
Fig. 1.

- Subsequent to construction of timber viaduct stones placed to protect piles/piers forming c. 40m wide submerged embankment.
- Current piers;
 - 11 'identical' cut stone
 - date from 1860 reconstruction
 - founded c. 4.5m below rail level on submerged bank of rock
 - foundations are within the tidal range (*approx ½m above mean sea level*)
