# The risk of derailment and collision, and safety systems to prevent the risk

Tomohisa Nakamura  
Transport Safety Department  
East Japan Railway Company

*International Railway Safety Conference in Hong Kong  
5 October, 2010*

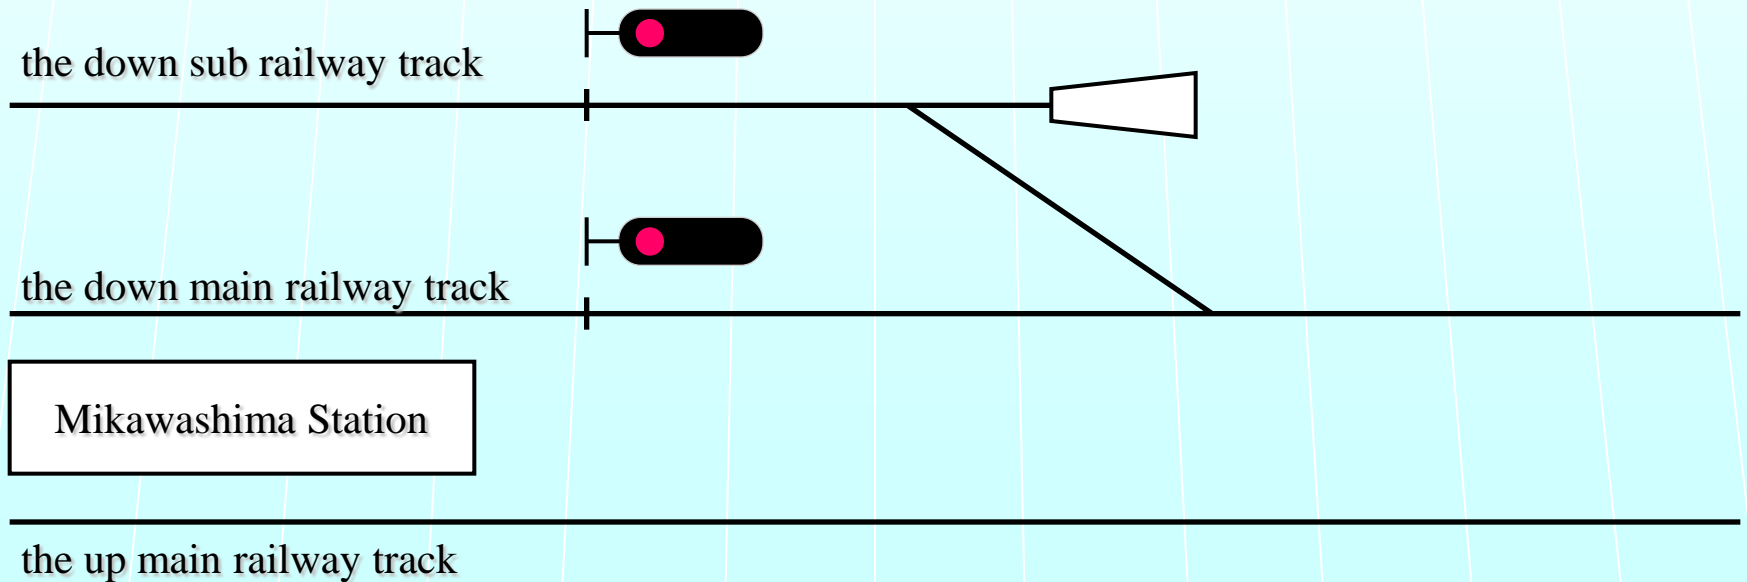
# The Mikawashima accident

A freight train ran through a red signal. Next, the locomotive and freight train derailed on the down main railway track and derailed cars were obstacle to movement on the down main railway track.

A down passenger train collided with the derailed cars. Next, this down passenger train derailed on the down main railway track and derailed cars were an obstacle to movement on the up main railway track.

An up passenger train collided with the derailed down passenger train. Next, this up passenger train derailed.

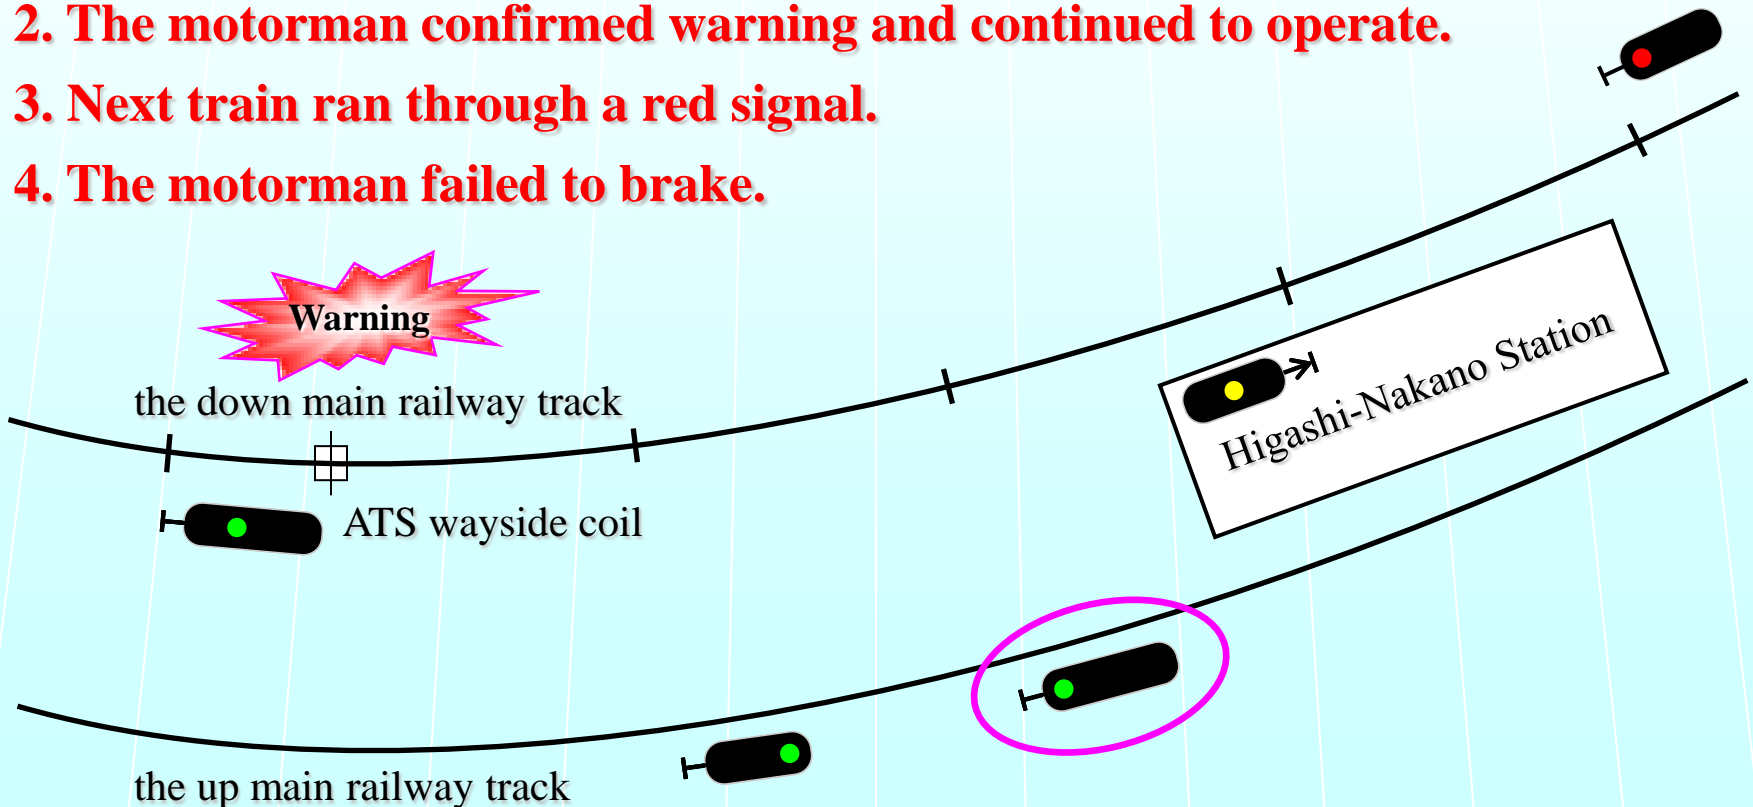
# The Higashi-Nakano accident

Tokyo metropolitan area is operated many trains. Therefore, there are a lot of signals. Warning very often rang to the motorman's cab and the motorman very often confirmed warning, too. As a result, the motorman failed to brake and this accident occurred.

1. **ATS wayside coil transmitted “ the red signal sign”.**
2. **The motorman confirmed warning and continued to operate.**
3. **Next train ran through a red signal.**
4. **The motorman failed to brake.**

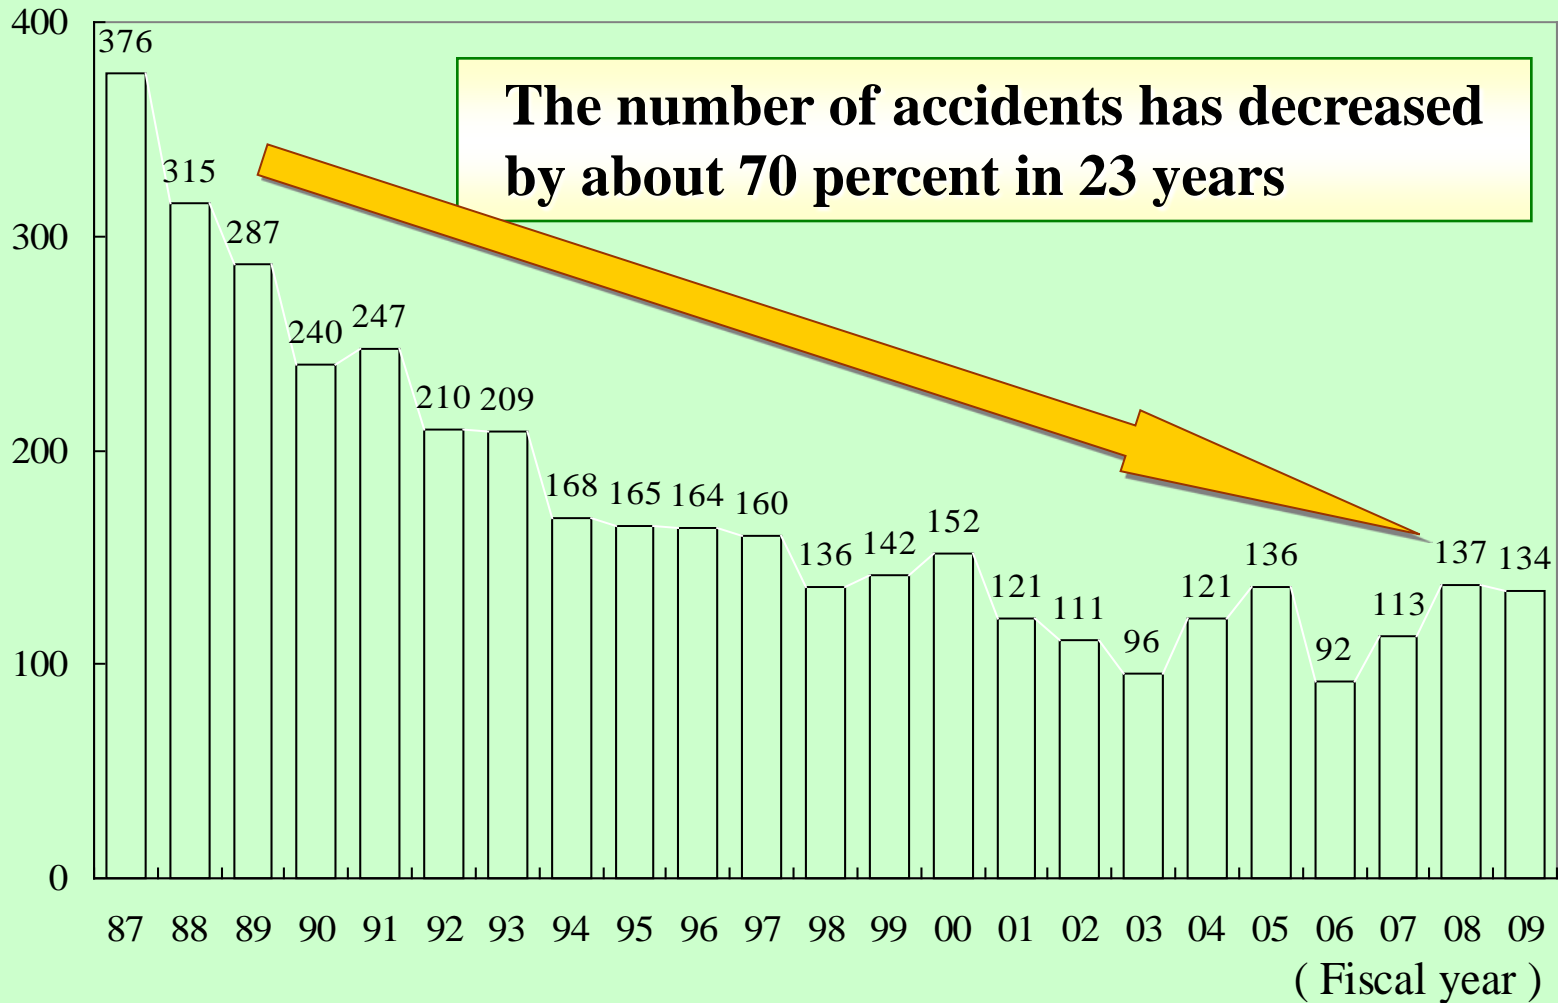
# Trend in the number of accidents since our establishment

( Number of accidents )
