Improving personal safety on commuter trains at stations in the Republic of South Africa: A study of Platform Train Interface incident solutions

Sethunya Matsie

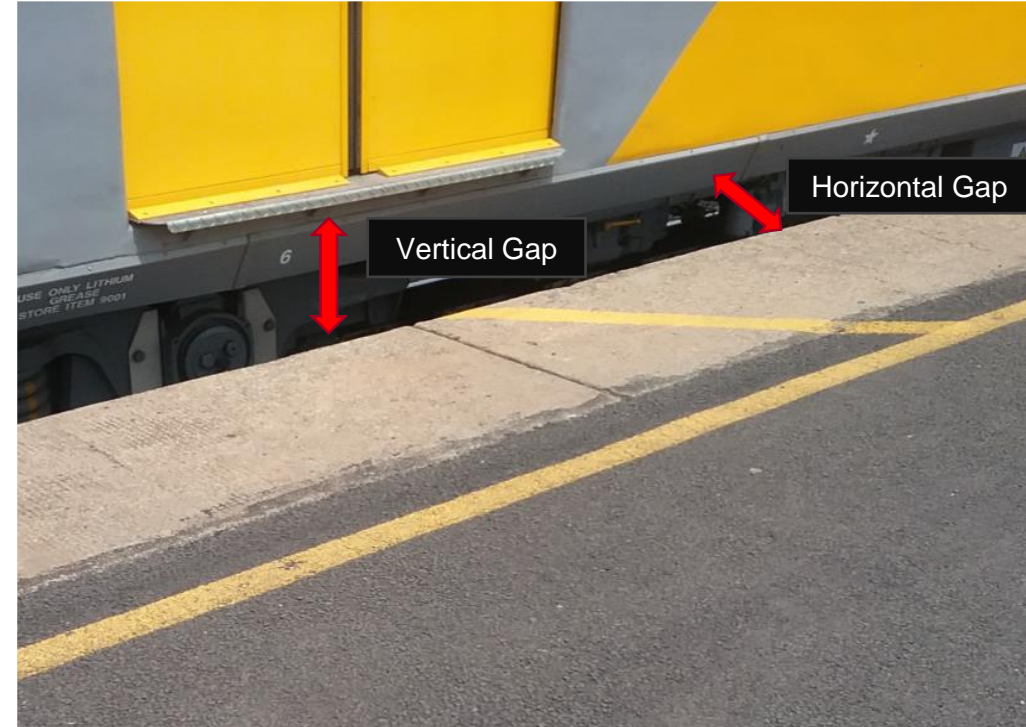
- The horizontal gap between platform and train on straight (tangent) track should remain constant.
- Gaps are usually slightly increased on horizontal curves.
- Changes in the size of the vertical and horizontal gap is at times a result of the shifting of platforms and tracks due to resurfacing, maintenance, weather, etc
