LESSONS LEARNED FROM TSB RAIL INVESTIGATIONS:

THE EVOLUTION OF THE TSB WATCHLIST

Transportation Safety Board of Canada

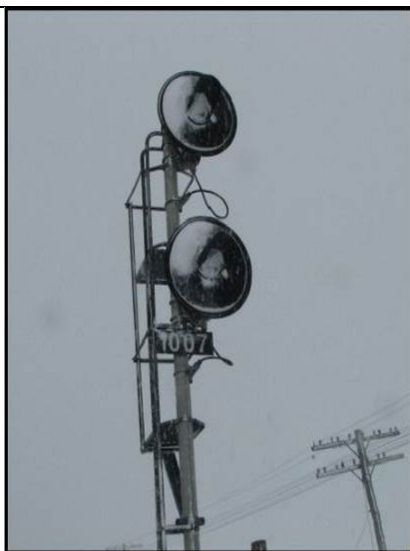
Extensive testing of the signaling system was carried out and it was determined that the signals did not malfunction; they operated exactly as intended. The investigation determined that the crew likely misperceived the signals displayed.

Picture 1. Advance signal displayed.

- The derailment occurred when the train entered the siding travelling at about 4 times the authorized speed.
- The crew's mental model combined with the poor weather likely led to the misperception that the advance signal was clear, rather than clear-to-stop.
- Due to reduced visibility caused by snow, the home signal was not recognized and acted upon until the crew was within 500 feet of the main-track switch.
- The crew's planning and reaction to more complex issues was likely degraded due to fatigue.

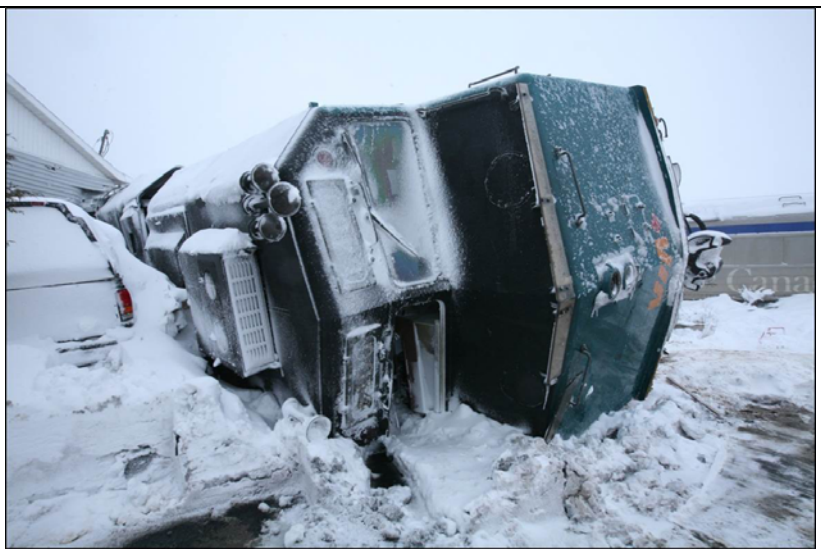
On 25 February 2010, VIA passenger train No. 15 was travelling west from Halifax, NS to Montréal QC, through a severe winter storm. Upon approaching Saint-Charles-de-Bellechasse QC, the train encountered an advance signal displaying a clear-to-stop indication (Picture 1) which meant to proceed at track speed and be prepared to stop at next signal. The next signal encountered was for the Saint-Charles-de-Bellechasse siding which displayed a restricting signal that should have indicated to the crew that the train was restricted to 15 mph. At about 0435, the train entered the siding at about 64 mph and derailed 2 locomotives and 6 passenger cars (Picture 2). Two locomotive engineers and 5 passengers were injured.

Picture 2. Locomotive derailed.

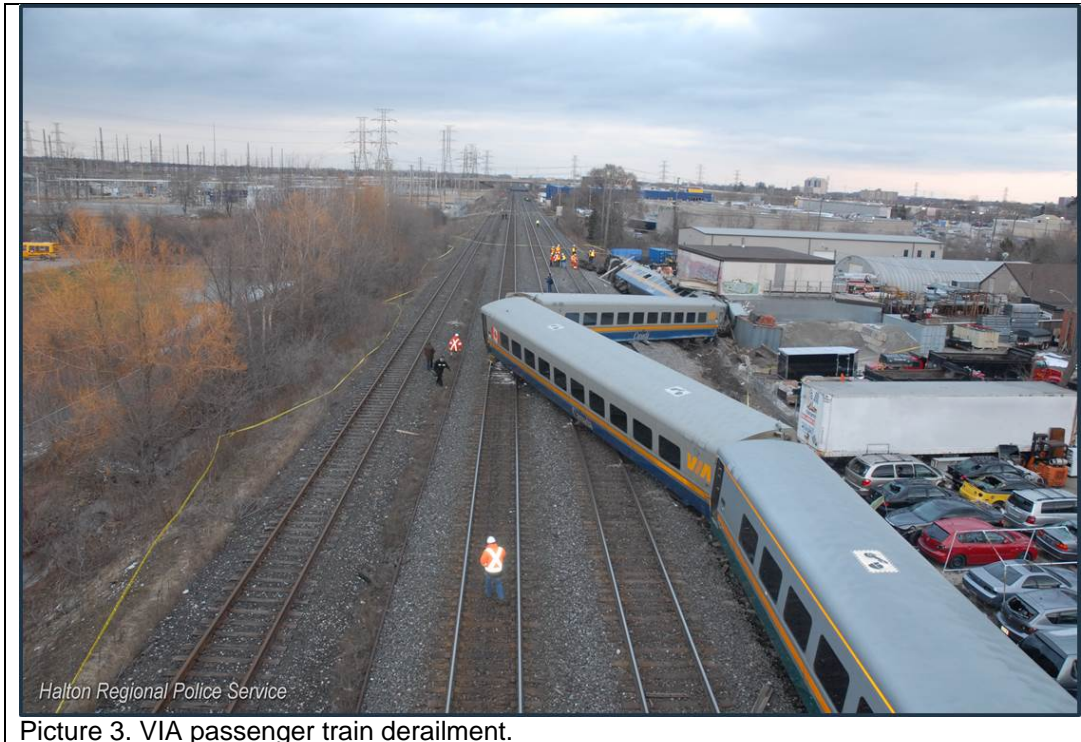
67 mph, causing the locomotive and all 5 coaches to derail (Picture 3). The 3 operating crew members in the locomotive cab were killed; 44 passengers and the VIA service manager were injured. About 4300 litres of diesel fuel spilled from the locomotive fuel tank.

Picture 3. VIA passenger train derailment.

- The stop at Aldershot Station interrupted the continuous progression of signals which may have contributed to the train crew forgetting the previous Clear to slow (Y/Y) indication.
- The frequent use of track 2 may have influenced the misperception of signal 334T2 as being more permissive.
- The crew likely became focused on resolving a track occupancy conflict with a signals crew working ahead on track 2 rather than identifying signal 334T2 and slowing the train.
- The crew may have become focused on the more salient Flashing Yellow (FY)/Flashing Green (FG) aspects and misinterpreted signal 334T2 as Advance Clear to Limited, which would permit them to travel at track speed, rather than Slow to Limited (Red/FY/FG) which should have restricted speed to 15 mph.

The Department of Transport require major Canadian passenger and freight railways implement physical fail-safe train controls, beginning with Canada's high-speed rail corridors.
(Recommendation R13-01)

The Department of Transport require that all controlling locomotives in main line operation be equipped with in-cab video cameras.
(Recommendation R13-02)
